Inspection of the GRO#3 Well Site

Nuussuaq peninsula,
West Greenland

Research Notes from NERI No.: 89

David Boertmann

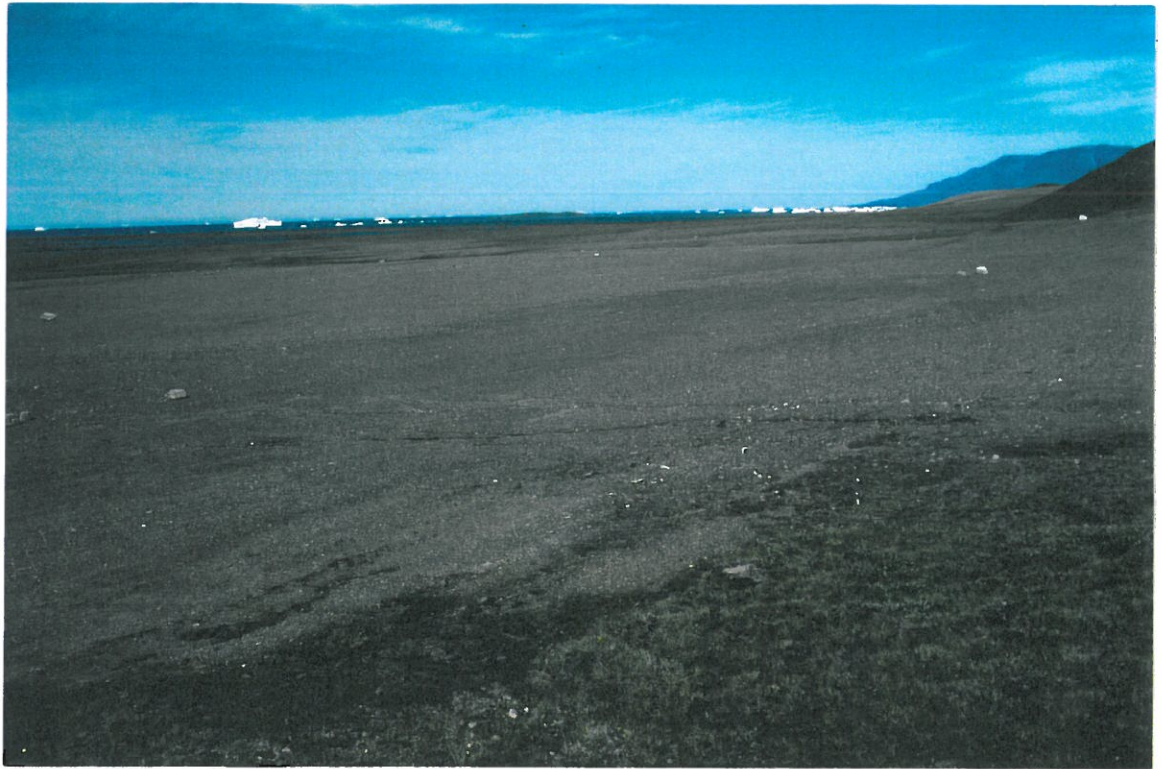
Fig. 2. The NE corner of the lease area. Compare to Fig. 2 in Photo report of 4 November 1996.

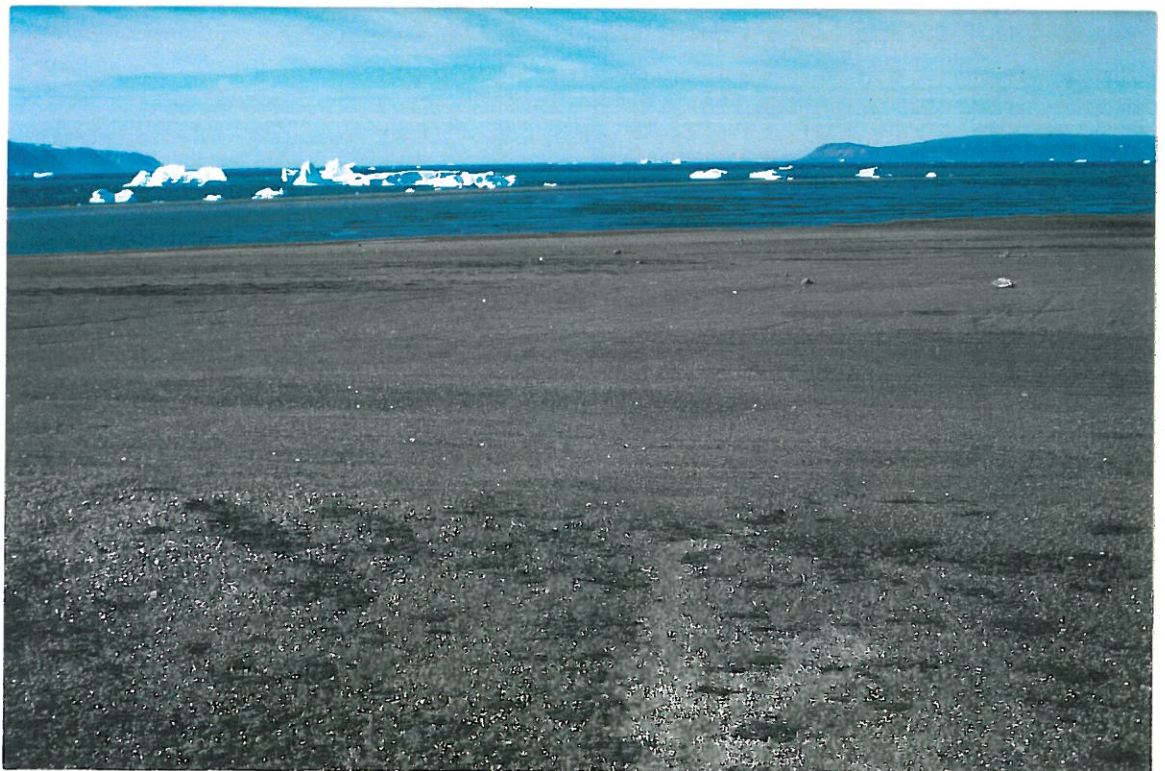
The lease area was levelled and grated, and looked at distance like the other gravel plains in the area. In close range caterpillar tracks etc. were obvious. In the southern part a depression (4x2 m wide and about 0.5 m deep) was located, obviously by compressing of layers below the gravel. This is probably the flare pit where the solid fraction of the drilling mud was deposited. On the brink along and above the northeastern side, streaming water had created several small erosion canyons.

In conclusion the restoration of the GRO#3 area is acceptable. The only feature which could give reason for some concern is the depression in the lease area. This is, however, in the dry gravel, which is well drained, and water erosion originating in this depression is unlikely.

Fig. 3. The lease area seen from NW. Compare to Fig. 3 in Photo report of 4 November 1996. The flare pit depression is indistinctly seen below the white stone in the right part of the photo.

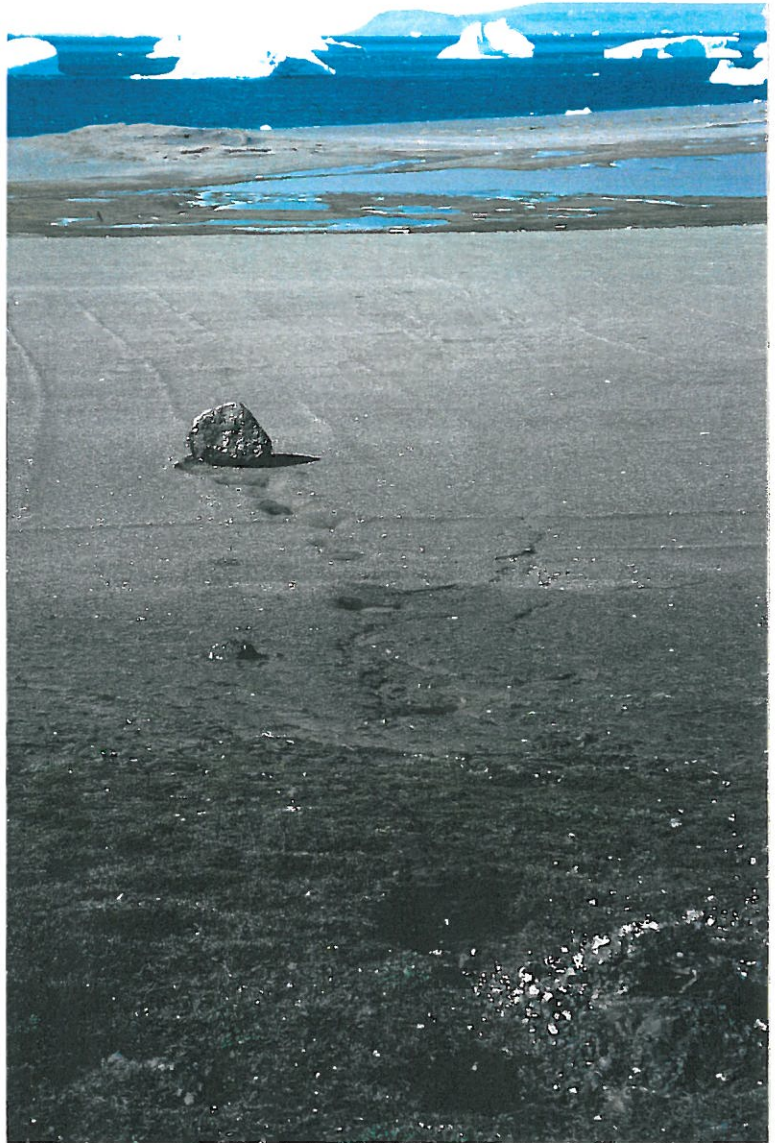
The camp site area was like the lease area levelled and grated, and looked at distance like the surrounding gravel areas. Caterpillar tracks were visible at close quarters. Forty barrels of Turbo Fuel A1 were left in the area, behind a low hill and probably not visible from the sea. In the centre of the area a large boulder had come to rest after tumbling down from the mountain side east of the camp area. This probably occurred recently (during spring 1998 ?).

Fig. 4. Part of the camp site area seen from the eastern edge. Note the boulder and its track.

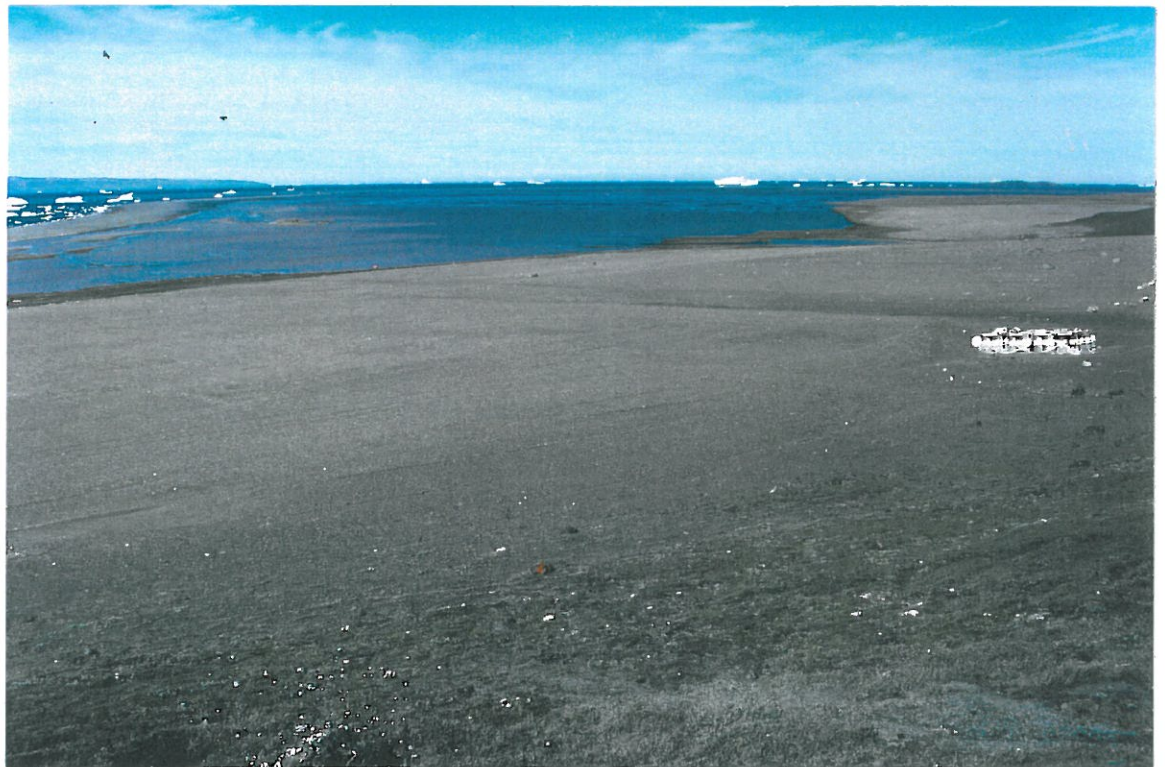
Fig. 5. The camp site area seen towards WNW. Note the fuel drums.

The forty fuel barrels in the camp site area has been purchased by Grønlandsfly. If they are to be moved away or shall remain there as a fuel storage, is not known. Removal of the barrels (at least when they have been emptied) is recommended.

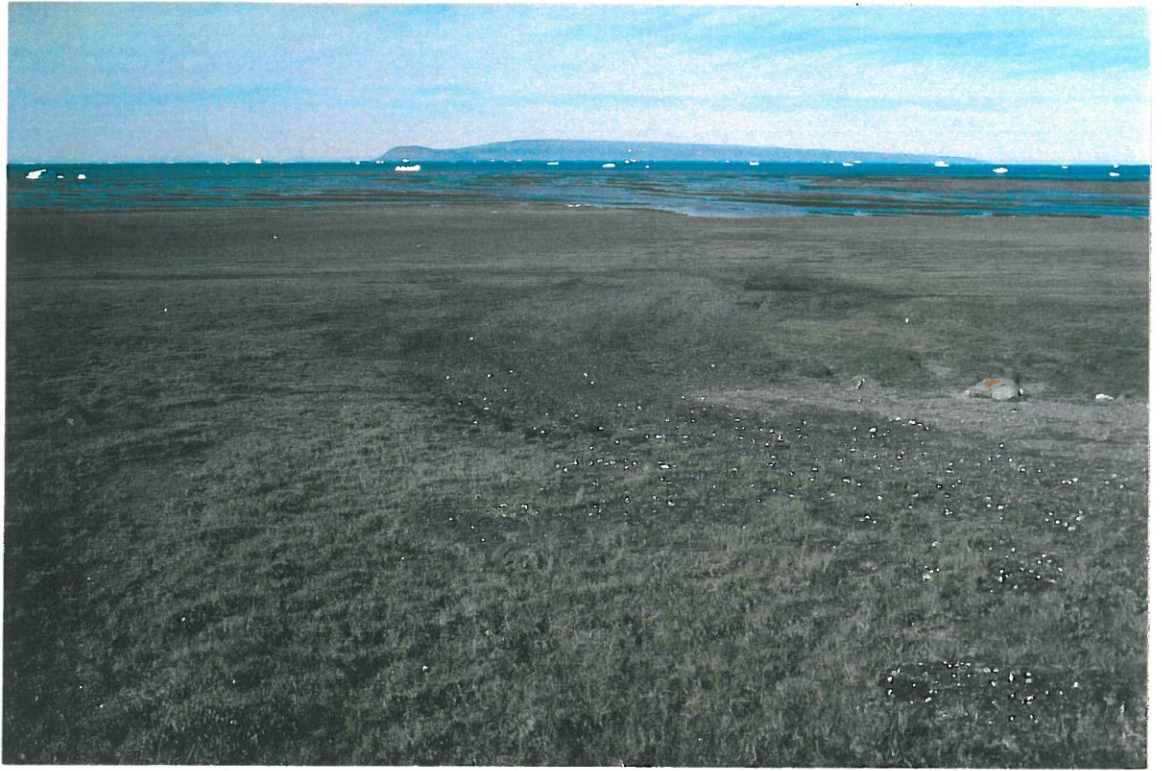
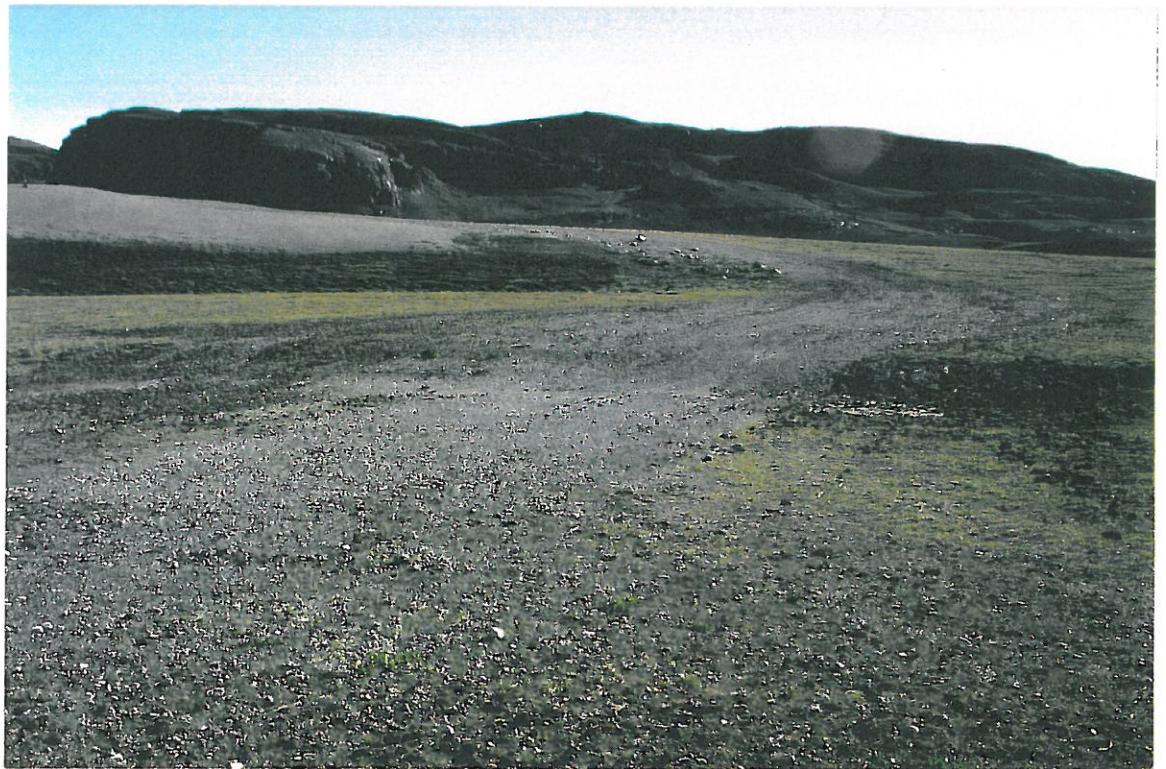
The deep ruts were filled with gravel and the damage area levelled. No water bodies were seen, and only a few shallow erosion canyons were present on the sloping parts. Here and there Common Horsetail (*Equisetum arvense*) was apparently re-established and scattered shoots and buds from mainly Willow (*Salix*) had penetrated the gravel.

The restoration measures were adequate, although the damage will be visible for many years, perhaps even decades.

Fig. 6. Vegetation and terrain damage #1 seen from N. Compare to Fig. 5 in Photo report of 4 November 1996.

Fig. 7. Vegetation and terrain damage #1 seen from S. Compare to Fig. 6 in Photo report of 4 November 1996.

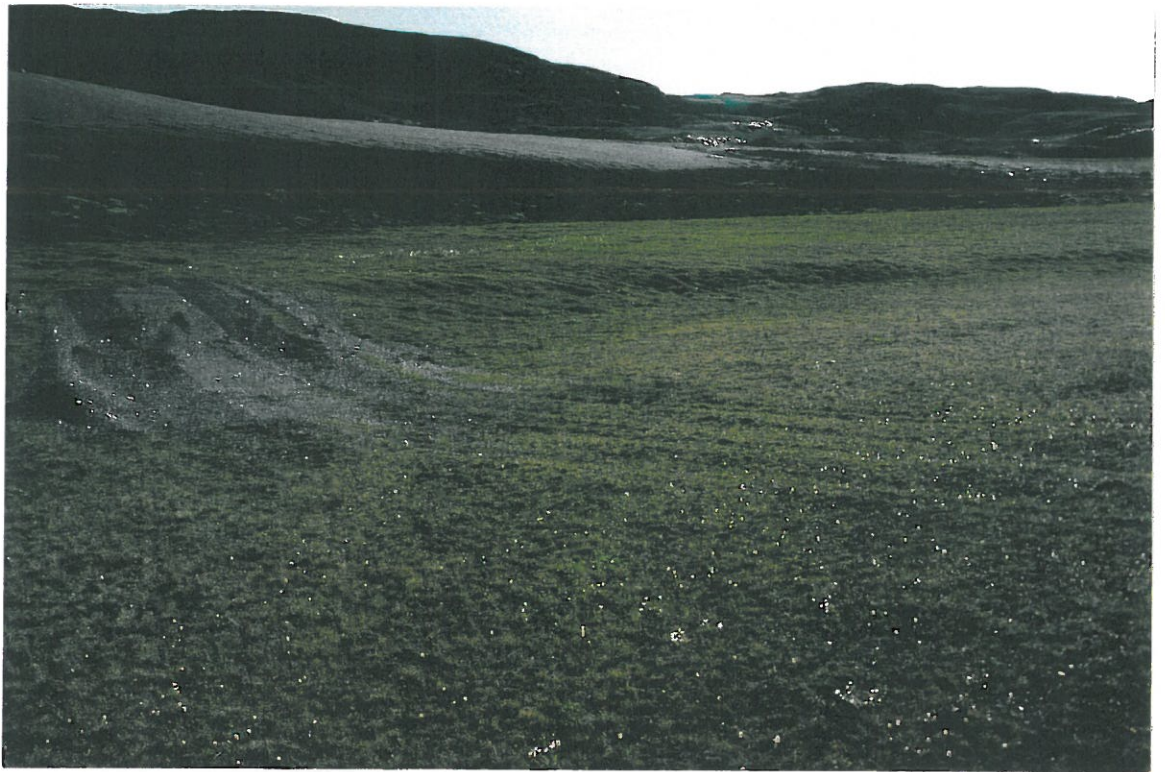
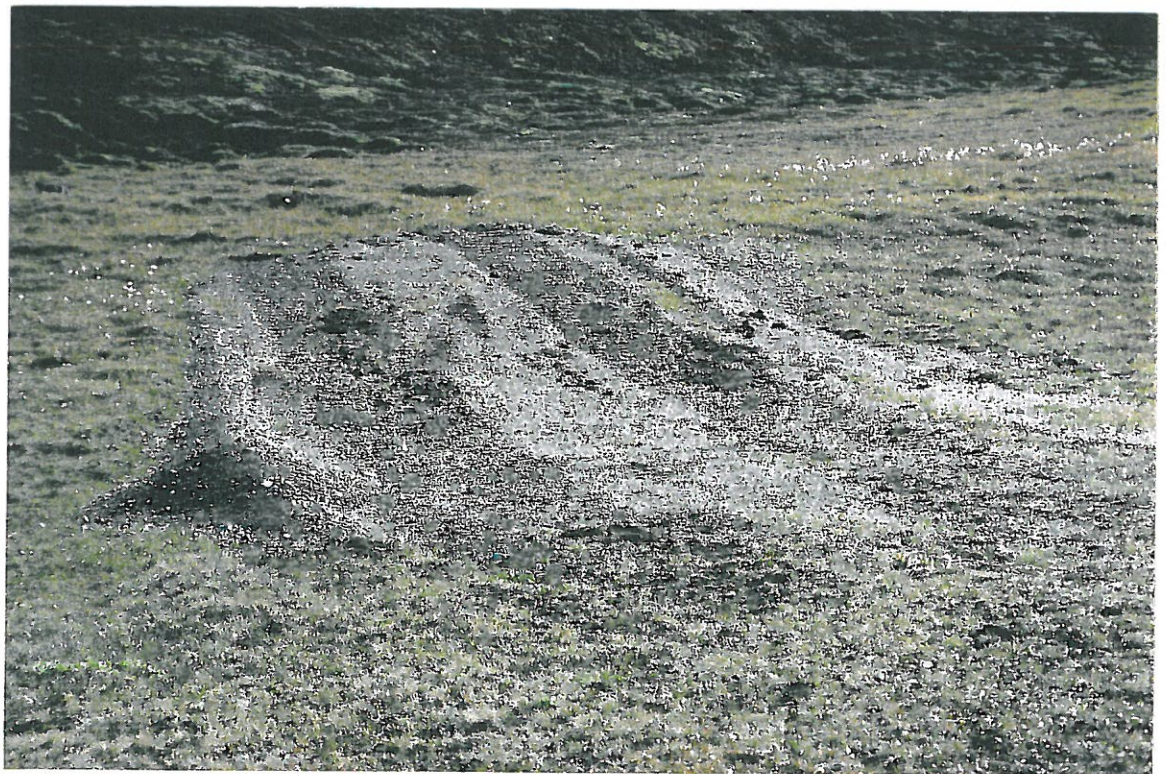
The deep ruts were filled with gravel and the area levelled. No water bodies were visible, and fresh shoots from underlying vegetation penetrated the gravel layer here and there. A Caterpillar track was very obvious in the gravel.

The restoration measures were adequate, and the area will probably be covered by vegetation within some years.

Fig. 8. Vegetation and terrain damage #2 seen from S. Compare to Fig. 7 in Photo report of 4 November 1996.

Fig. 9. Vegetation and terrain damage #2 seen from S. Compare to Fig. 7 in Photo report of 4 November 1996.

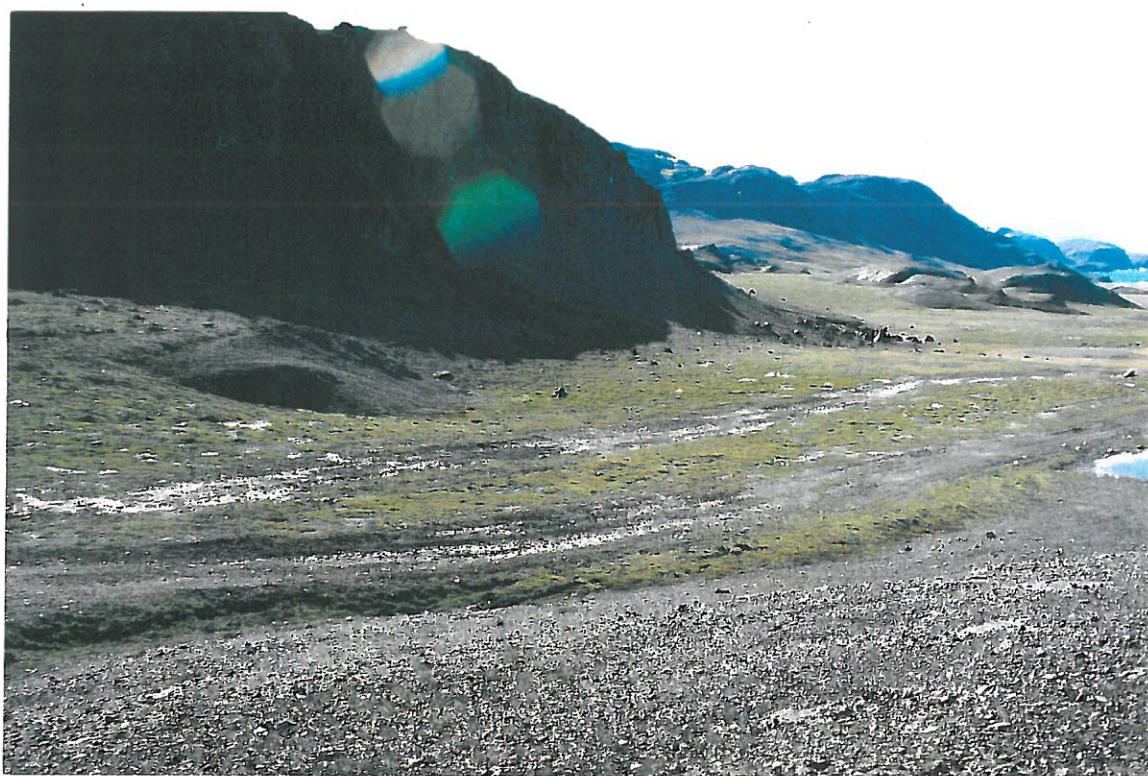
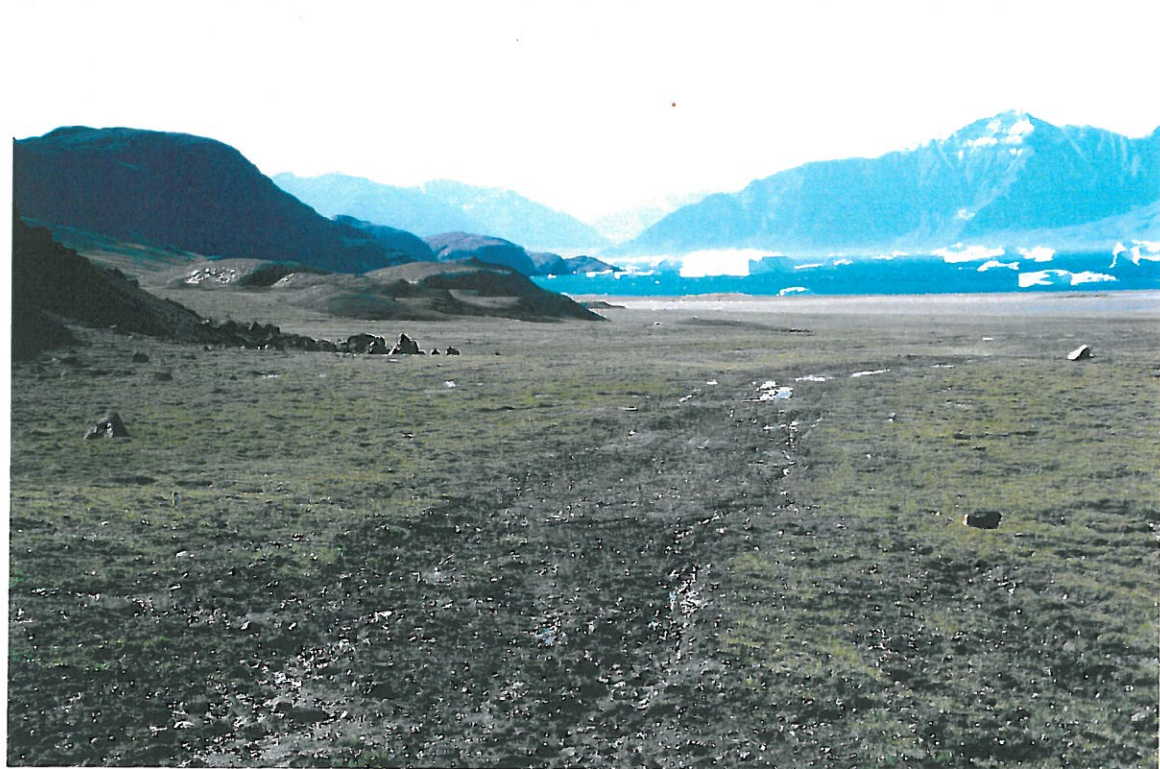
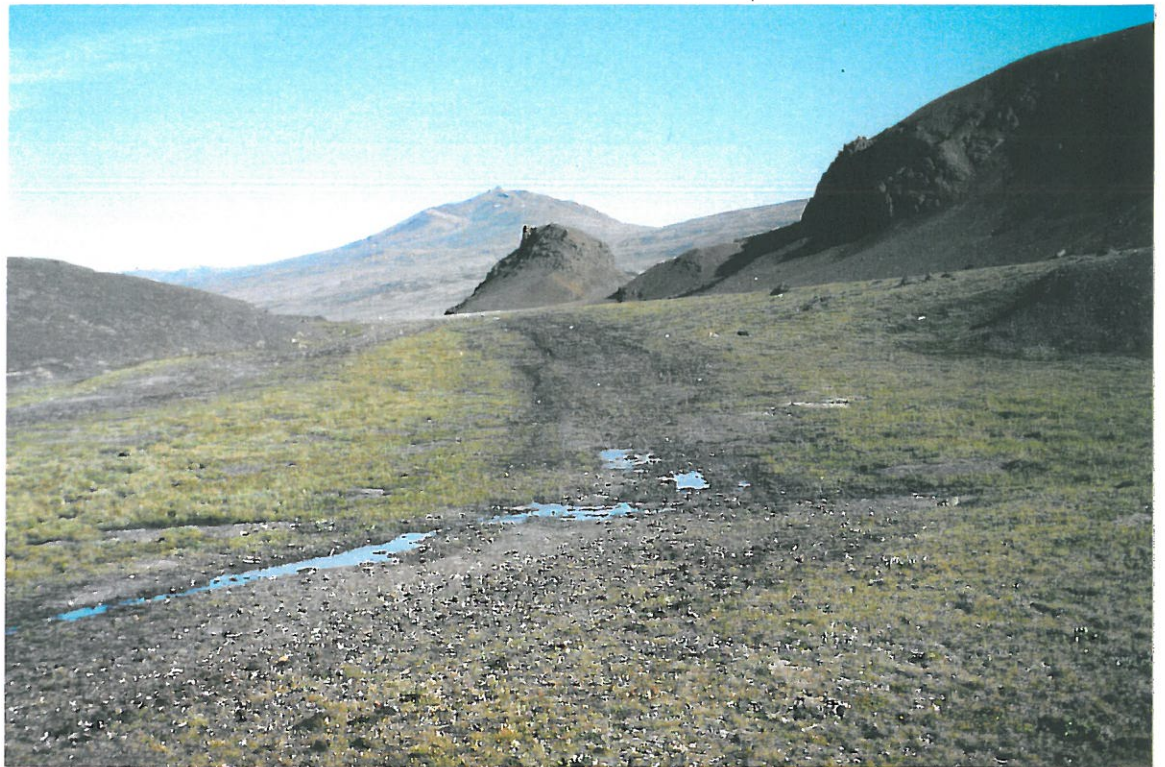
The many parallel ruts and banks caused by the driving were levelled, and as far as I could judge no gravel had been filled in. There were standing water in some shallow depressions, and small streams in sloping parts. No re-established vegetation was seen in the restored areas.

The restoration measures were adequate. The damage area will be visible for many years, probably for decades.

Outside the specific damage areas, streaming water had created erosion canyons on sloping ground below #3. The canyons were about 2 m long and 20 cm deep.

Fig. 10. Vegetation and terrain damage #3 seen from NW. Compare to Fig. 9 in Photo report of 4 November 1996.

Fig. 11. Vegetation and terrain damage #3 seen from NW. Compare to Fig. 10 in Photo report of 4 November 1996.

Fig. 12. Vegetation and terrain damage #3 seen from SE. Compare to Fig. 11 in Photo report of 4 November 1996.

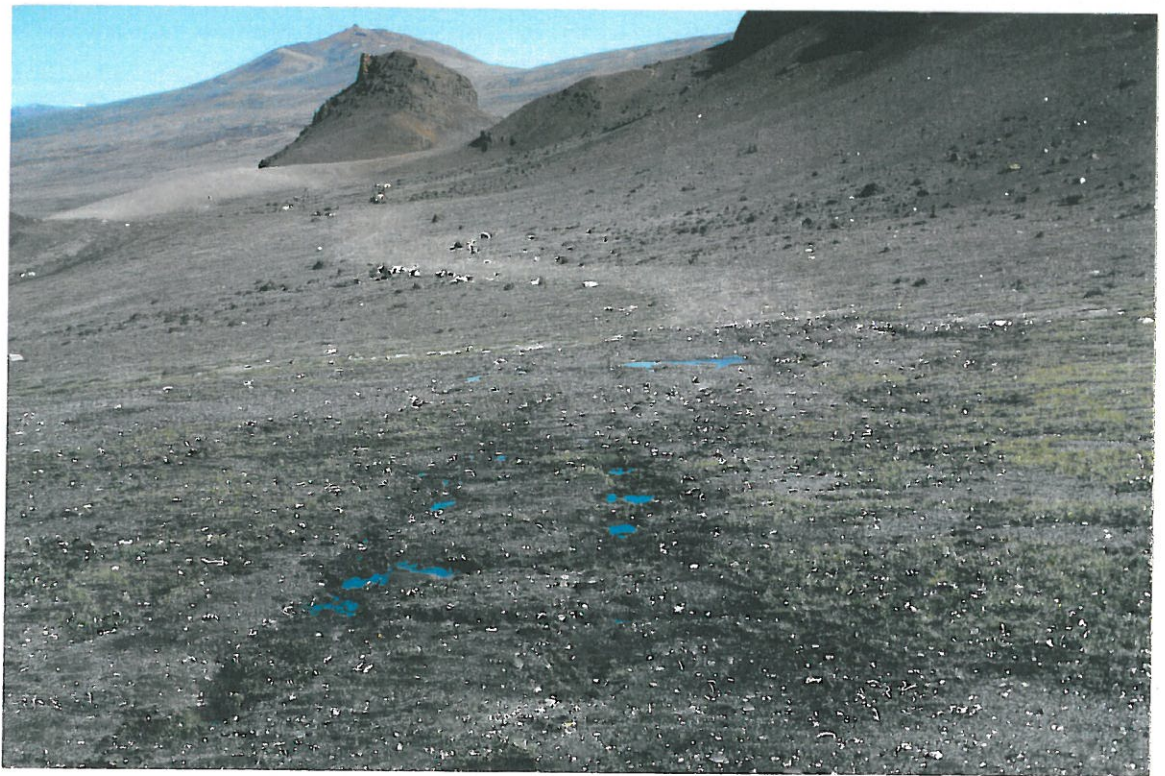
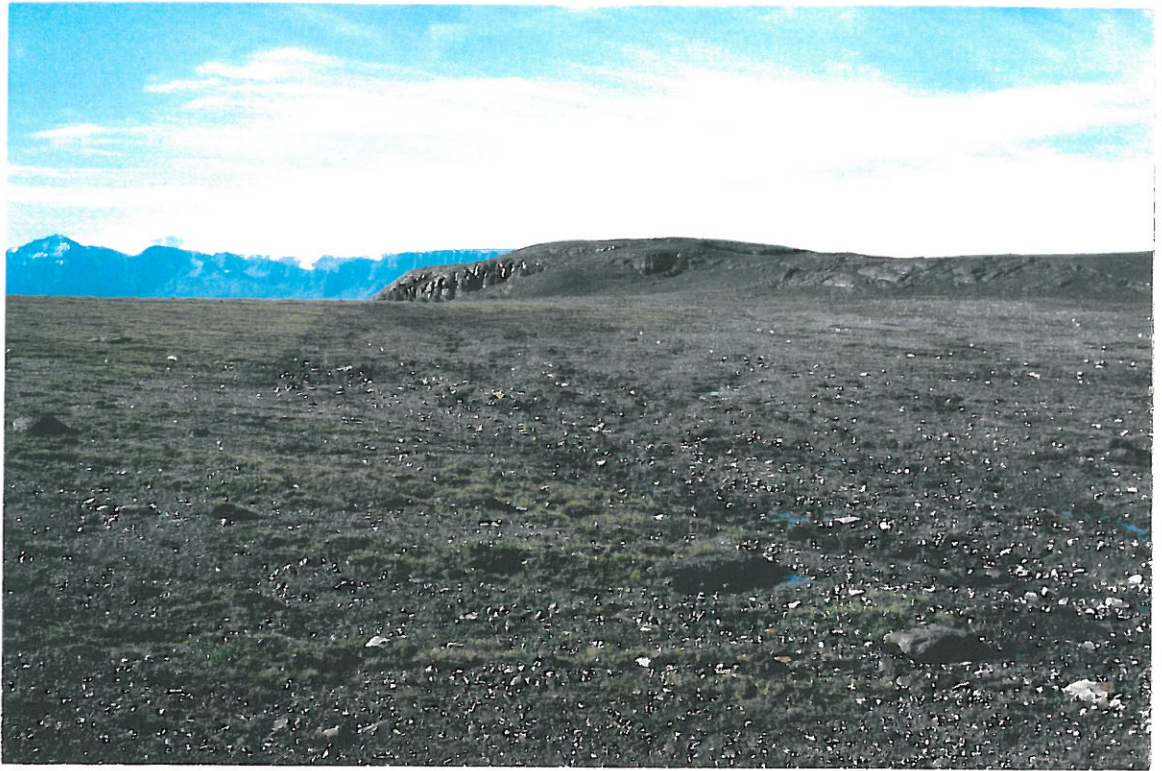
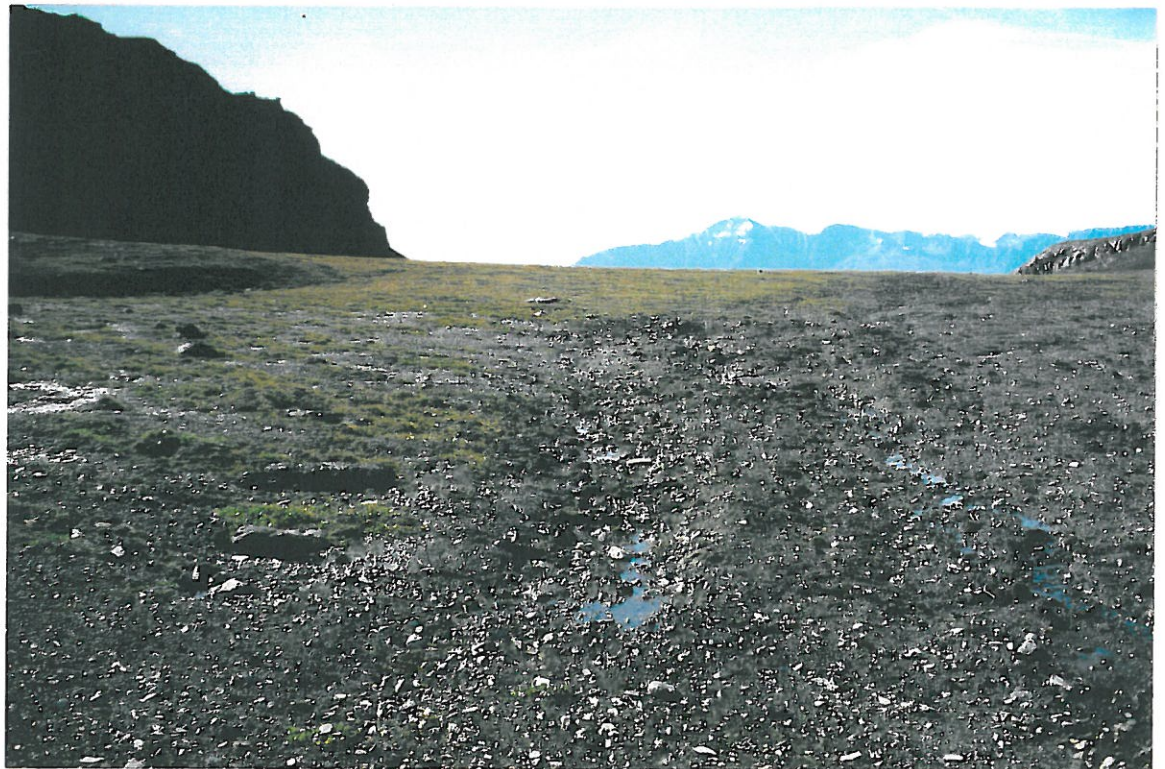
The many deep ruts and the deep holes where the bulldozers got stuck were filled with gravel and levelled. Standing water was seen in several shallow depressions. No re-established vegetation was seen in the restored areas.

Compared to how bad this site looked in September 1996, the restoration is good. There is no doubt that it will be visible for many years, probably decades.

Fig.13. Vegetation and terrain damage #4 seen from SE. Compare to Fig. 13 in Photo report of 4 November 1996.

Fig. 14. Vegetation and terrain damage #4 seen from NE. Compare to Fig. 12 in Photo report of 4 November 1996, although seen from another angle.

Fig. 15. Vegetation and terrain damage #4 seen from N. Compare to Fig. 12 in Photo report of 4 November 1996, although seen from a different angle.

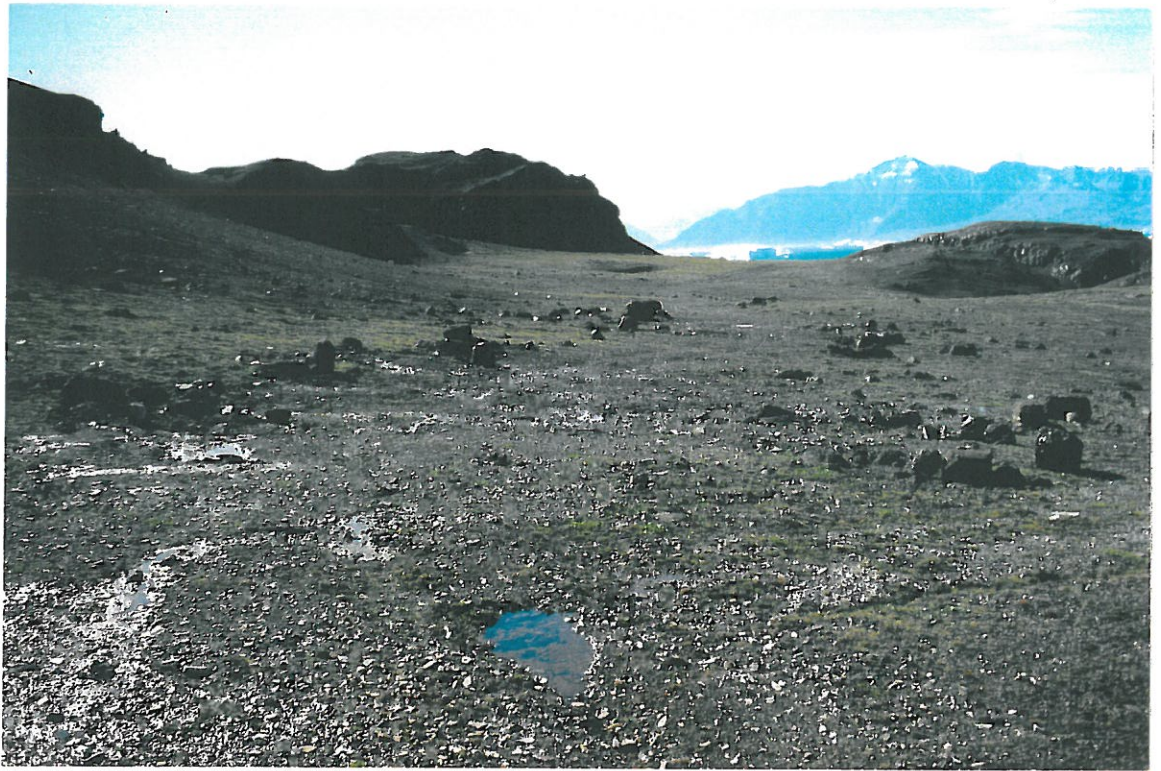
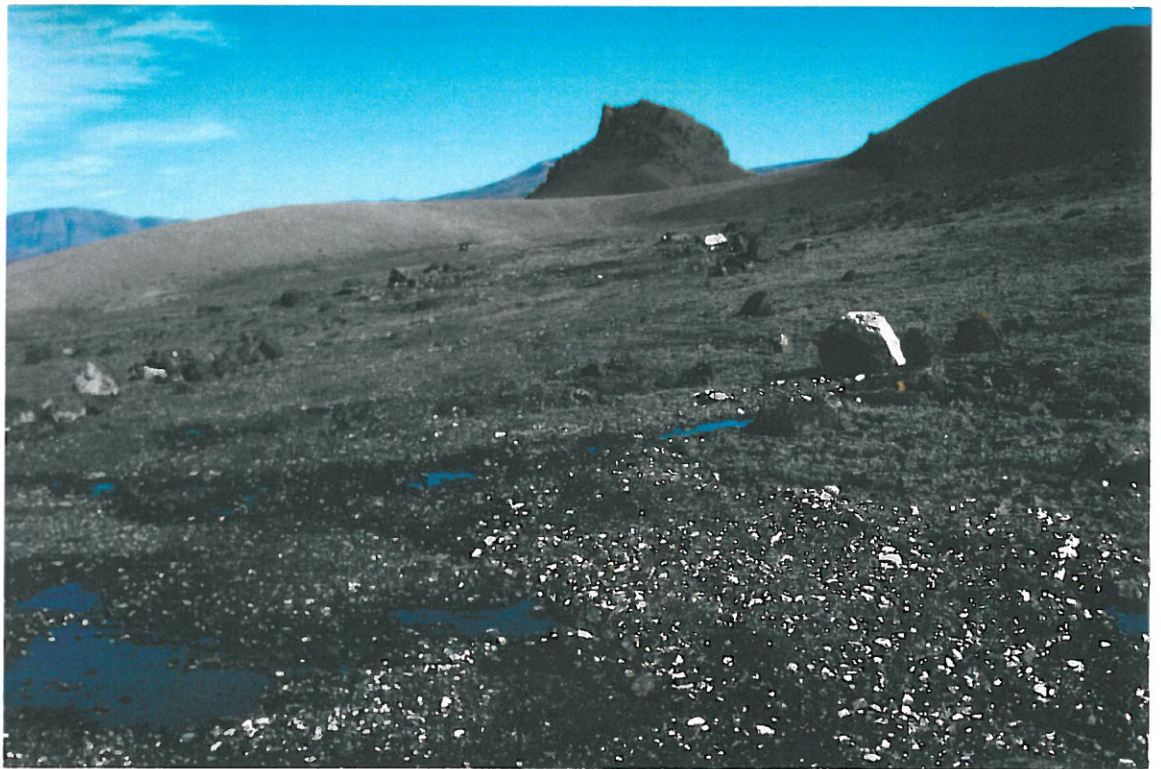
The tracks in this dry gravel area were levelled. A few depressions held shallow standing water.

The restoration measures were good. The track will be visible for decades in this area.

Fig. 16. Vegetation and terrain damage #5 seen from N. Compare to Fig. 15 in Photo report of 4 November 1996.

Fig. 17. Vegetation and terrain damage #5 seen from S.

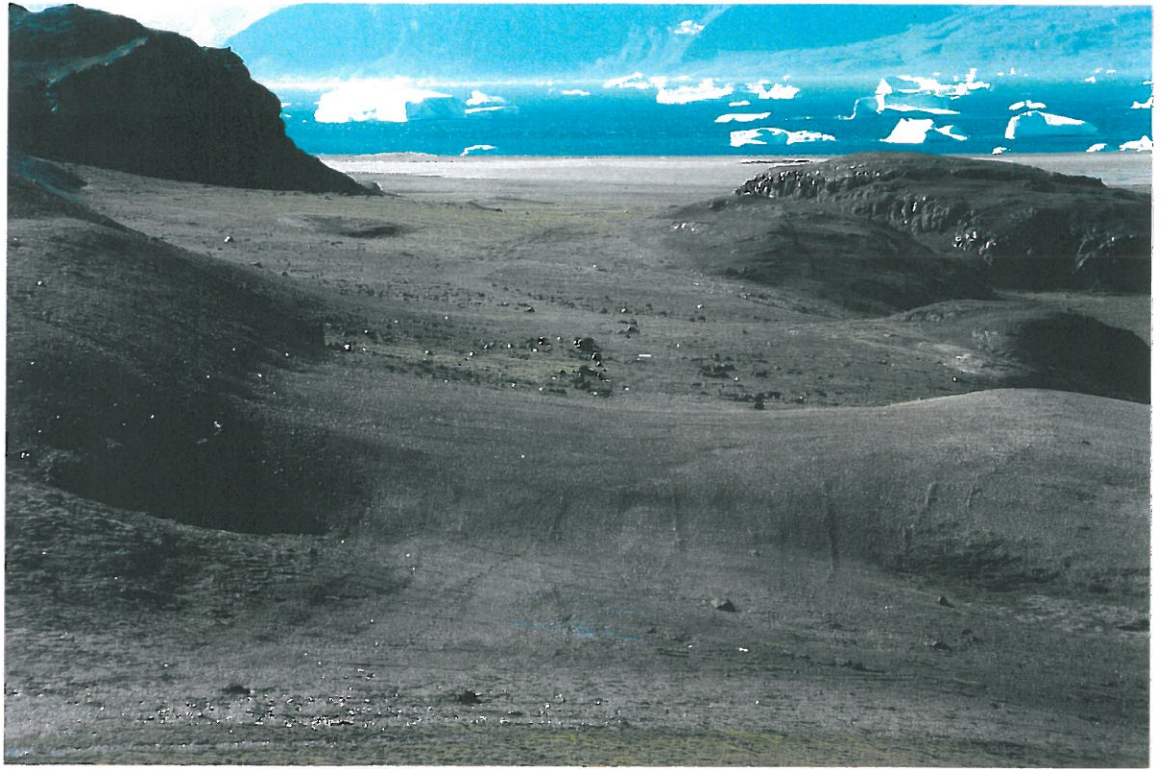
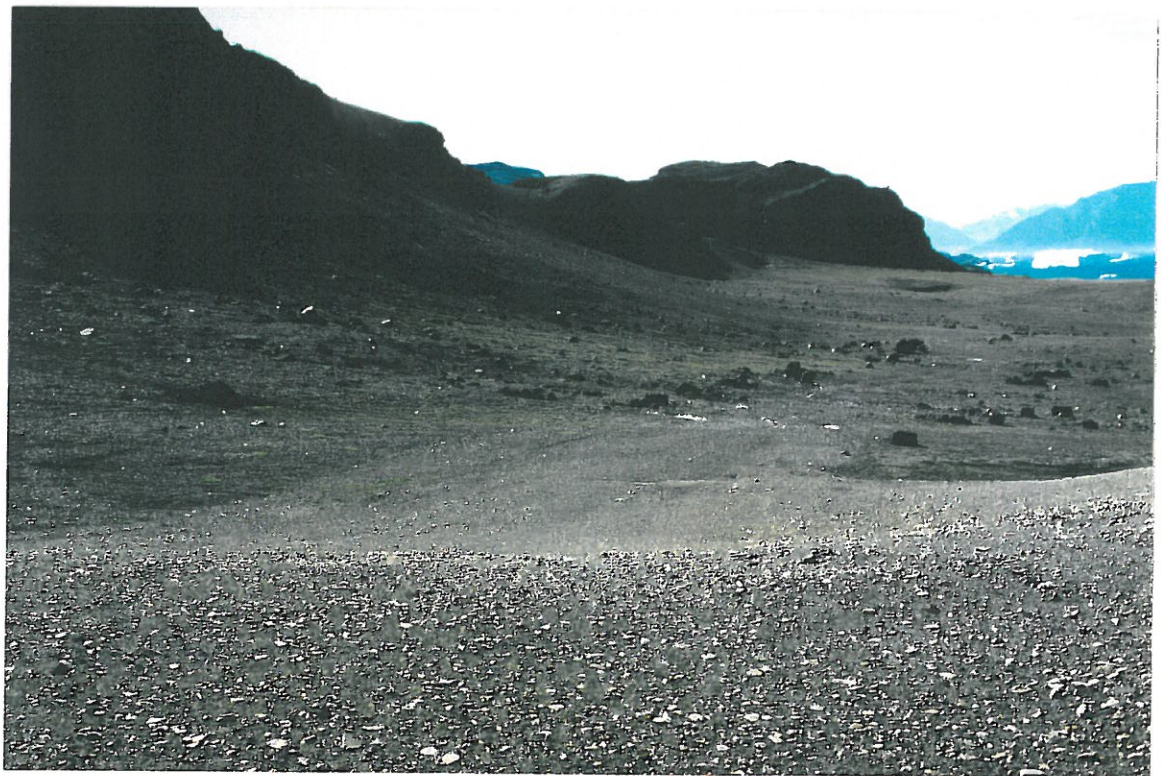
The tracks and the terrain was levelled.

Restoration measures good.

Fig. 18. Vegetation and terrain damage #6 with #5 and #4 in background, seen from N. Compare to Fig. 16 in Photo report of 4 November 1996.

Fig. 19. Vegetation and terrain damage #6 with #5 in background seen from N. Compare to Fig. 17 in Photo report of 4 November 1996.

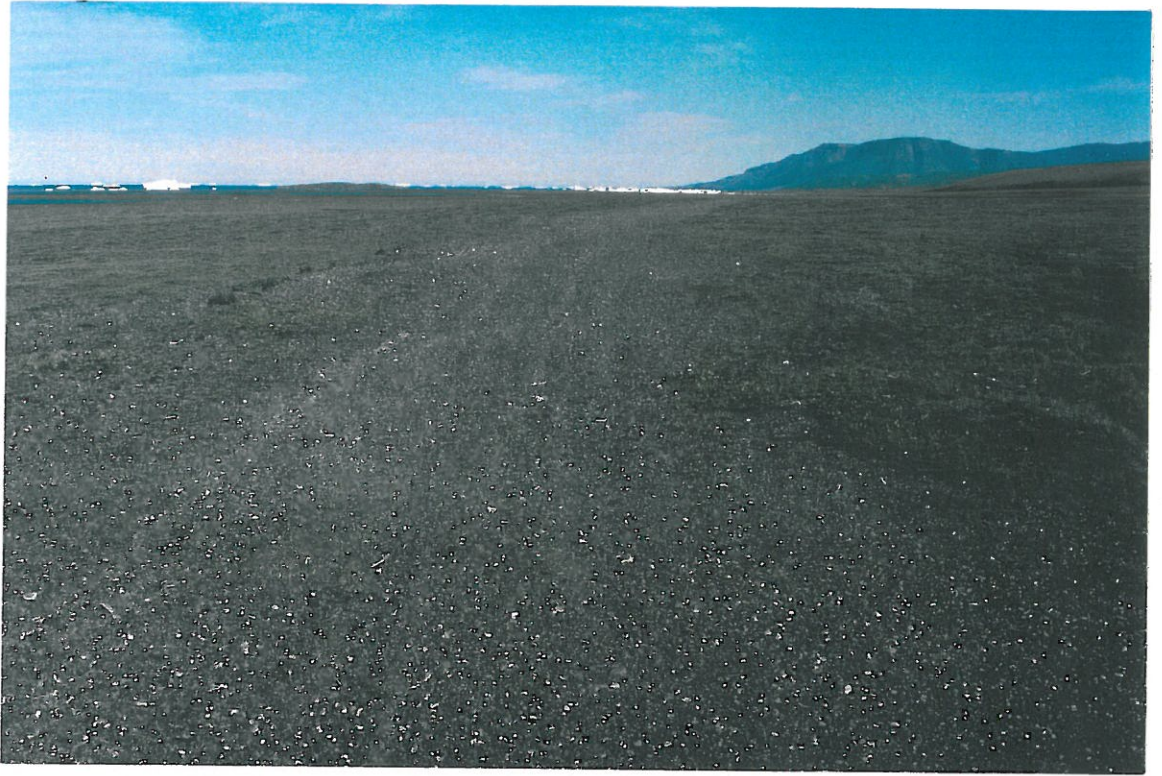
The general impression was that the main routes between the camp area, the lease area and from the lease area and northwards are clearly visible particularly from the air. Moreover many small tracks made outside the main routes by the ATV vehicle and the VSP vehicle are visible as well.

Fig. 20. Access route just north of lease area.

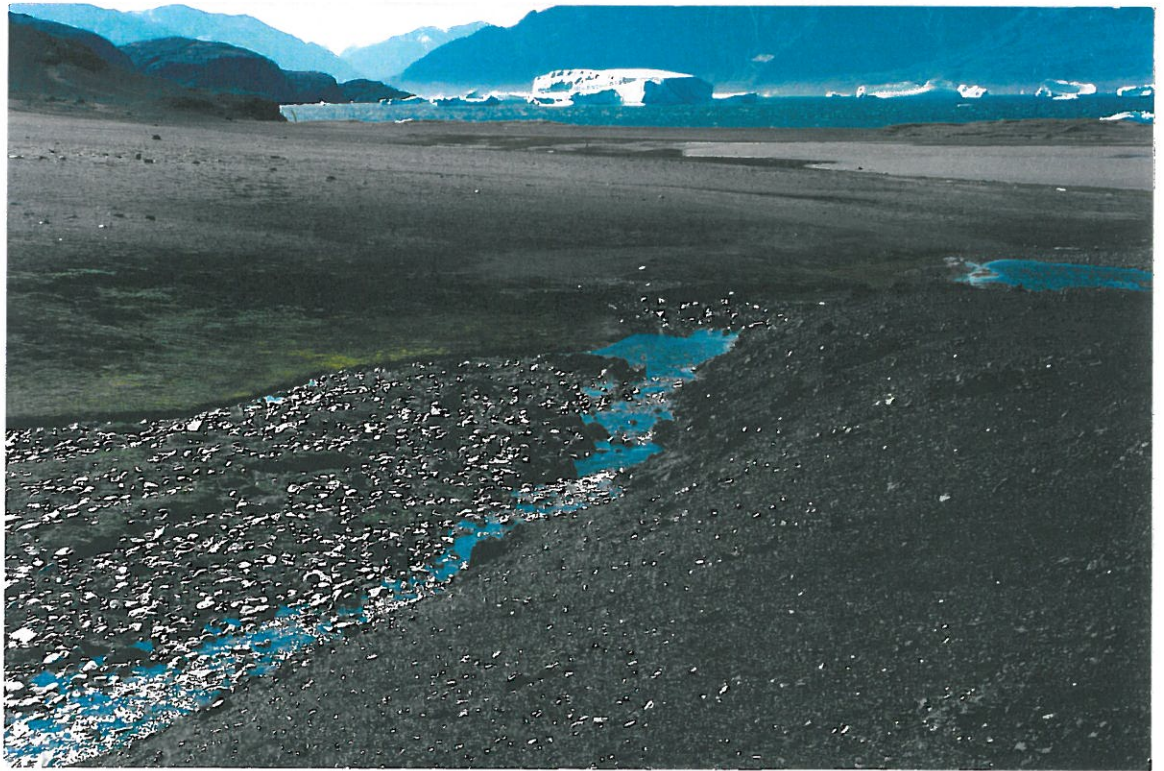
The small dam creating the water reservoir southeast of the lease area was removed, and the stream flowed free.

Fig. 21. Former water reservoir. The dam has been removed.
