ANALYSIS OF MICROPLASTIC PARTICLES IN DANISH DRINKING WATER

Scientific Report from DCE - Danish Centre for Environment and Energy

No. 291

2018

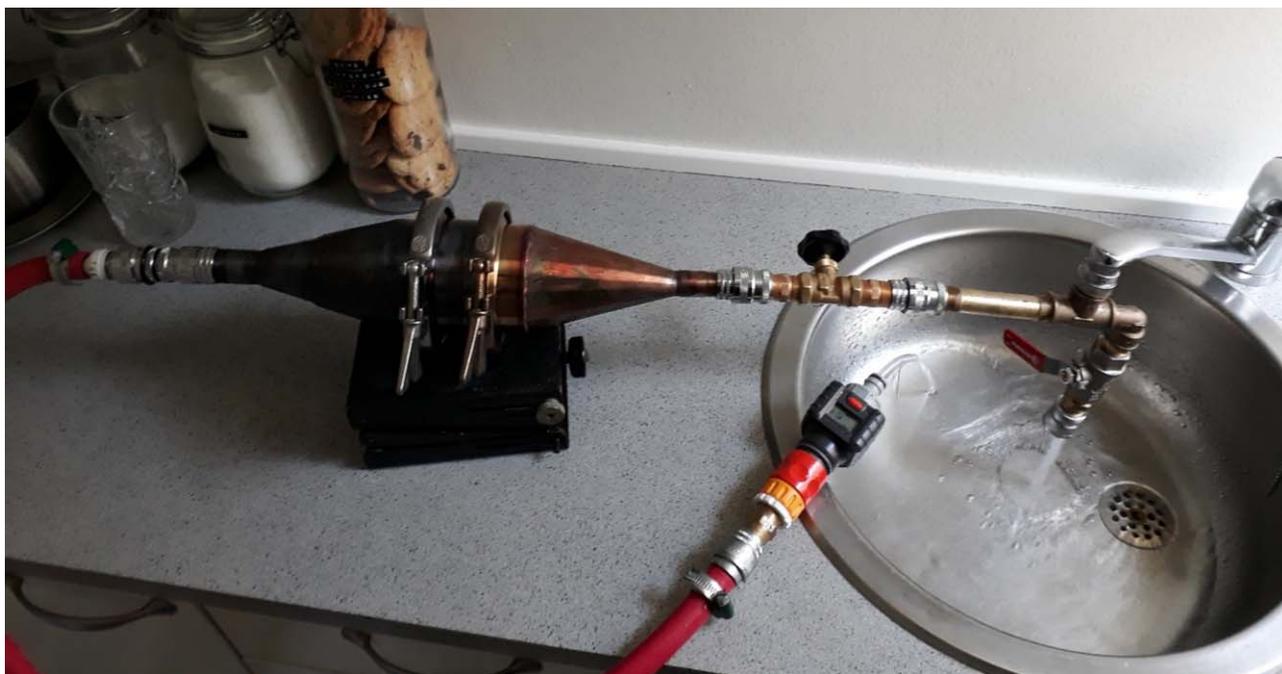
Figure 2. Tap water sampling. Deployment of the stainless steel sampling column to the drinking water tap for collection of 50 L water samples.

Sampling of tap water was performed by direct coupling of a stainless steel column mounted with a stainless steel filter to the tap (Fig. 2), as previously described in the method developed for analysis of MP in tap water (Strand, 2018). A small modification was made to the equipment by exchange of the 20 μm filters with new steel filter nets with a finer pore size and an absolute filtering ability of 11-12 μm .

Before sampling was initiated, a short flushing of the tap outlet was performed for about 2 minutes. The sampling equipment was deployed to the tap using a small pipe with an appropriate thread, which was coupled directly to the sampling column with a fitting. During sampling, the taps were opened to full water pressure, and the flow through the sampling column was adjusted to 2.0 L per minute, while the residual water was led directly to the sink through an outlet tube. For each sample, a volume of 50 L was passed through the sampling column and potential MP in the water were retained in the steel filter for quantification and chemical analysis.

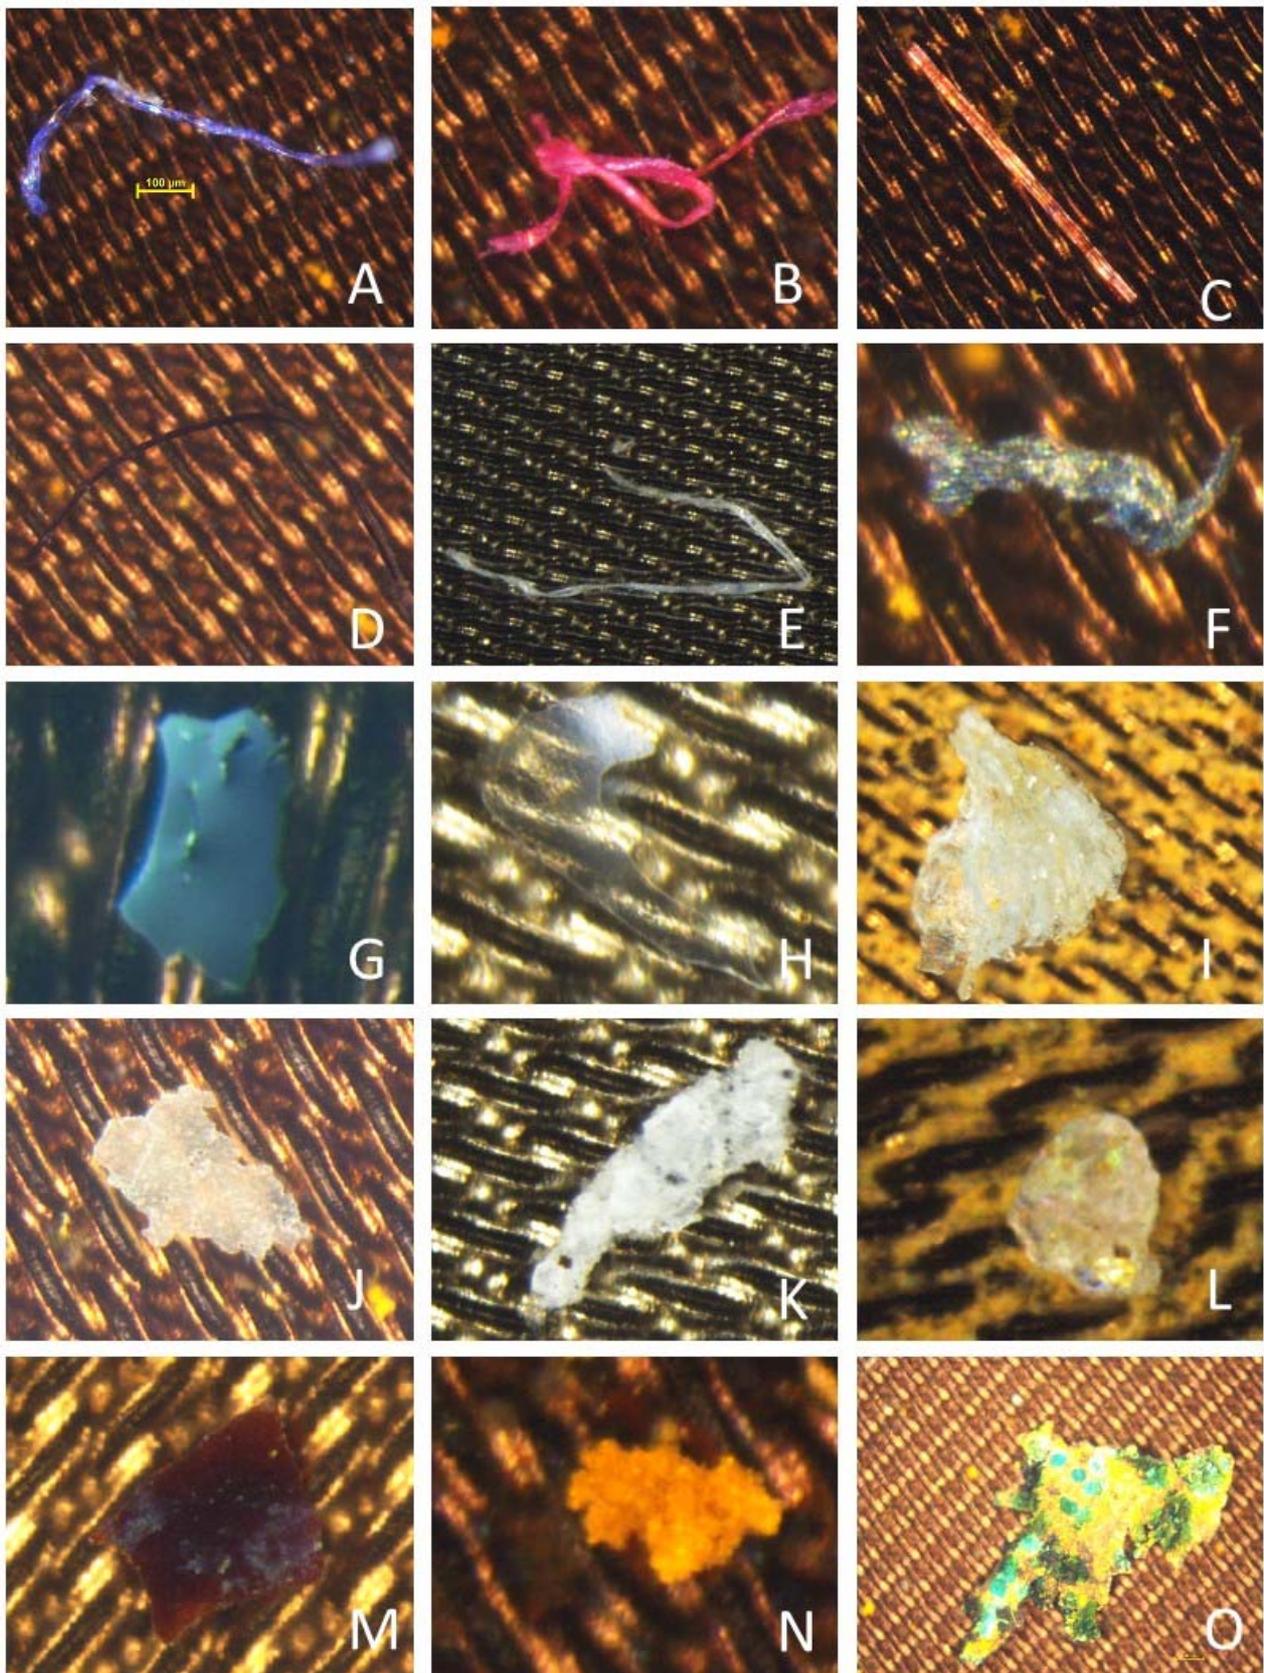
Figure 3. Stereomicroscopy and classification of characteristic particles > 100 μm observed in the water samples. The pictures show examples of particles characterized as potential MP-like fibers (A-D); uncertain MP-like fibers (E); potential MP-like fragments (F,G,I) and potential MP-like films (H). Particles of inorganic and organic material resembling salts (J-K), quartz (L), protein-like (M), rust (N) or metallic particles (O) were disregarded as MP.

The quantification and characterization of MP-like particles by stereomicroscopy relies on a subjective discrimination, as the filters contained a range of different particle types that were not MP. Particles that were regarded as potential MP were MP-like fibers with strong colors such as blue, pink or black (see examples in Fig. 3A-D). Furthermore, all fragments and films with characteristics of MP (see examples in Fig. 3F-I), were also counted as potential MPs. The most dominant group of particles that were regarded as uncertain MPs were fibers or fiber-like filaments with white to transparent colors (see example Fig. 3E). Other fragments or films with MP-like but less characteristic features than the particles grouped as potential MPs, were also recorded as uncertain MPs. Particles that were disregarded in the quantification were all white to transparent fragments with characteristics of either organic or inorganic material (e.g. salts, crystalline material, quartz, skin) (see examples Fig. 3J-L). In addition, all protein-like, rust-like and metallic-like particles (see examples Fig. 3M-O) were also disregarded.

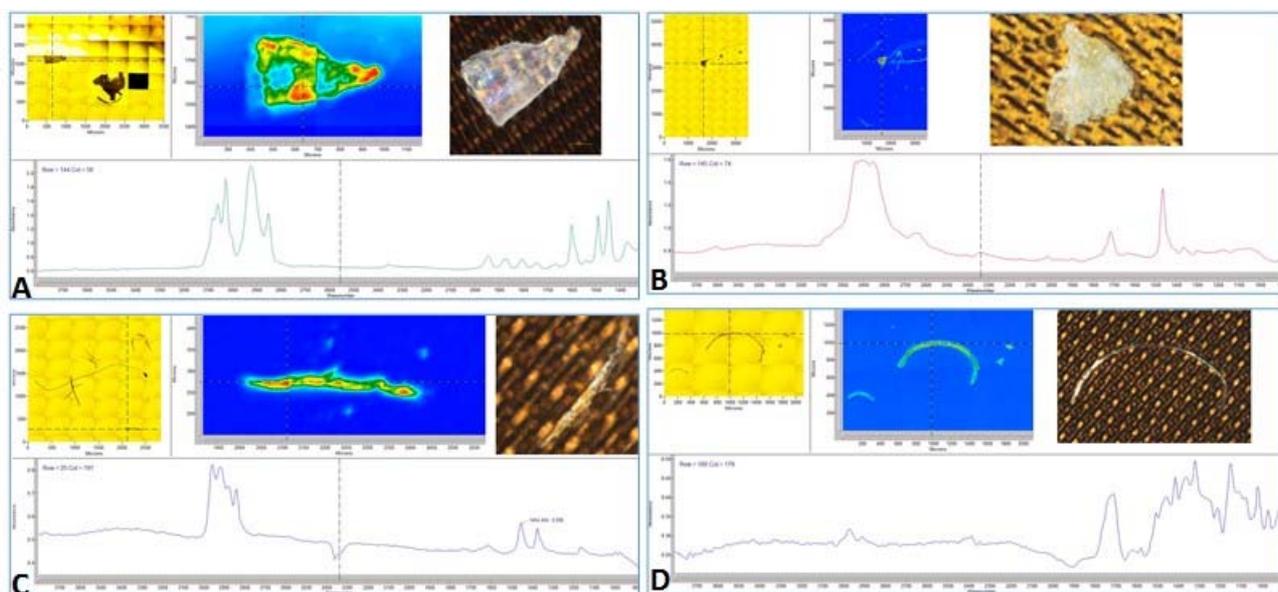
Figure 4. Verification and identification of MP-particles > 100 µm by µFT-IR. Specific µFT-IR spectres and corresponding photos from microscopy are shown for; A) a transparent fragment (~600 µm) from site 8 characterized as a potential MP-fragment by visual inspection and identified as polystyrene; B) a transparent fragment (~400 µm) from site 15 characterized as a potential MP-fragment and identified as polypropylene; C) a transparent fiber (~450 µm) from site 7 characterized as an uncertain MP-fiber and identified as polypropylene; D) a transparent fiber (~1500 µm) from site 16 characterized as an uncertain MP-fiber and identified as polyethylene terephthalate.

The predominant type of MP-like particles observed were fibers (82 %). With a total of 231 MP-like fibers detected in the tap water samples, in comparison to only 39 and 11 MP-like fragments (14 %) and films (4 %), respectively (Table 2). All of the water samples contained MP-like fibers, and most of these were white to transparent and were categorized as uncertain MP-like fibers, whereas only a minor proportion of the fibers had strong colors like pink, blue or black and were categorized as potential MP-like fibers. Validation by $\mu\text{FT-IR}$ revealed that the majority of these fibers were not MP, but primarily were fibers consisting of cellulose-like material (see example in Appendix 2). Yet, in two tap water samples originating from site 7 and 16, two transparent fibers were verified as MP of the type PP and PET (Fig. 4C,D).

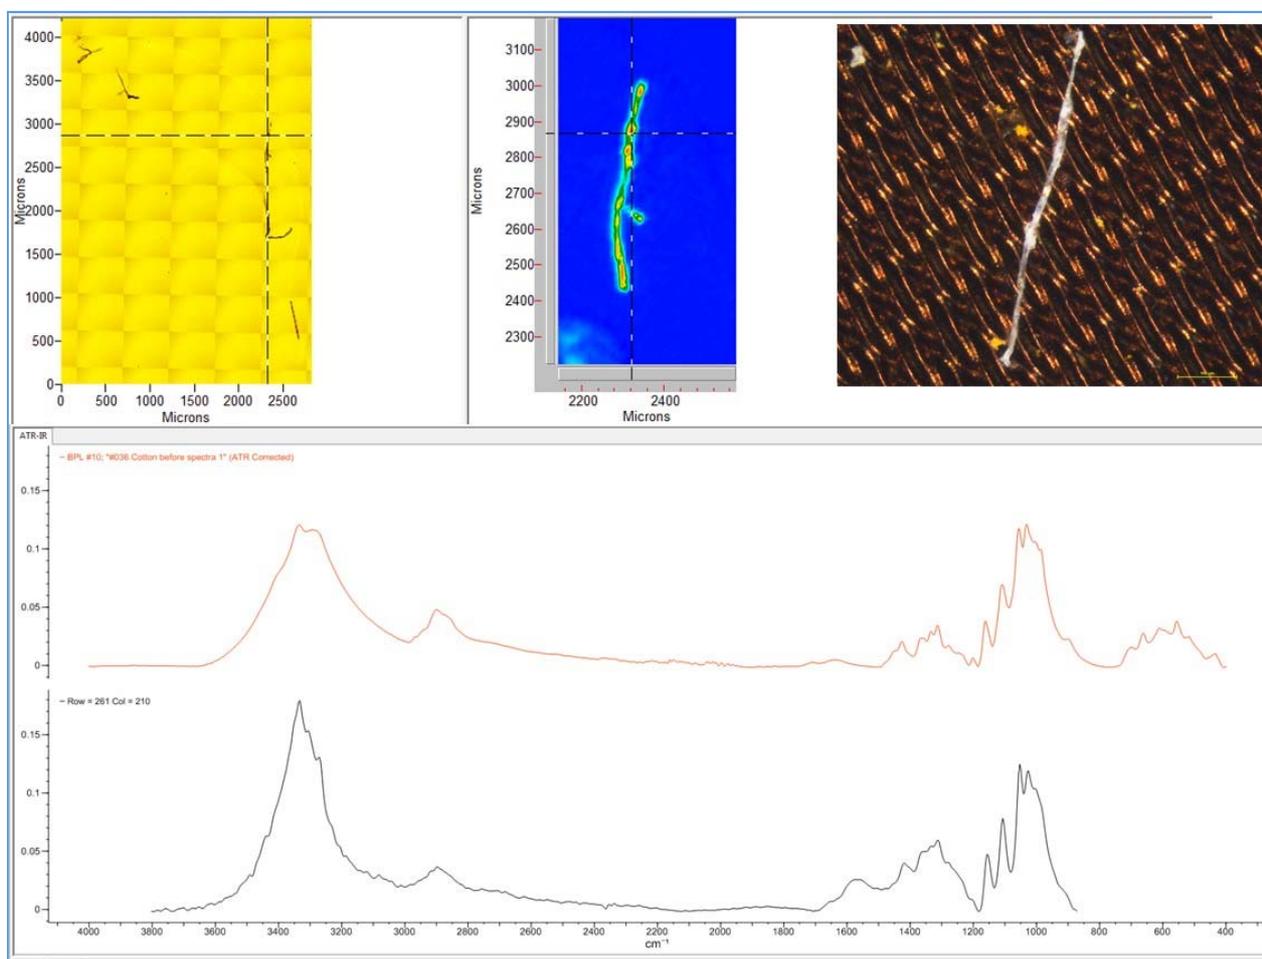
Appendix 2. Identification of cellulose-like particles by μ FT-IR

Appendix 2. Example of an MP-like particle validated by μ FT-IR as cellulose-like material. The microscopy-photo of a fiber classified as an uncertain MP-like fiber is shown (upper right) together with the corresponding photo of the ZnSe-disc and heat-map of the same fiber from the μ FT-IR analysis (upper left and upper middle, respectively). The spectra shows in black the μ FT-IR spectra of the analyzed fiber and in orange the matching spectra of cotton from the MP Hunter reference database.

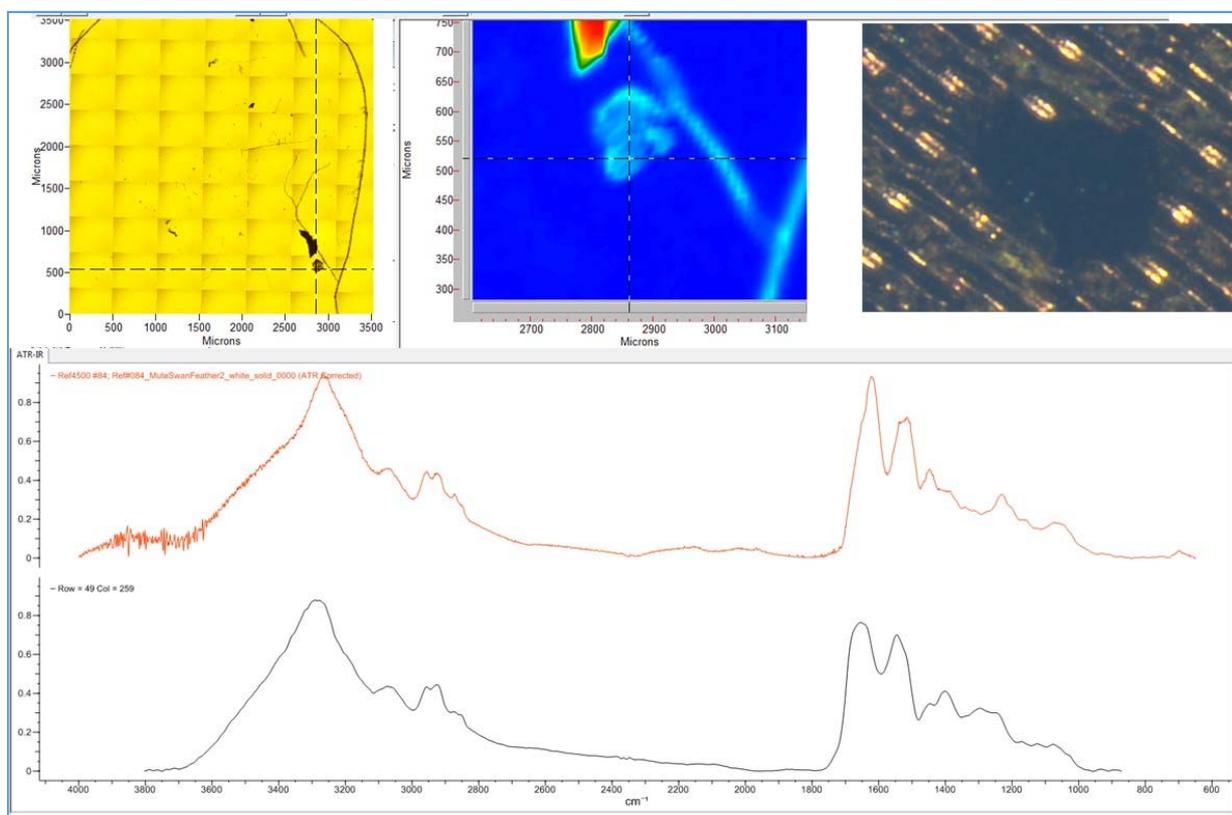
Appendix 3. Identification of protein-like particles by μ FT-IR

Appendix 3. Example of an MP-like particle validated by μ FT-IR as protein-like material. The microscopy-photo of a fragment classified as an uncertain MP-like fragment is shown (upper right) together with the corresponding photo of the ZnSe-disc and heat-map of the same fragment from the μ FT-IR analysis (upper left and upper middle, respectively). The spectra shows in black the μ FT-IR spectra of the analyzed fragment and in orange the matching spectra from the MP Hunter reference database of swan feather (only a few protein-based spectra are present in the database, and hence a close match of the origin of the protein material is not possible).

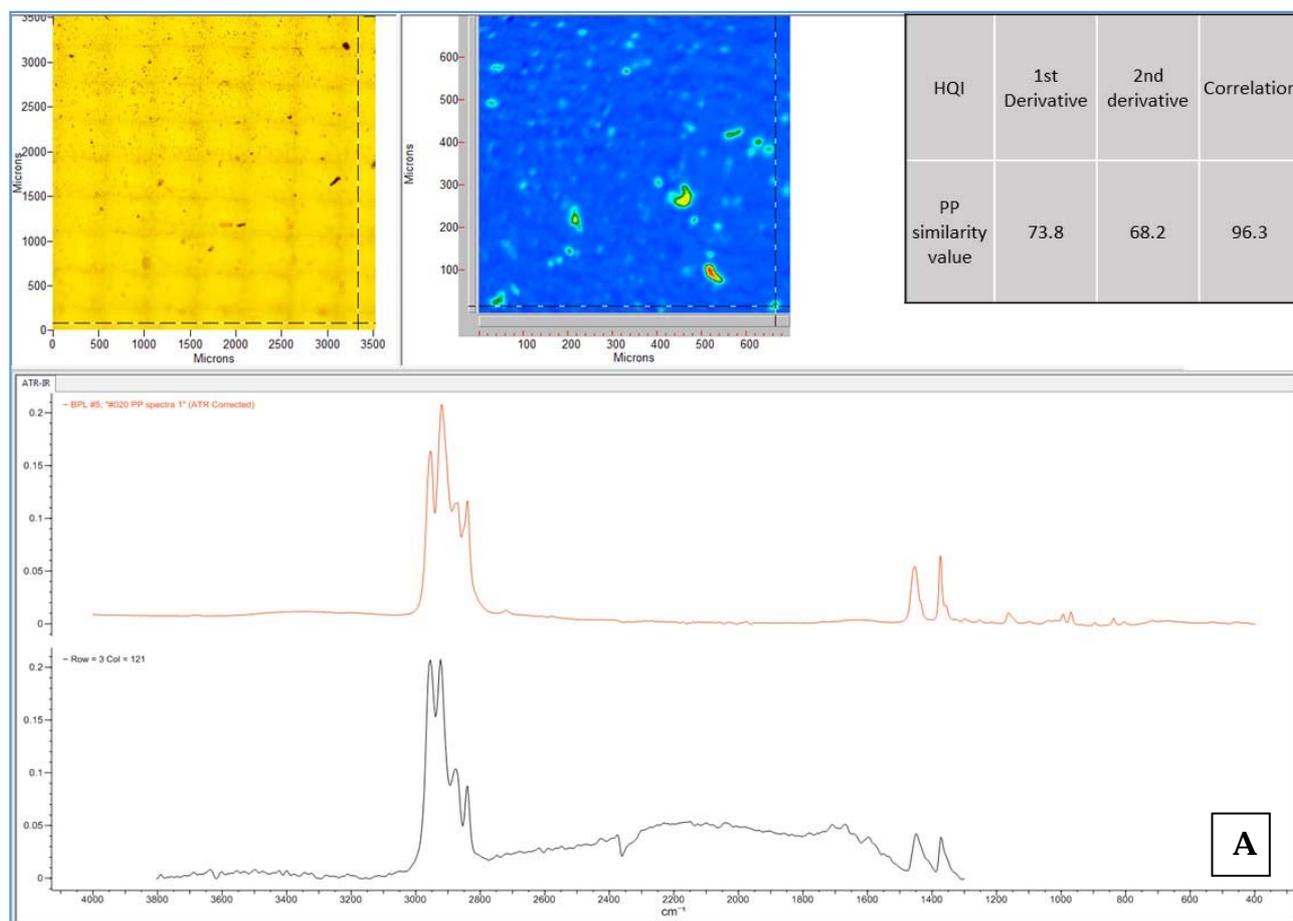
Appendix 5A. Example of a particle validated by Anodisc analysis as polypropylene (PP). The photos show the Anodisc and the corresponding heat-map of the PP-fragment from the μ FT-IR analysis (upper left and upper middle, respectively). The spectra shows in black the μ FT-IR spectra of the analyzed PP-fragment and in orange the matching spectra from the MP Hunter reference database of PP. The table shows the high-quality index (HQI) with the PP similarity values calculated by the MP Hunter software and giving a correlation of 96.3 % for the spectra match.

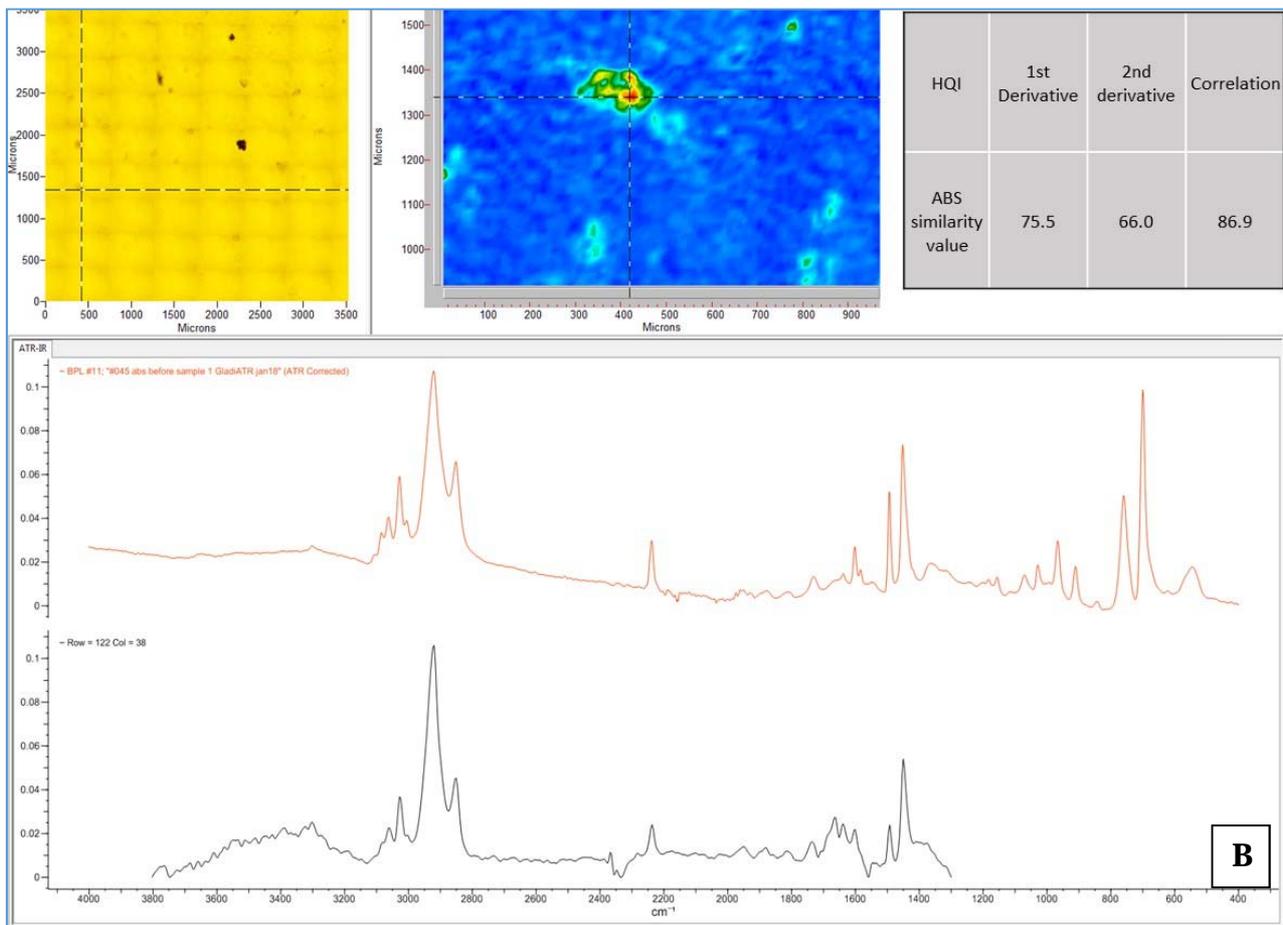
Appendix 5B. Example of a particle validated by Anodisc analysis as acrylonitrile butadiene (ABS). The photos show the Anodisc and the corresponding heat-map of the ABS-fragment from the μ FT-IR analysis (upper left and upper middle, respectively). The spectra shows in black the μ FT-IR spectra of the analyzed ABS-fragment and in orange the matching spectra from the MP Hunter reference database of ABS. The table shows the high-quality index (HQI) with the ABS similarity values calculated by the MP Hunter software and giving a correlation of 86.9 % for the spectra match.

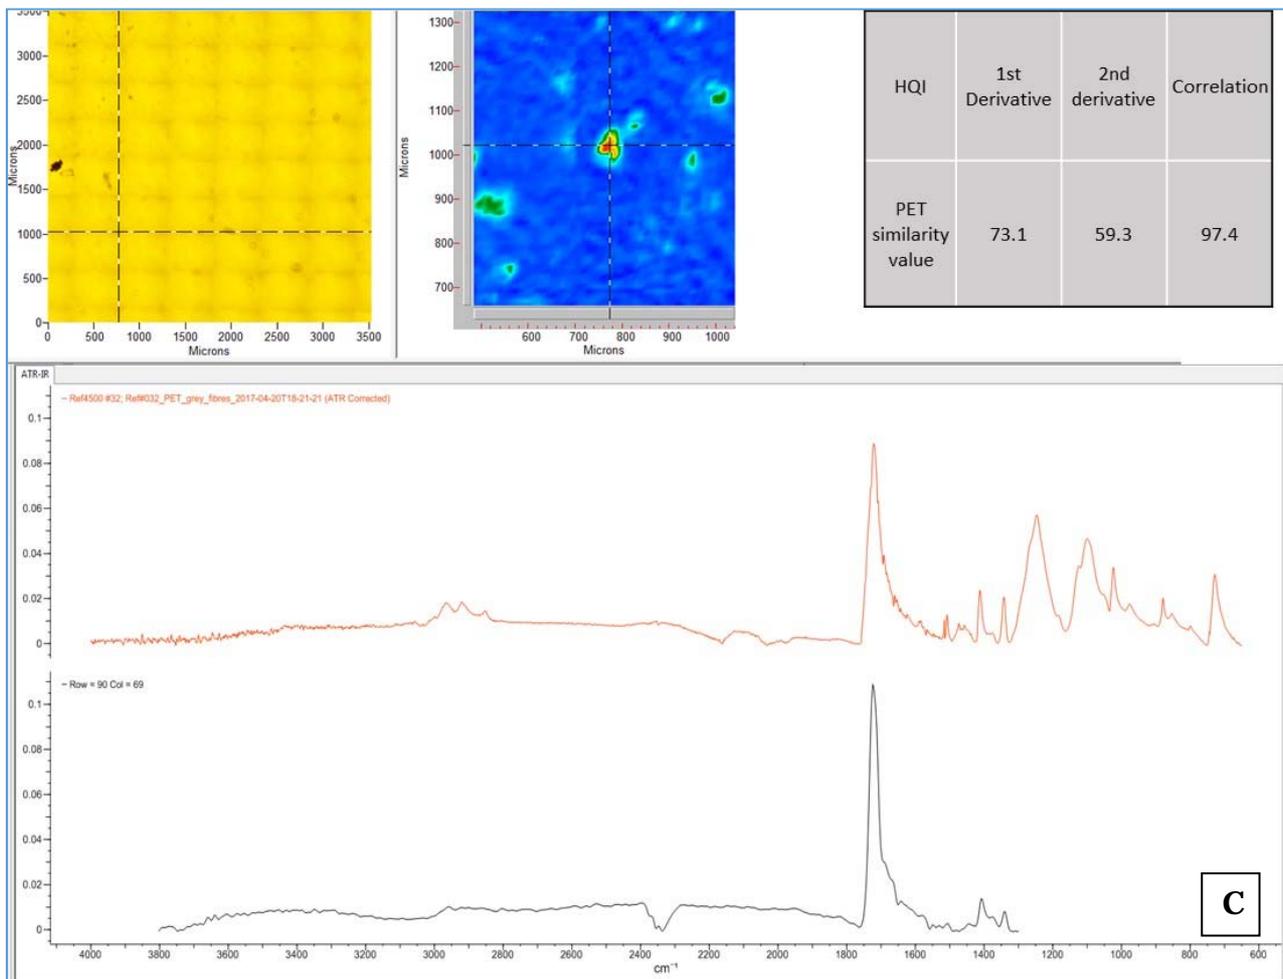
Appendix 5C. Example of a particle validated by Anodisc analysis as polyethylene terephthalate (PET). The photos show the Anodisc and the corresponding heat-map of the PET-fragment from the μ FT-IR analysis (upper left and upper middle, respectively). The spectra shows in black the μ FT-IR spectra of the analyzed PET-fragment and in orange the matching spectra from the MP Hunter reference database of PET. The table shows the high-quality index (HQI) with the PET similarity values calculated by the MP Hunter software and giving a correlation of 97.4 % for the spectra match

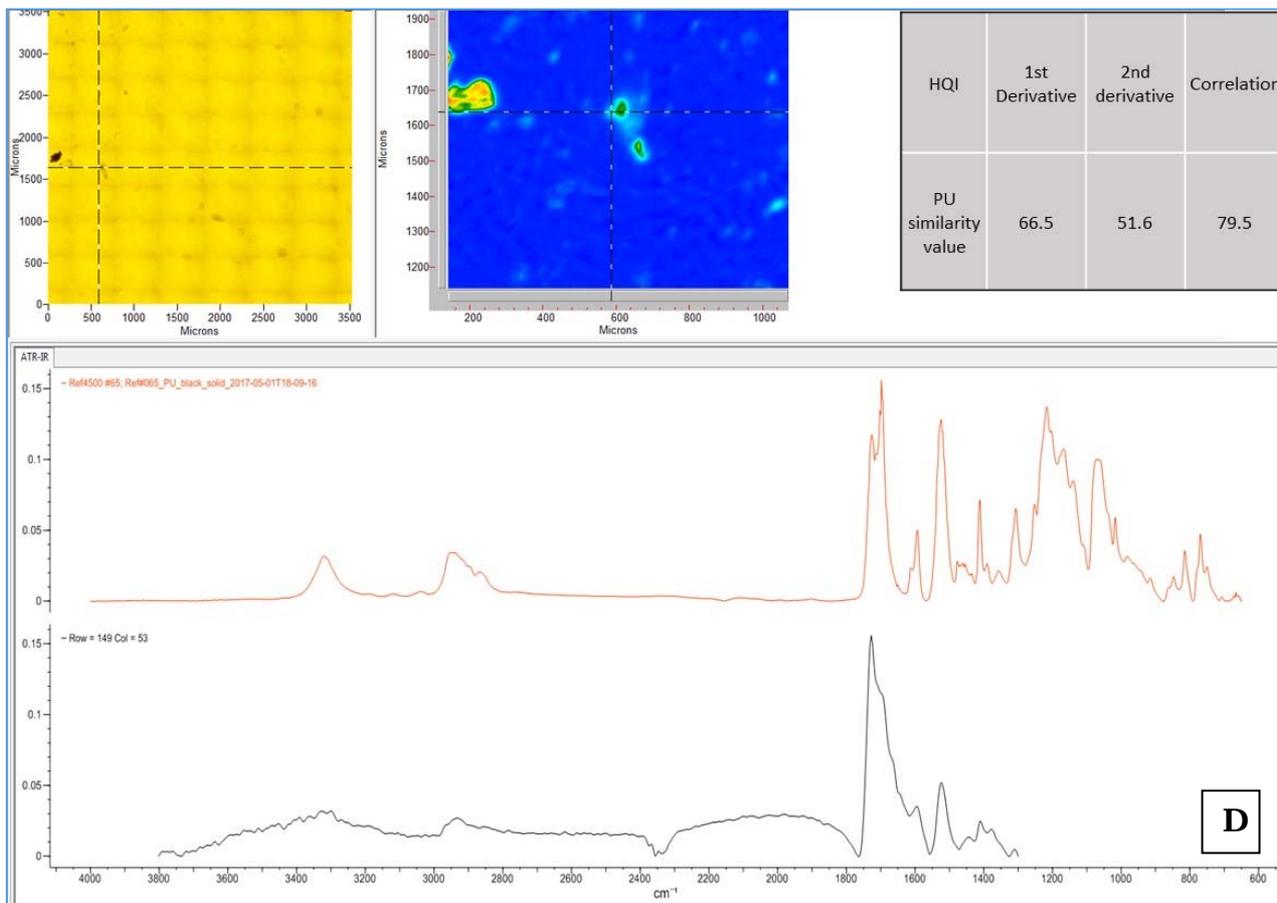
Appendix 5D. Example of a particle validated by Anodisc analysis as polyurethane (PU). The photos show the Anodisc and the corresponding heat-map of the PU-fragment from the μ FT-IR analysis (upper left and upper middle, respectively). The spectra shows in black the μ FT-IR spectra of the analyzed PU-fragment and in orange the matching spectra from the MP Hunter reference database of PU. The table shows the high-quality index (HQI) with the PU similarity values calculated by the MP Hunter software and giving a correlation of 79.5 % for the spectra match.

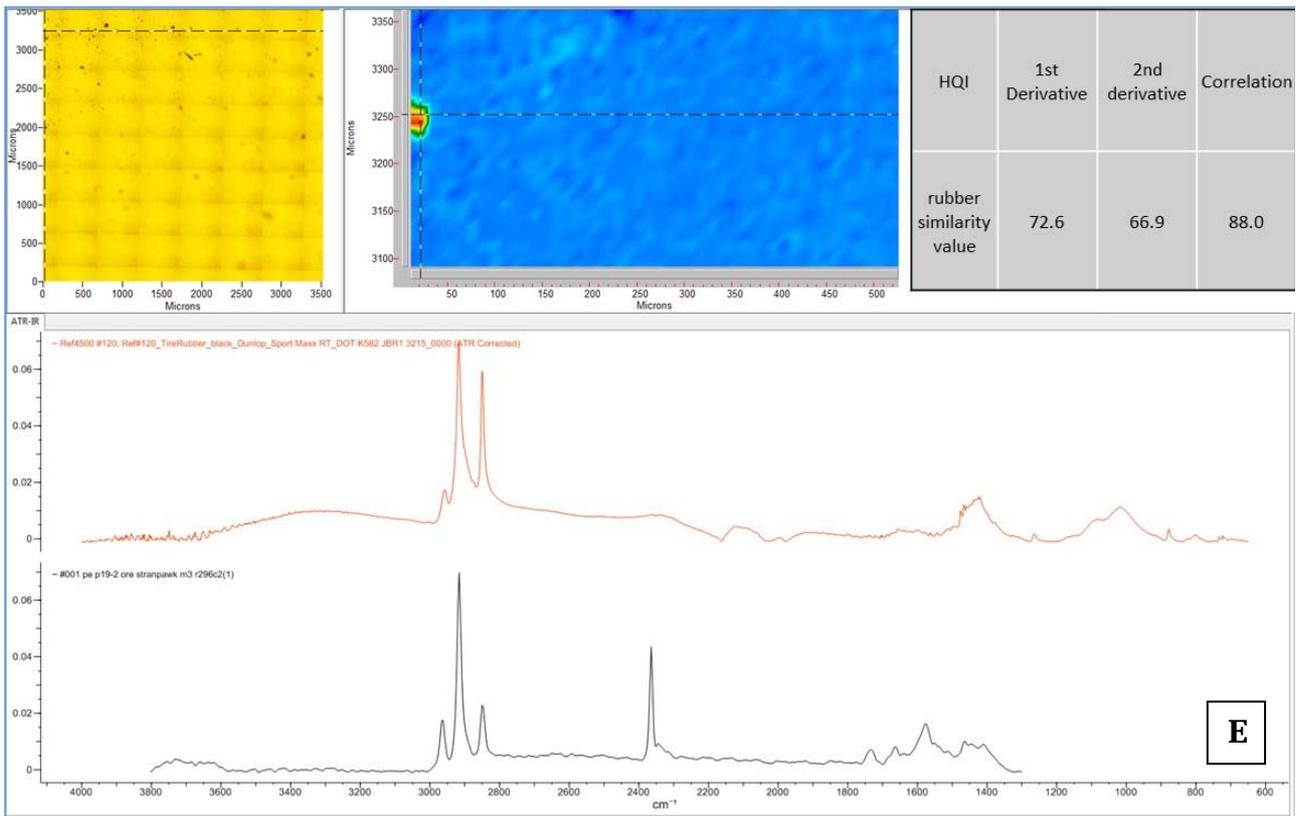
Appendix 5E. Example of a particle validated by Anodisc analysis as rubber. The photos show the Anodisc and the corresponding heat-map of the rubber-fragment from the μ FT-IR analysis (upper left and upper middle, respectively). The spectra shows in black the μ FT-IR spectra of the analyzed rubber-fragment and in orange the matching spectra from the MP Hunter reference database of rubber. The table shows the high-quality index (HQI) with the rubber similarity values calculated by the MP Hunter software and giving a correlation of 88.0 % for the spectra match.
