ENVIRONMENTAL MONITORING AT THE NALUNAQ GOLD MINE, SOUTH GREENLAND, 2015

Scientific Report from DCE - Danish Centre for Environment and Energy

No. 181

2016

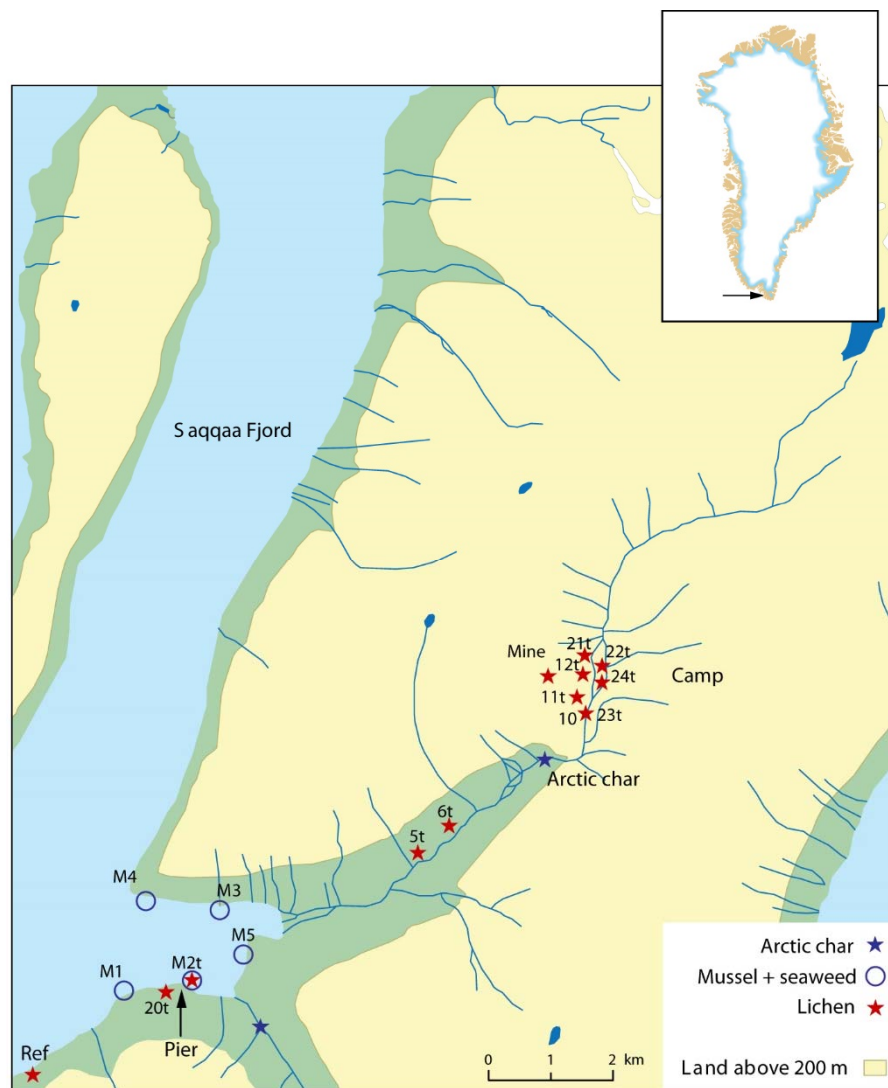
Figure 2.1. Sampling stations in the Nalunaq Gold Mine area, Nanortalik, South Greenland. M: Marine stations: Blue mussel and brown seaweed. Arctic chars were caught at the waterfall station. Lichens transplanted in 2014 from reference station (Ref) were sampled at stations M2t, 5t, 6t, 11t, 12t, 20t, 21t, 22t, 23t and 24t, and replaced with new lichens from the reference station. The mine entrance is west of the camp area

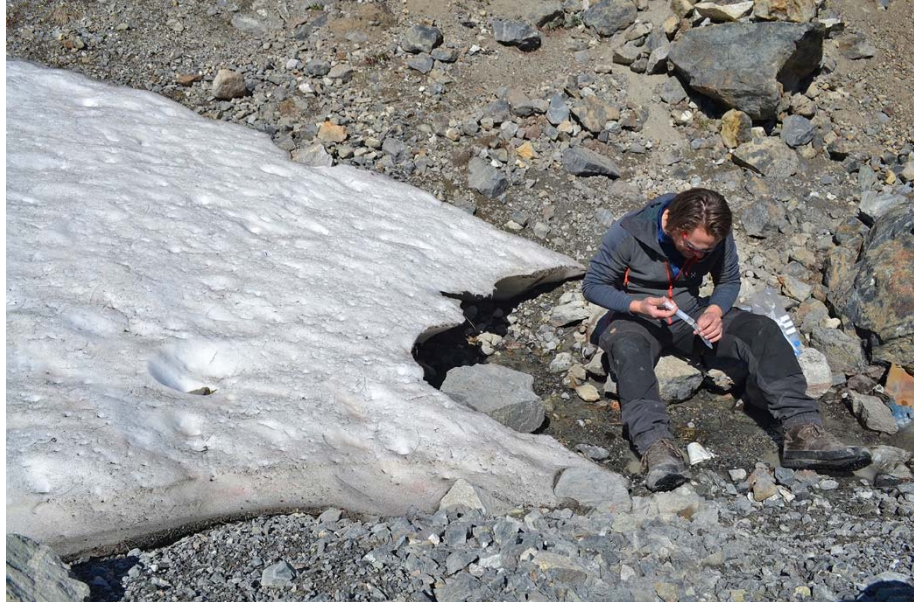
Photo 2.2. Water samples were taken in the water flowing from the mine at the 300 m portal for analyses of cyanide and elements (photo L. Bach).

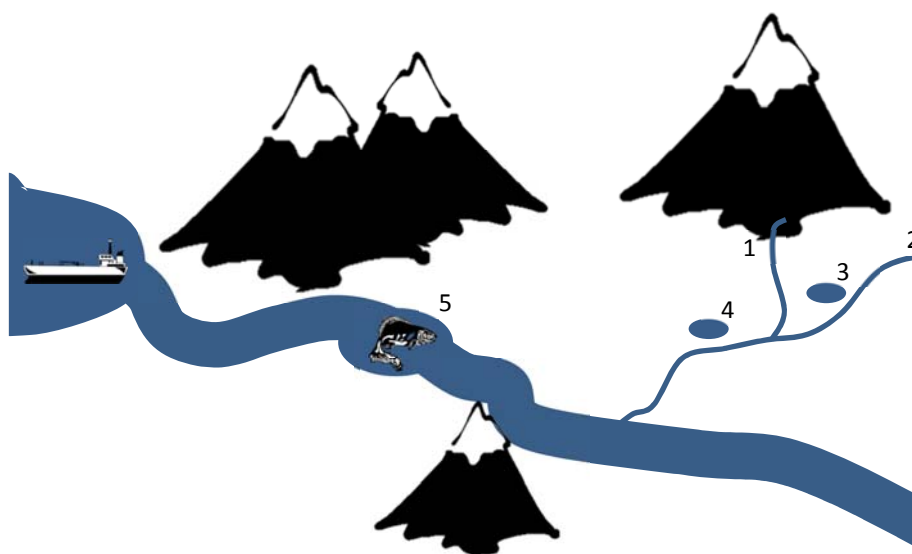
Water samples were taken from the outlet at the 300 m portal (1), upstream the small river (2), monitoring wells (3 and 4), and Kirkespir River (5) (figure 3.1).

Figure 3.1. Illustration of sampling sites for cyanide monitoring in the environment.
