ENVIRONMENTAL MONITORING AT THE NALUNAQ GOLD MINE, SOUTH GREENLAND, 2004-2019

Scientific Report from DCE - Danish Centre for Environment and Energy

No. 386

Lis Bach

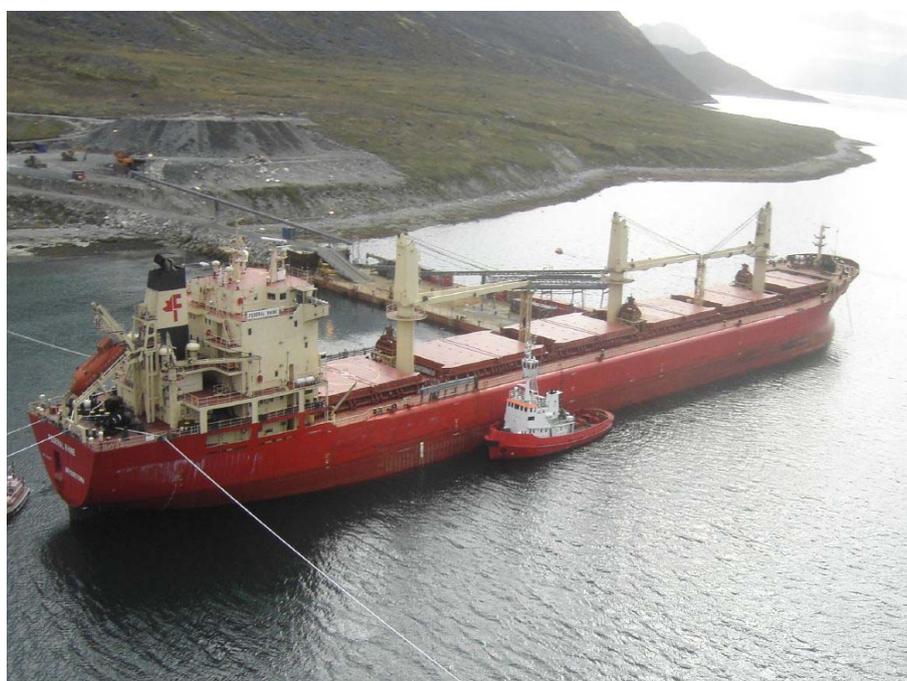
Figure 3. Photo showing the loading of ore to a ship during Crew Mining in 2008. Source: Aerial photo by DCE.

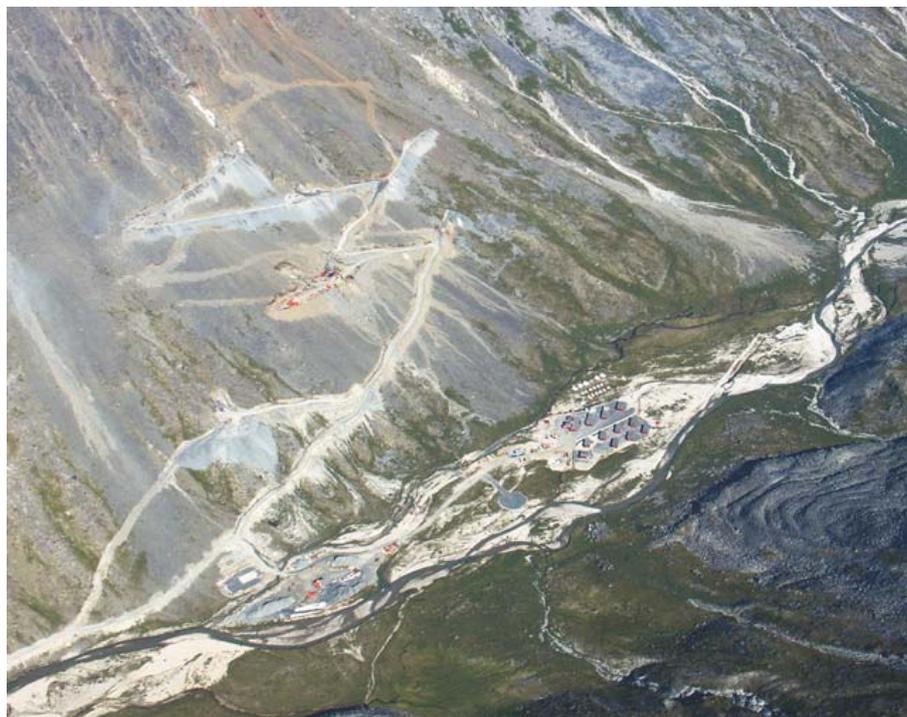
Figure 4. Mine area, camp and workshop area in 2008. Source: Aerial photo by DCE.

An overview of the mining area with roads, buildings and quay areas is shown in figure 4.

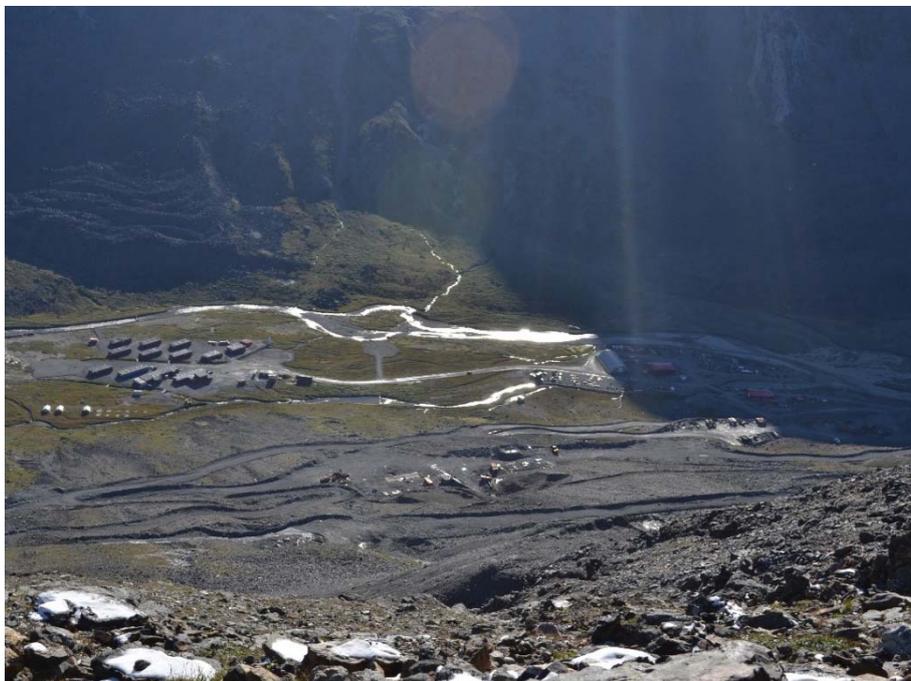
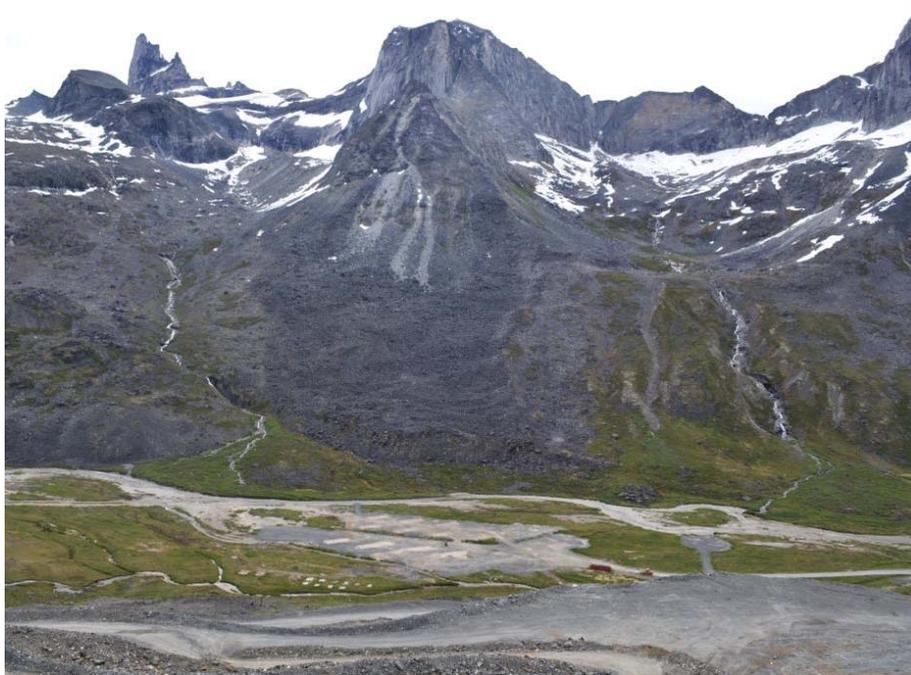
Figure 5. Overview of the camp area during Angel Mining in 2013 (above) and after decommission in 2014 (below). Source: Photos by L. Bach.

The production decommissioned in October 2013 due to economic reasons. In 2014, the mine was closed and the area was cleaned up (removal of buildings, machines etc. – see figure 5). Soil and gravel that were contaminated by oil, for example the gravel under the former generator at the 350 m portal and the

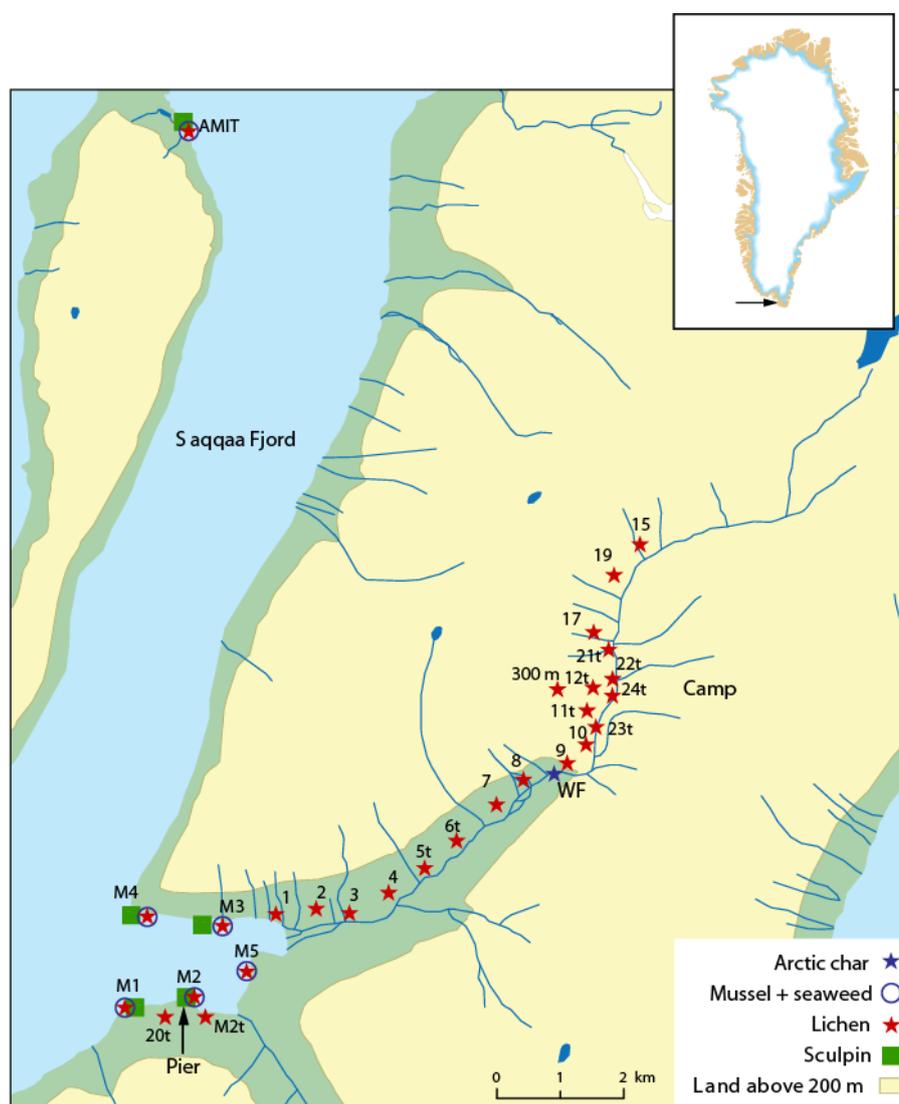
Figure 12. Sampling stations in the Nalunaq area. M: Marine stations: sculpins, blue mussel and brown seaweed. The terrestrial area is covered by lichen samples, where t-stations hold transplanted lichens initially collected at the AMIT station. Freshwater samples were collected at the waterfall (WF), upstream at station 22, downstream at station 23 and at the mine entrance at the position marked by '300 m'

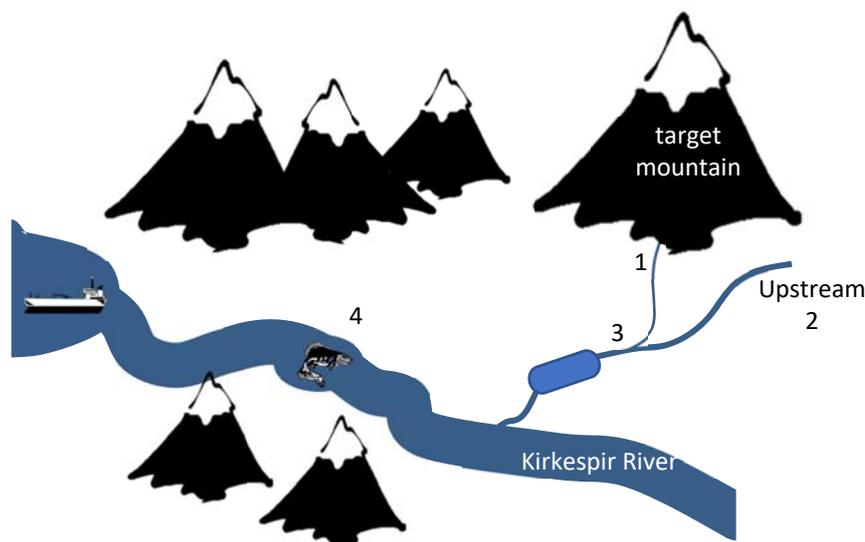
Figure 13. Illustration of freshwater sampling stations. Sample 1 was taken upstream, sample 2 was taken at the 300 m mine entrance, where process waste water is discharged. Sample 3 was taken after mine water was mixed with the little creek but before the settlement pond. Sample 4 was taken further down the Kirkespir River in the pool at the waterfall and is the first place in the Kirkespir River after mine water is admixed.

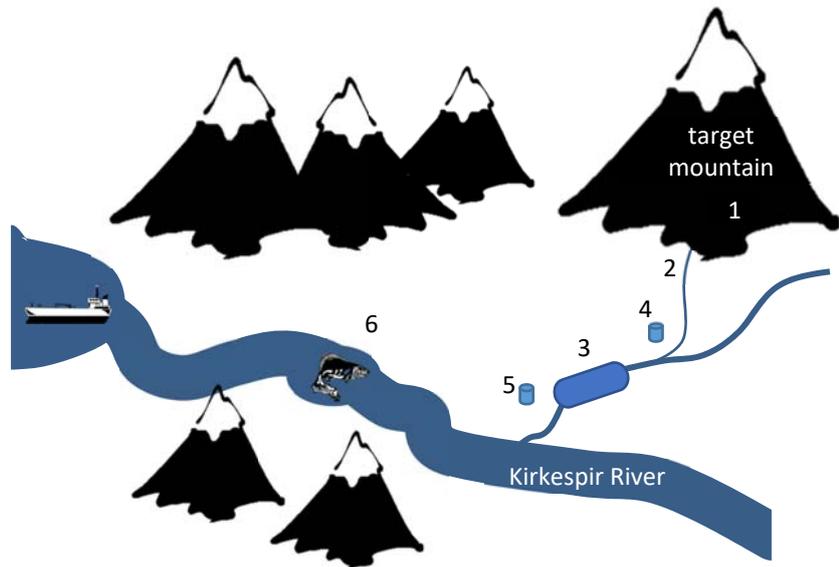
Figure 14. Illustration of sampling stations for cyanide monitoring. Sample 1 was taken from the tailings water, sample 2 was taken at the 300 m mine entrance, where process waste water is discharged. Sample 3 was taken at the settlement pond and sample 4 and 5 from monitoring wells. Sample 6 was taken further down the Kirkespir River at the first place in the Kirkespir River after mine water is admixed.

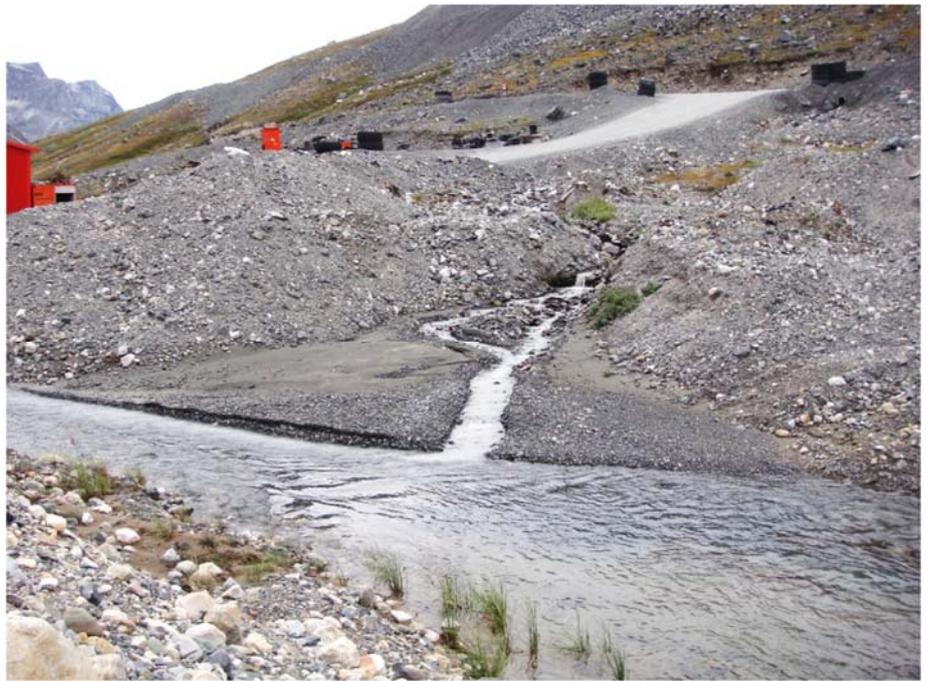
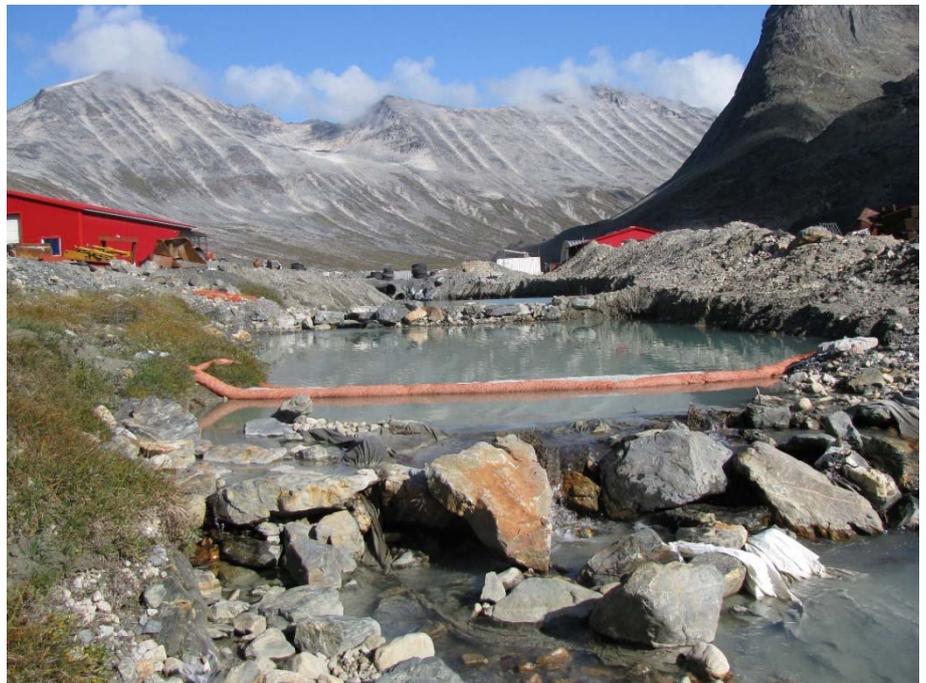
Figure 15. A) Water from the mine enters the small creek before entering the settlement pond prior to mixing with the larger Kirkespir River. B) Settlement pond with oil skimmer. The settlement pond acted to retain surface oil and delay the mine water before mixing with the large Kirkespir River. This enhanced settlement of particles and degradation of cyanide residues originating from the mine process waste water. Source: Photos by L. Bach.

When the waste water left the mine, it entered a smaller creek and thus became diluted before entering a settlement pond. The settlement pond was constructed with an oil skimmer and acted to retain surface oil and delay the mine water before mixing with the large Kirkespir River. This enhanced the settlement of particles and degradation of cyanide residues originating from the waste water.

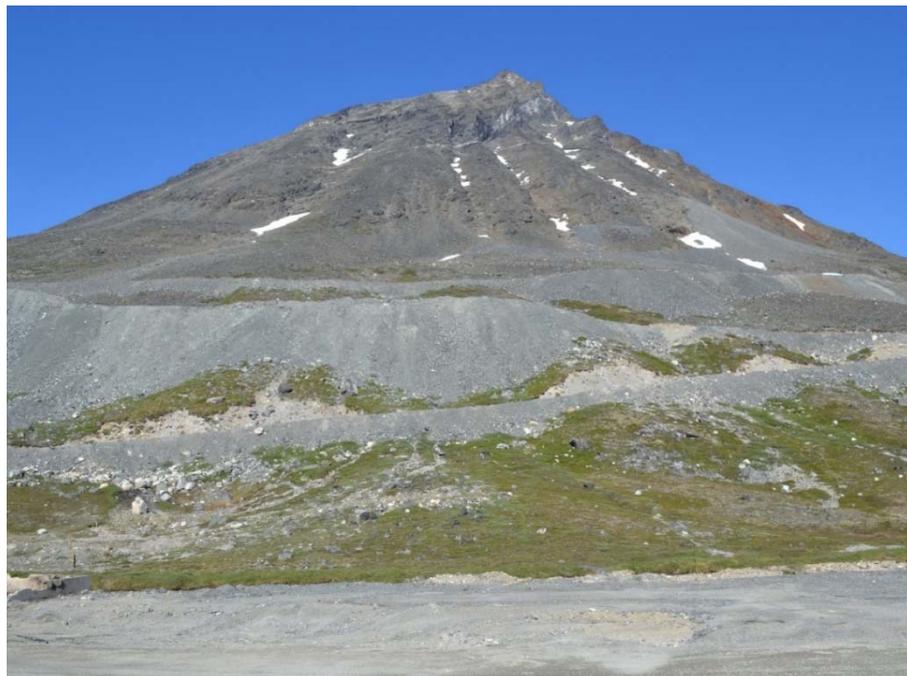
Figure 17. Target mountain with deposited waste rock on the mountain slope. Source: Photo by L Bach.

The camp and mining area was presented by stations 11t, 12t, and from 2013 also 21t, 22t, 23t and 24t (the latter four stations are not included in figure 19). This area was affected by dust dispersal from the rock crusher that in the first mining period 2004-2009 was placed at ground level and from stockpiles of the ore at ground. Later (2010-2013), rock crushing was now and then conducted in open air on the 300 m portal as back-up to the underground crusher. This was assessed to cause some dust dispersal. In both periods, driving and mine traffic on the roads would also cause dust dispersal, as the roads and working fields were constructed and maintained of crushed waste rock and gravel from the quarries in the area. Also, the waste rock disposed in the mountain slope (figure 17) was considered to contribute to the dust dispersal.

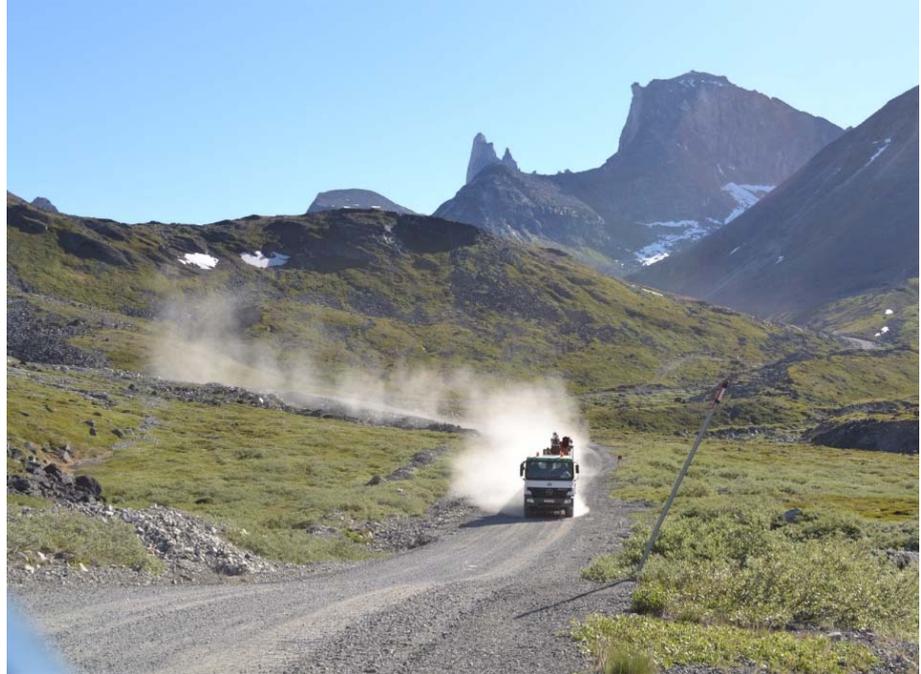
Figure 18. Dust generation by traffic on the gravel road. Source: Photo by L Bach.

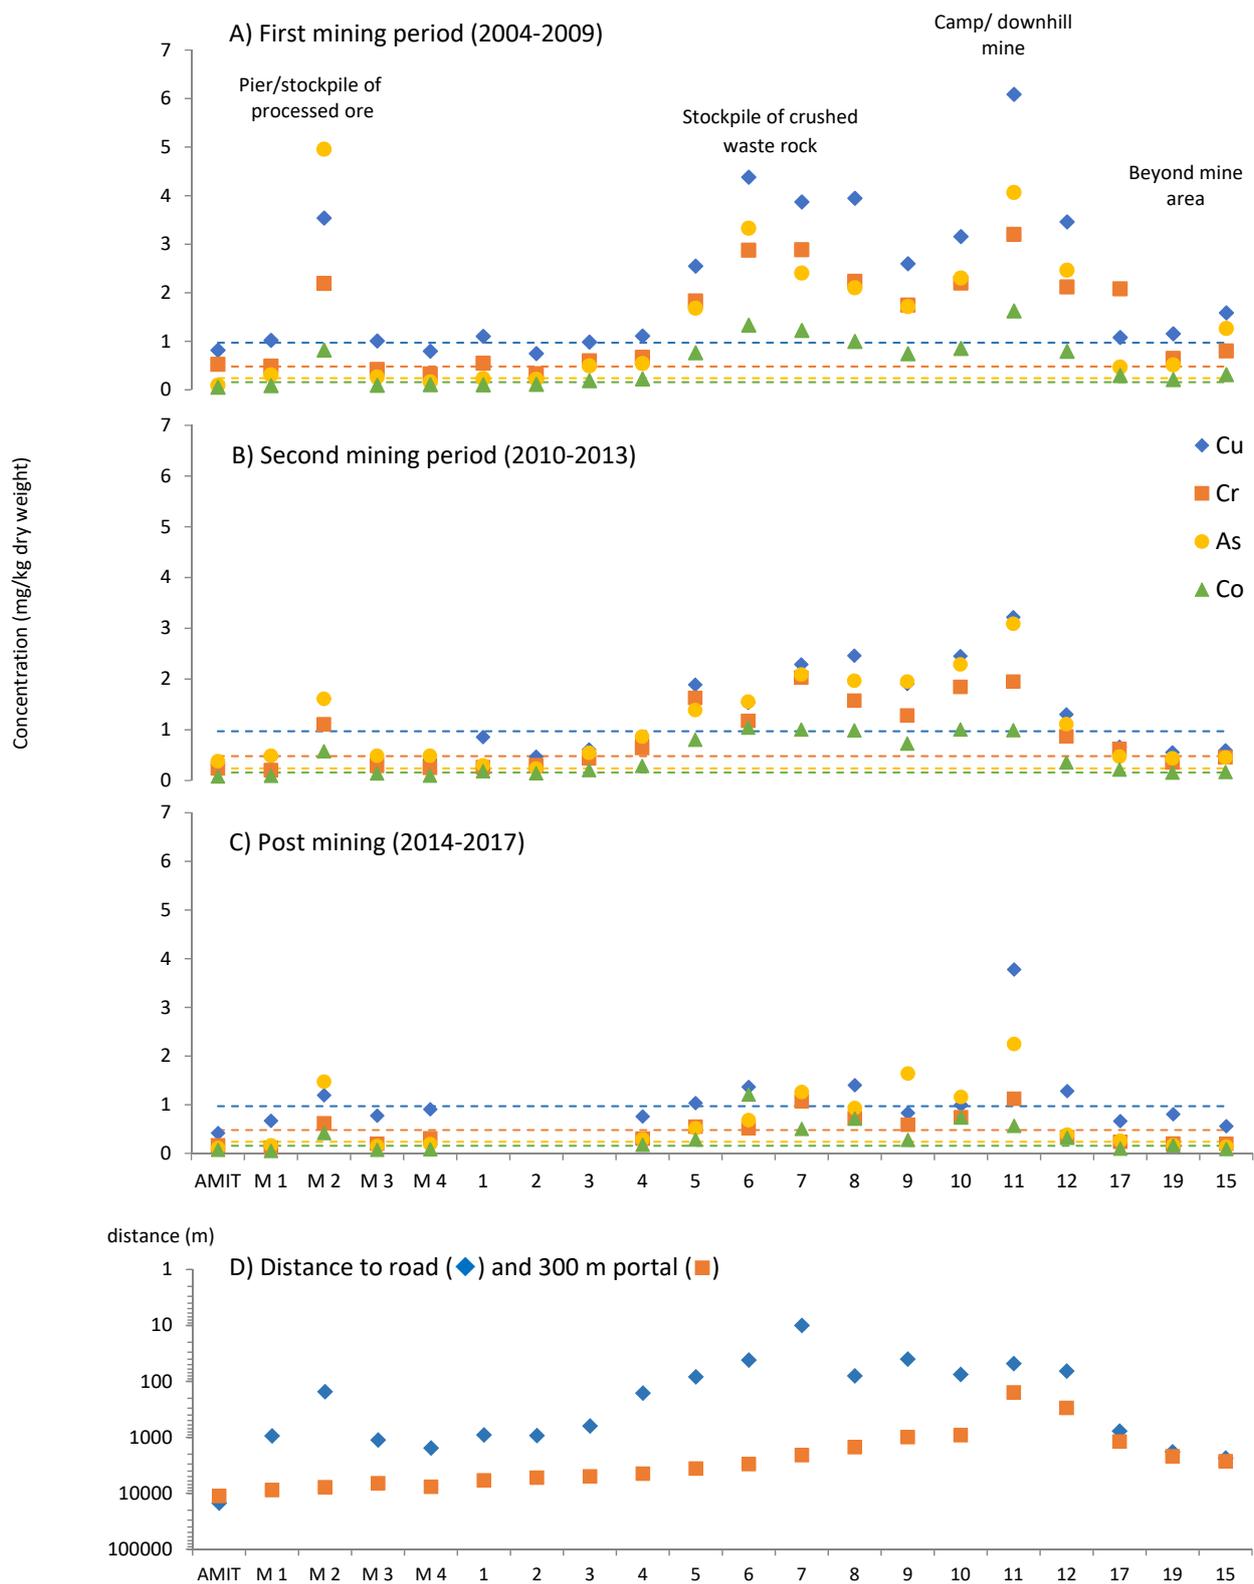
Figure 19. Concentrations of Cu (◆), Cr (■), As (●) and Co (▲) in the lichen *Flavocetraria nivalis* measured at the lichens stations A) during the first mining period, where ore was shipped out (2004-2009), B) during the second mining period, where ore was processed on site, and C) post closure. Also, the D) the distances (in meter on a log scale) from the lichen stations to the road (◆) and to the 300 m portal (■). Stations are arranged from the coast and up through the valley to the mine area and beyond the mine area. For localization of lichen stations see figure 12. The dashed horizontal lines in A-D indicate average background concentrations of the four metals.

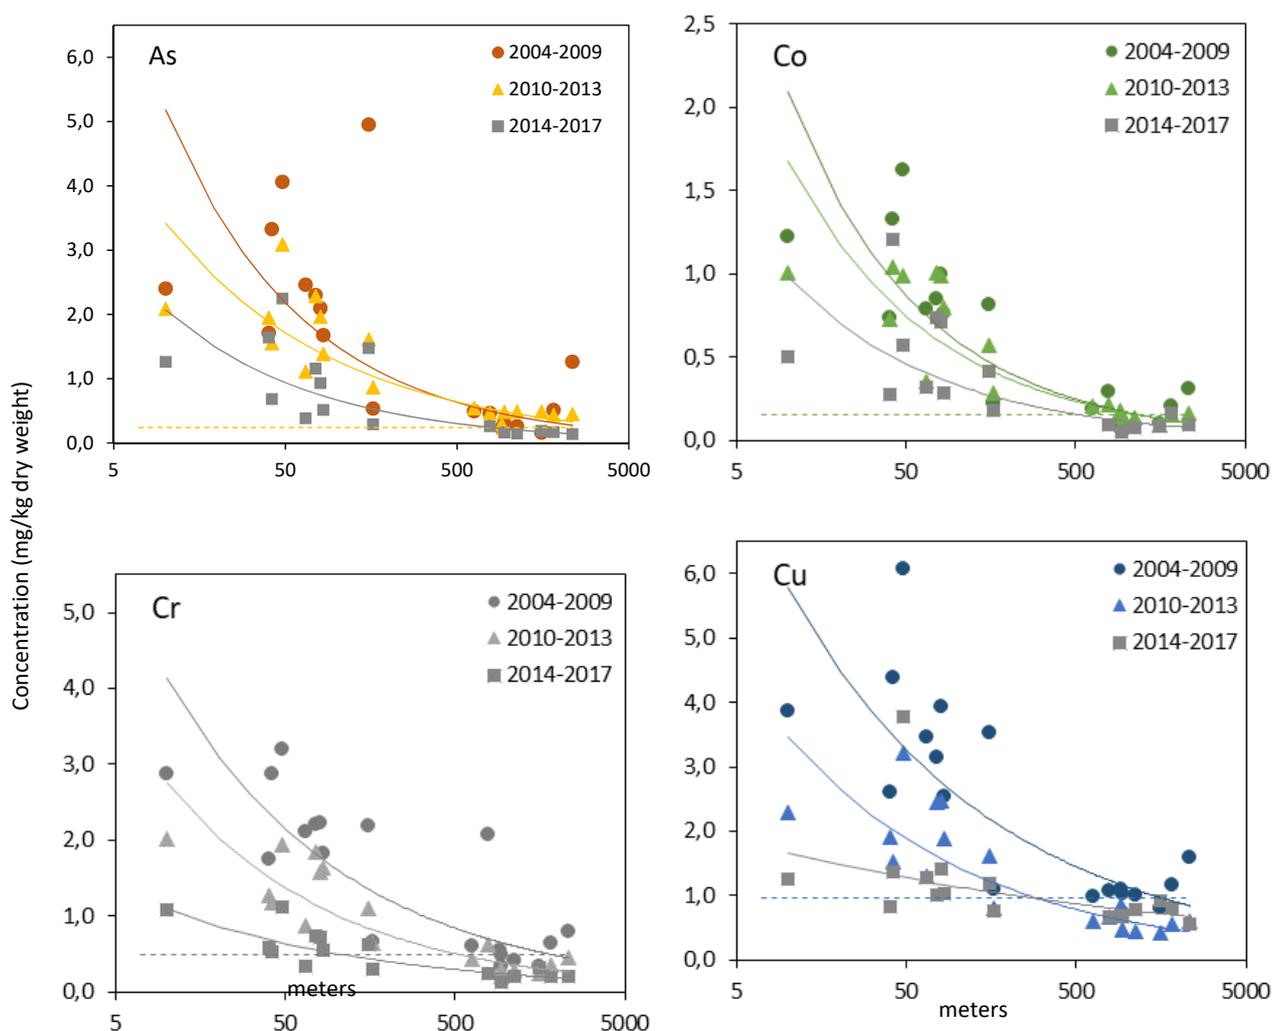
Figure 20. Concentrations of Cu, Cr, As and Co in the lichens, *Flavocetraria nivalis*, as a function of the stations' distances to the gravel road (in meters - on a log scale). Background average concentrations are shown with horizontal dashed lines.

Figure 20 shows how far from the road elevated concentrations of Cu, Cr, As and Co were found in the Kirkespir Valley for the three mining periods. For As, the background concentrations were met at about 3000, 5000 and 800 m from the road, respectively for the three periods. For Co the distances were ca. 1100, 1100 and 500 m. For Cr 2000, 550 and 100 m, while the background concentrations for Cu were met at 1500, 250 and 250 m, respectively, from the road. This indicates that the pollution effects of the road decrease with time. While the impact was most pronounced during the first mining period, the background concentrations were met at within 100-800 m post mining as a result of the ceased mining activities.

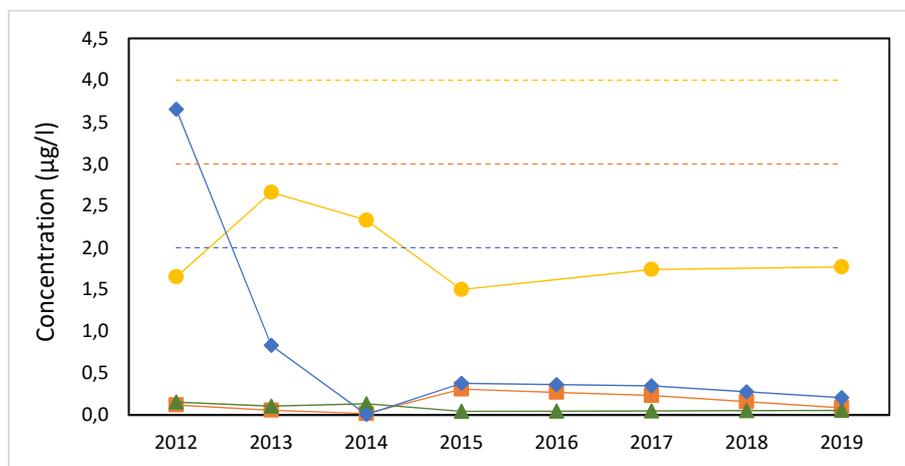
Figure 21. Concentrations of As (●), Co (▲), Cr (■) and Cu (◆) in water samples collected in Kirkespir River at the waterfall station (in µg/l). The dashed horizontal lines indicate GWQC for As, Cr and Cu.

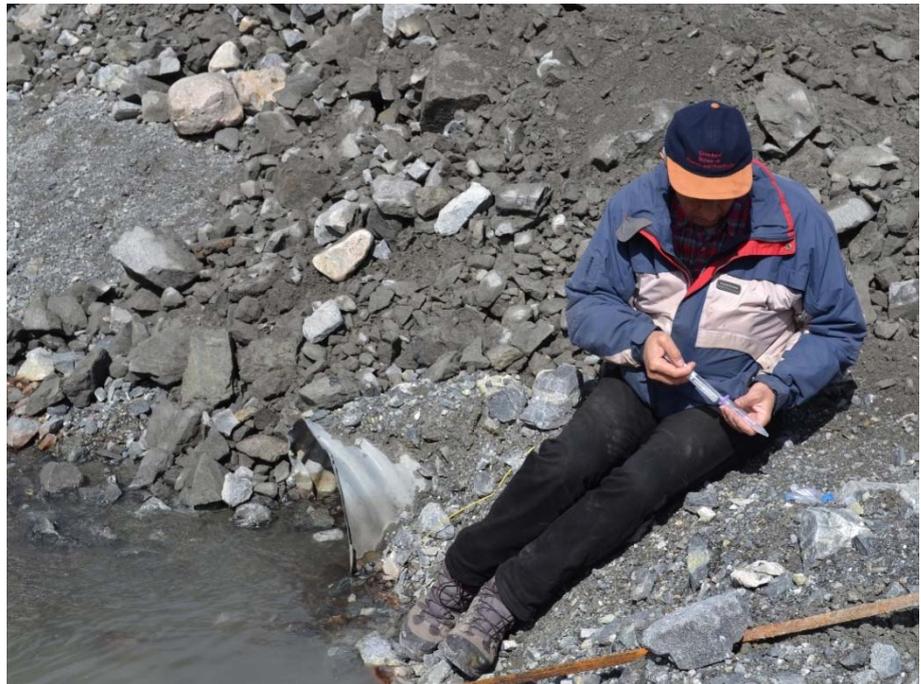
Figure 22. Collection of water samples in the sedimentation pond. Source: Photo by L Bach.

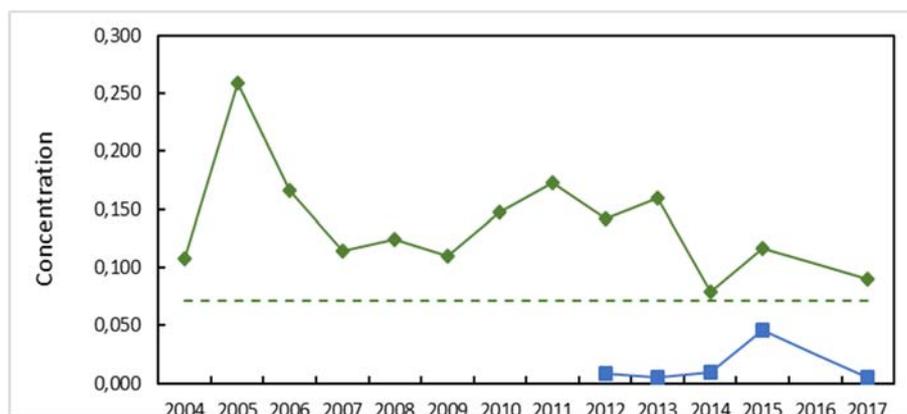
Figure 23. Concentrations of Cd in the Arctic char (◆) in mg/kg wet weight and in water samples (■) µg/l in the Kirkespir River at the waterfall station. Background average concentrations for the Arctic char are shown with horizontal dashed lines. The Greenland Water Quality Criteria (GWQC) for cadmium is 1 µg/l. Water samples were unfortunately not collected for analyses before 2012. .

Compared to background concentrations, the data for metal load in livers of Arctic chars showed that there was a tendency for Cd to slightly accumulate in the fish. Especially during the period of Arctic Mining the measured concentrations found were slightly elevated. Cd is a heavy metal known to accumulate in livers and especially kidneys in organisms, incl. fish species, due to its lipophilic character (Dallinger et al., 1997). When comparing the Cd concentrations in the water samples (table 3 and figure 23) with the GWQC at 1 $\mu\text{g}/\text{l}$ for cadmium, the water concentration appeared low. Thus, bioaccumulation occurred. The guideline maximum levels of Cd for food consumption is 0.05-0.1 mg/kg fish (Fødevaredirektoratet 2003). This level was exceeded by the liver concentrations in the Nalunaq chars. However, the guideline value is given for the fish muscle, and not the liver, which tend to accumulate metals to much greater extent than muscles. It was thus assessed that the maximum level was not reached for the fish in the Kirkespir River. The tolerable intake of cadmium per kg human body weight per week is set at 2.5 μg (Fødevarestyrelsen 2008) corresponding to ca. 200 μg per person and a tolerable intake of 800 g Arctic char liver a week. It is therefore assessed that there is no risk for human consumption of the Arctic chars or the livers.

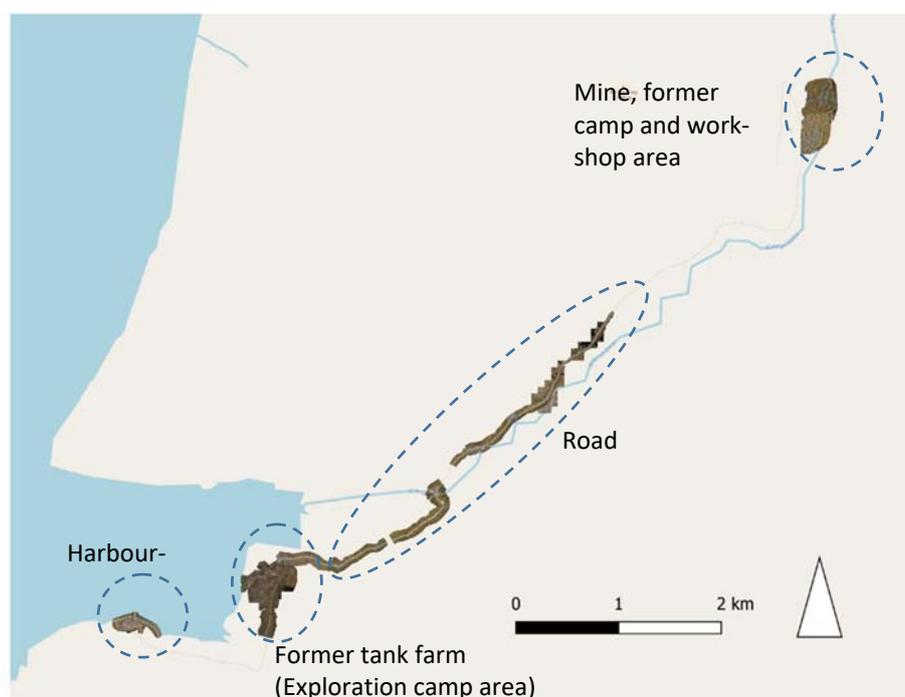
Figure 26. Areas with updated orthophoto with marked focus areas. The former tank farm area is presently used as camp area for the exploration team. Source: Revised figure from Larsen 2020.

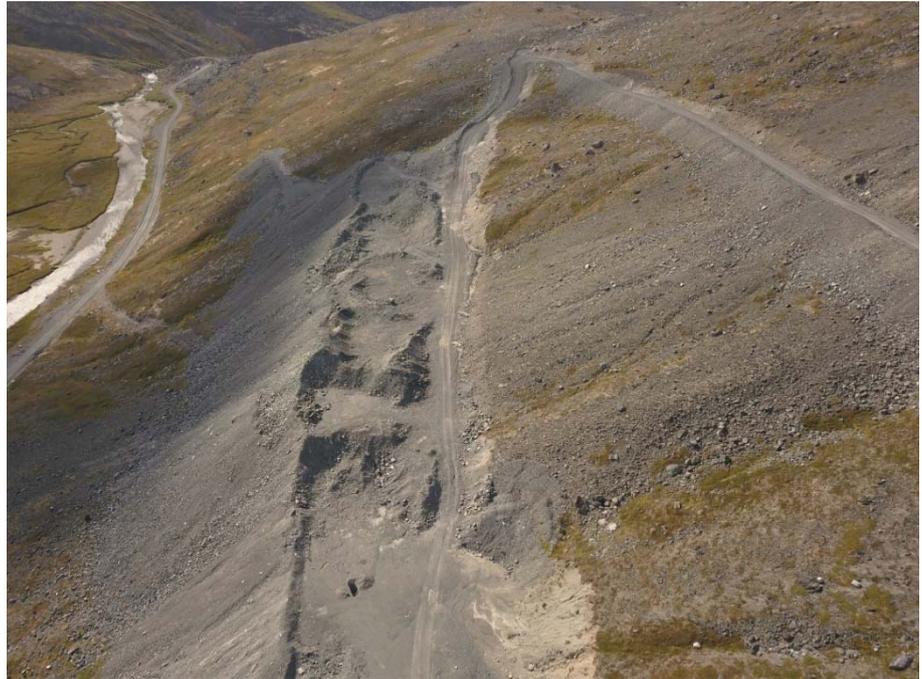
Figure 27. An overview of the mine area and mine portal at 300 m level. Source: Larsen 2020.

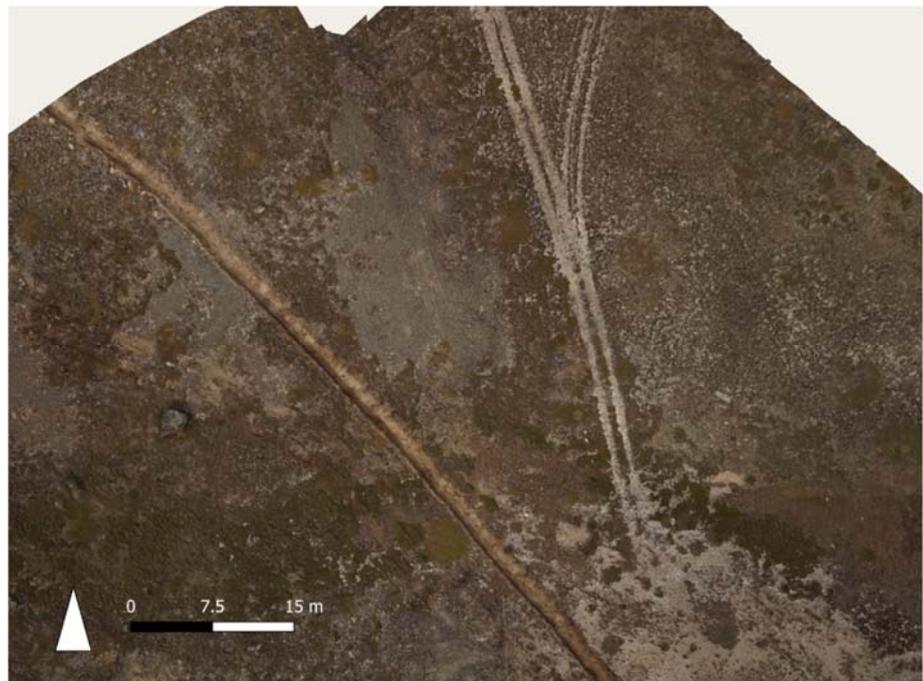
Figure 28. This photo shows a newly dug trench from the exploration camp down to the coast for waste water piping. Also an old driving track is visible. Source: Larsen 2020.

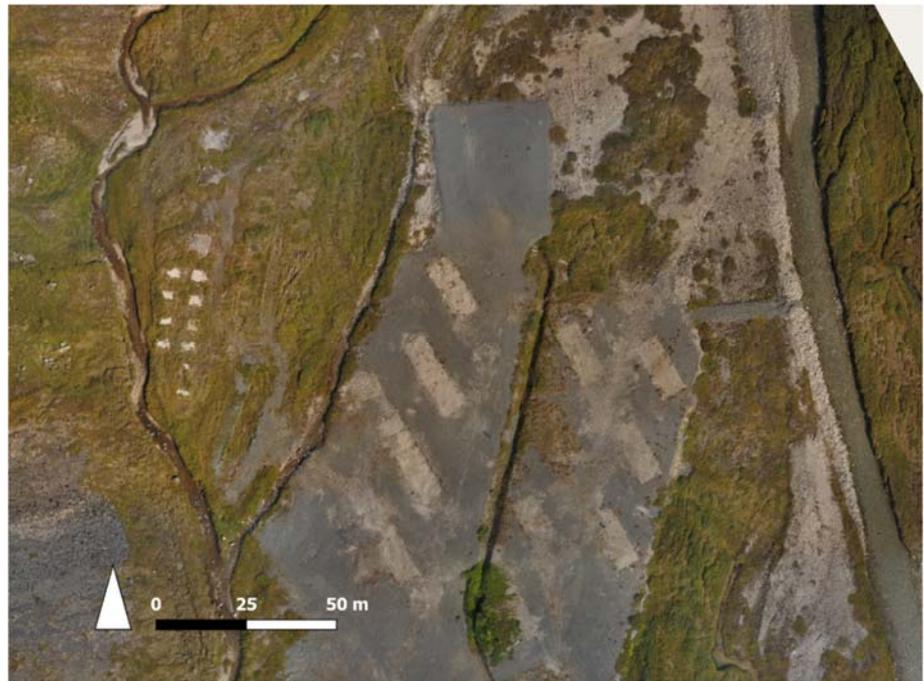
Figure 29. An overview of the former mine area. The former location of buildings and tents are visible. Source: Larsen 2020.

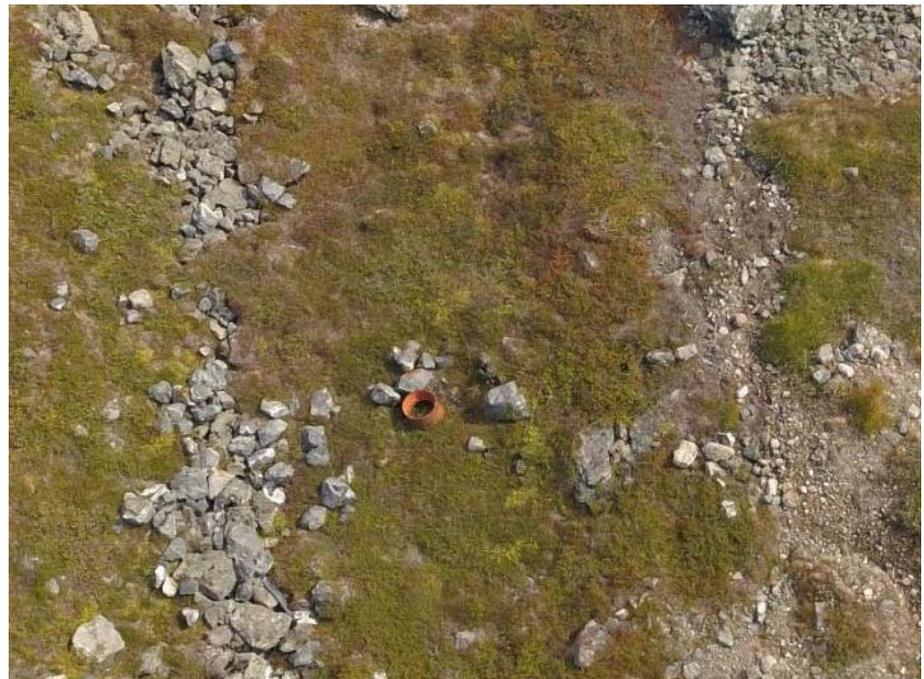
Figure 30. An example of waste in the terrain; here of a piece of orange PVC piping. Source: Larsen 2020.

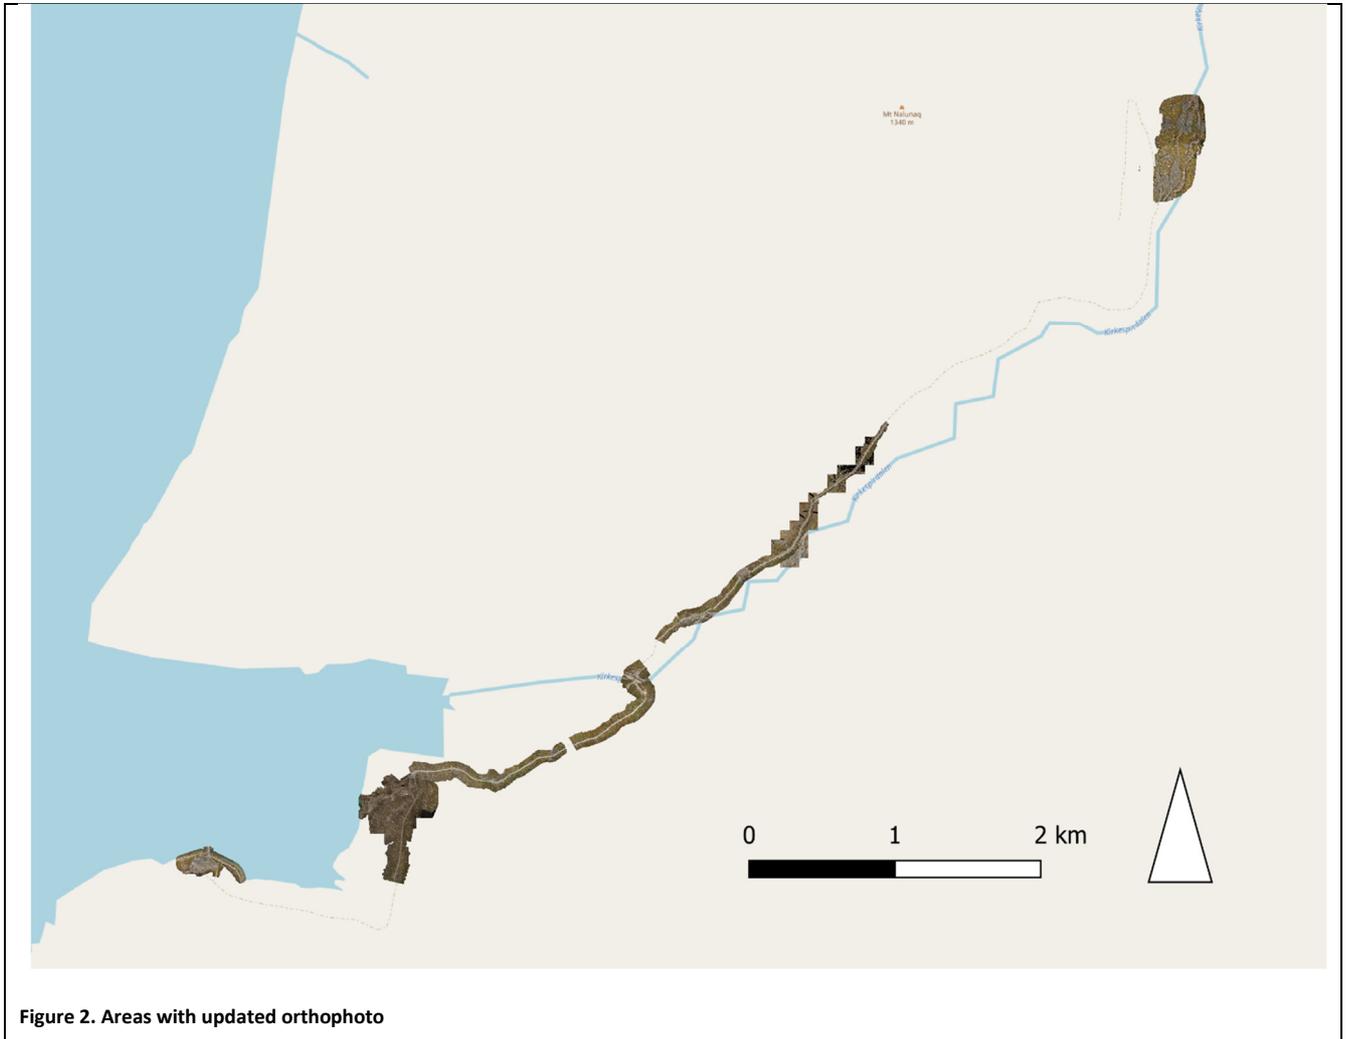
Figure 1. Satellite photo of the Kirkespir Valley

The main focus of the mapping was the former camp area, the mine area, the area around the harbor, and around the current camp as well as parts of the road from the harbor to the mine area. Figure 1 shows a satellite photo of the Kirkespir Valley with location of harbor, the new camp and the former camp and mining area. Figure 2 shows the areas that has been updated with new orthophoto.

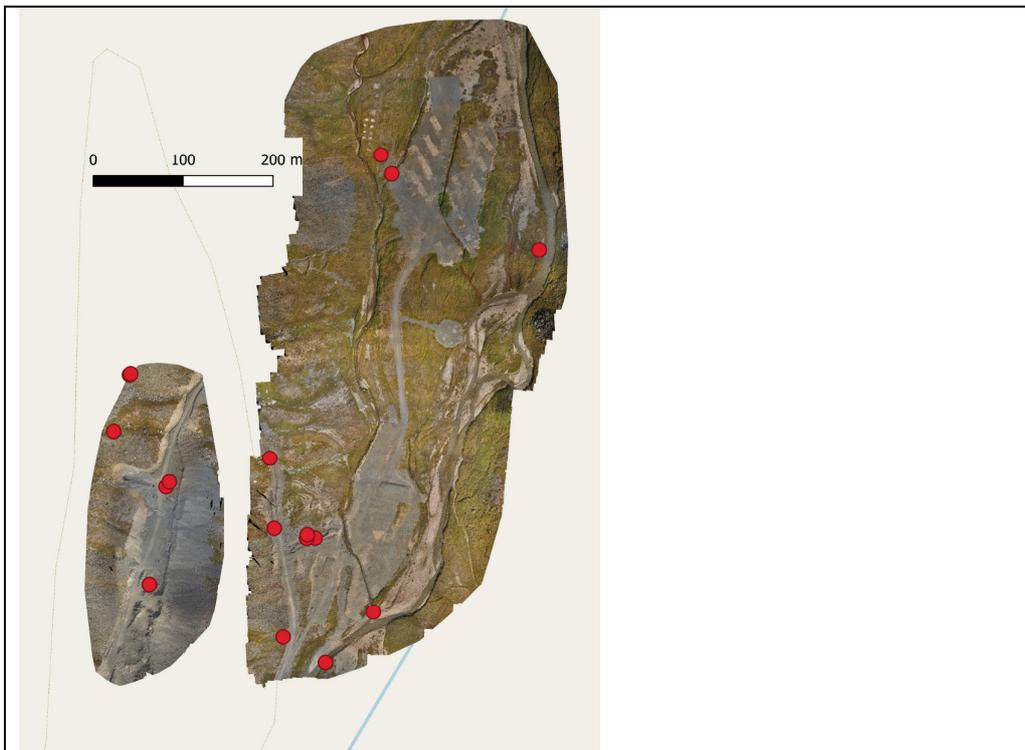
Figure 3. Localized waste in the mine area and the former camp area

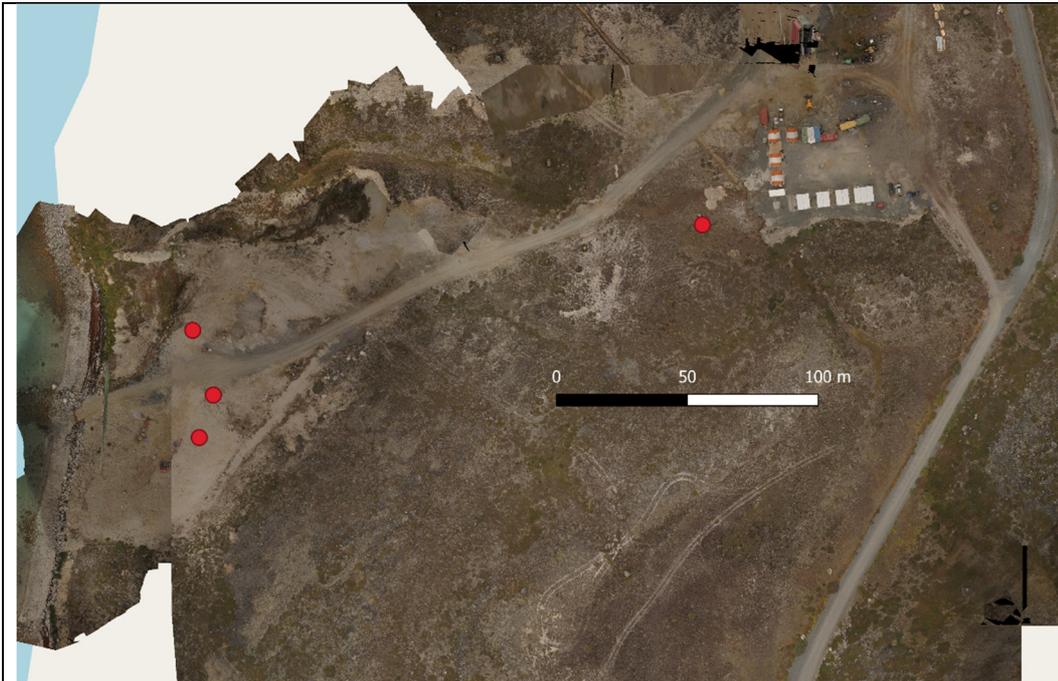
Figure 4. Waste found around the new camp area.

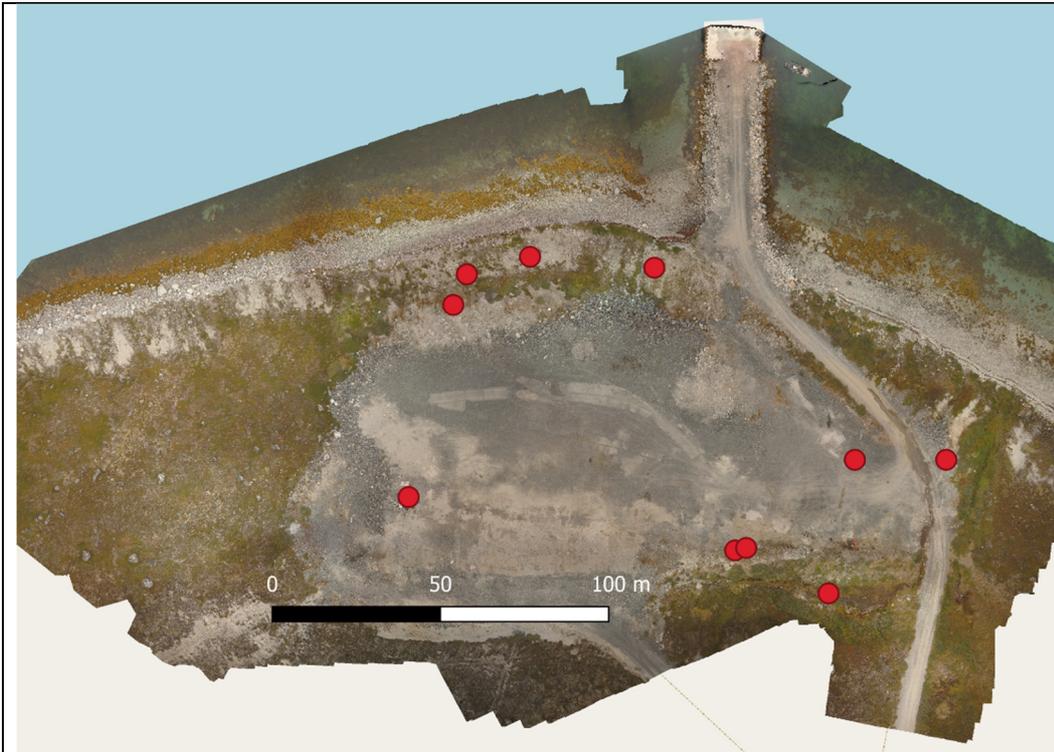
Figure 5. Waste found around the harbor site

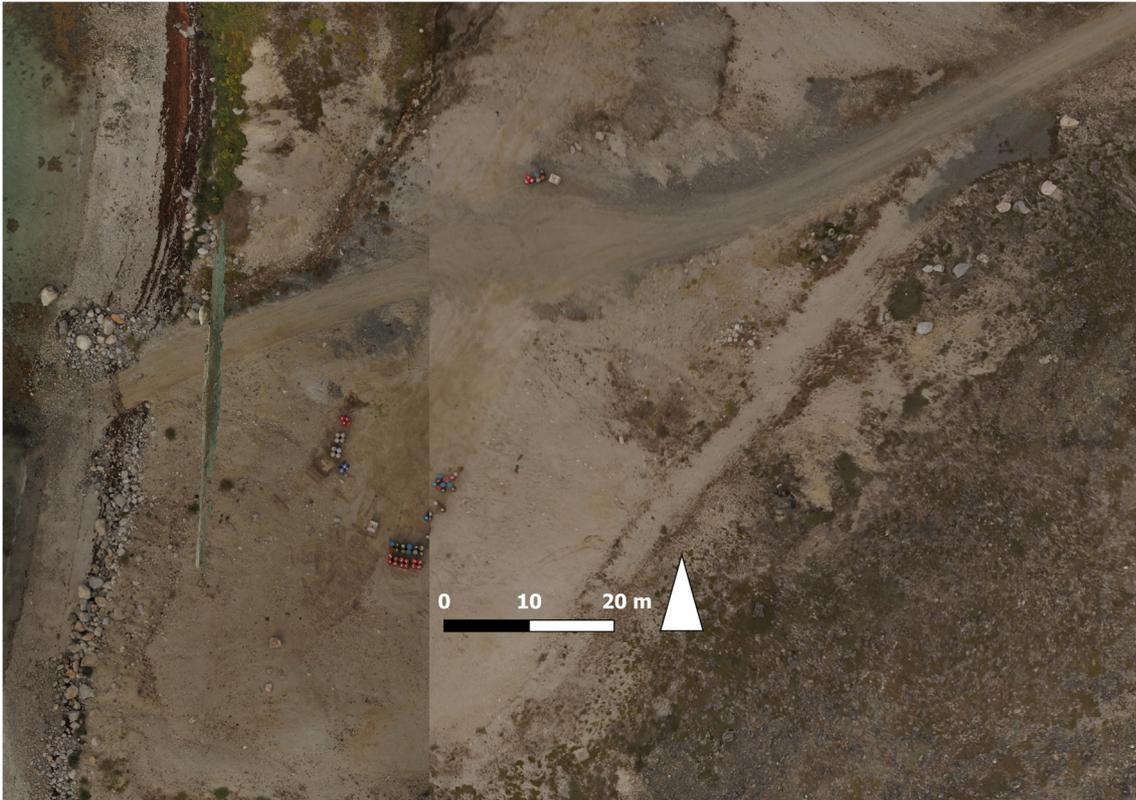
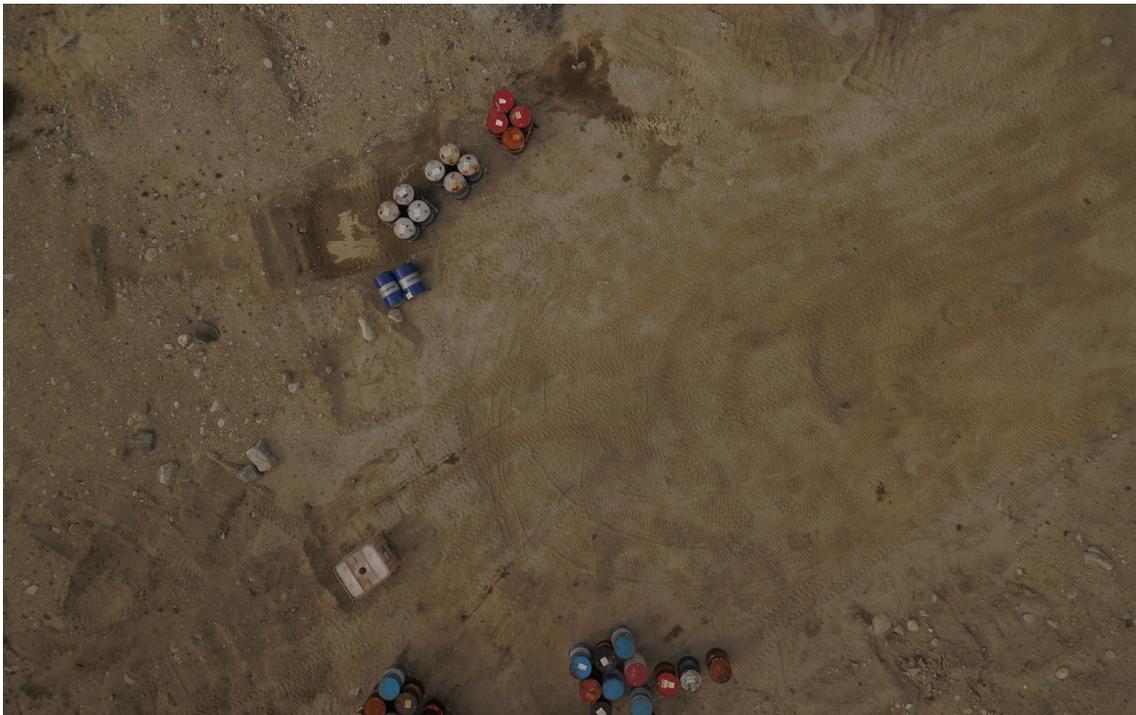
Figure A2-a and -b. Orthophoto from the beach area just west of the new camp, where heavy equipment is landed (a), as well as the actual photo of the area where the fuel barrels are located. At the top of the picture you see staining of the sand around the barrels, which may be due to a spill or possibly rain-water from the top of the barrels.
