ENVIRONMENTAL MONITORING AT THE NALUNAQ GOLD MINE, SOUTH GREENLAND, 2004-2019

Scientific Report from DCE - Danish Centre for Environment and Energy

No. 386

Lis Bach

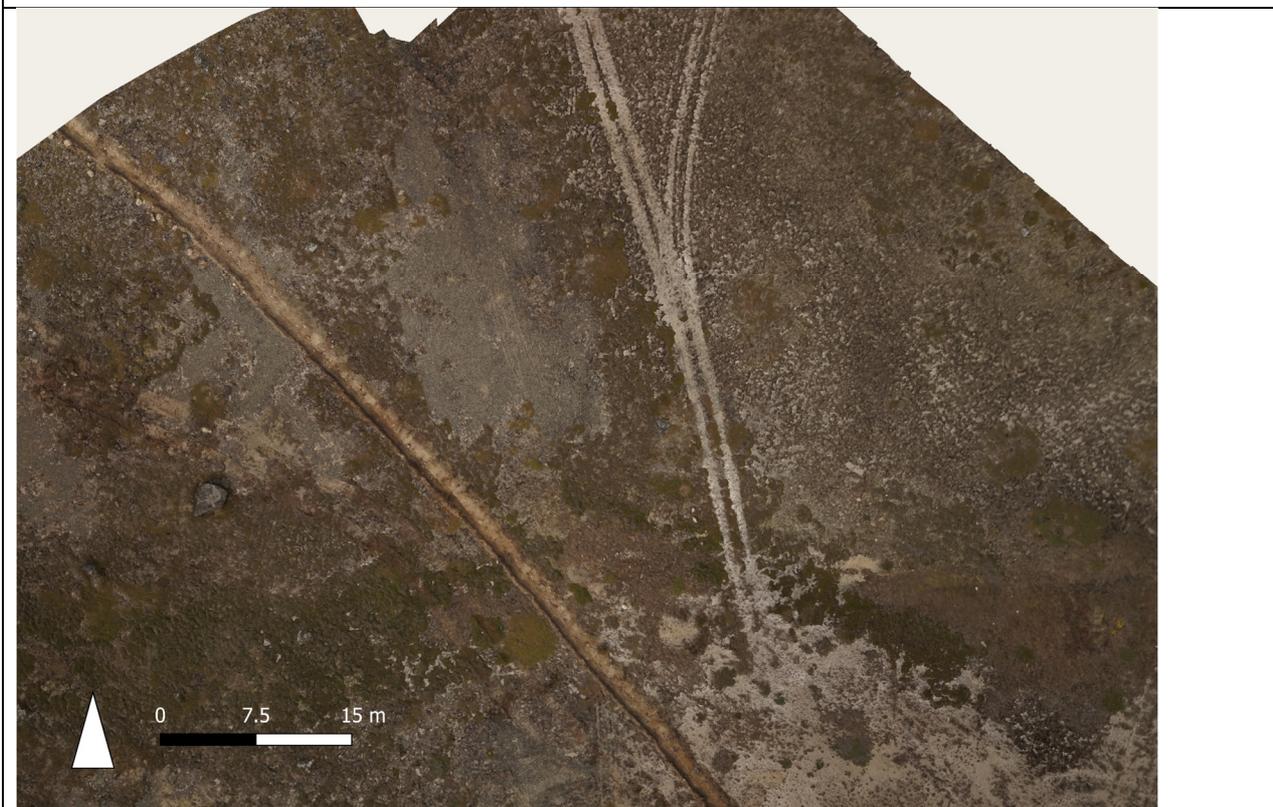
Figur A4. On the left side is the newly dug trench from the camp down to the coast for wastewater piping. To the right is an old driving track.

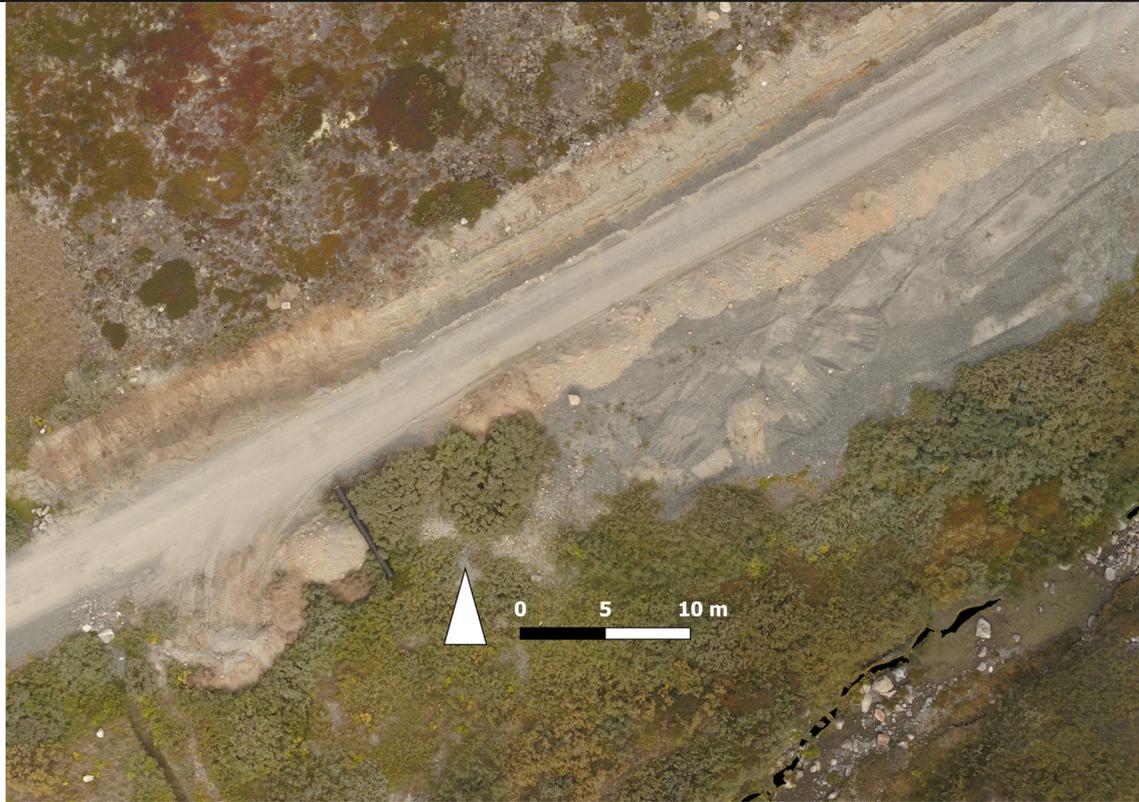
Figure A5. Road repair and trench excavation. Also seen is a plastic tube that is used for culverts.

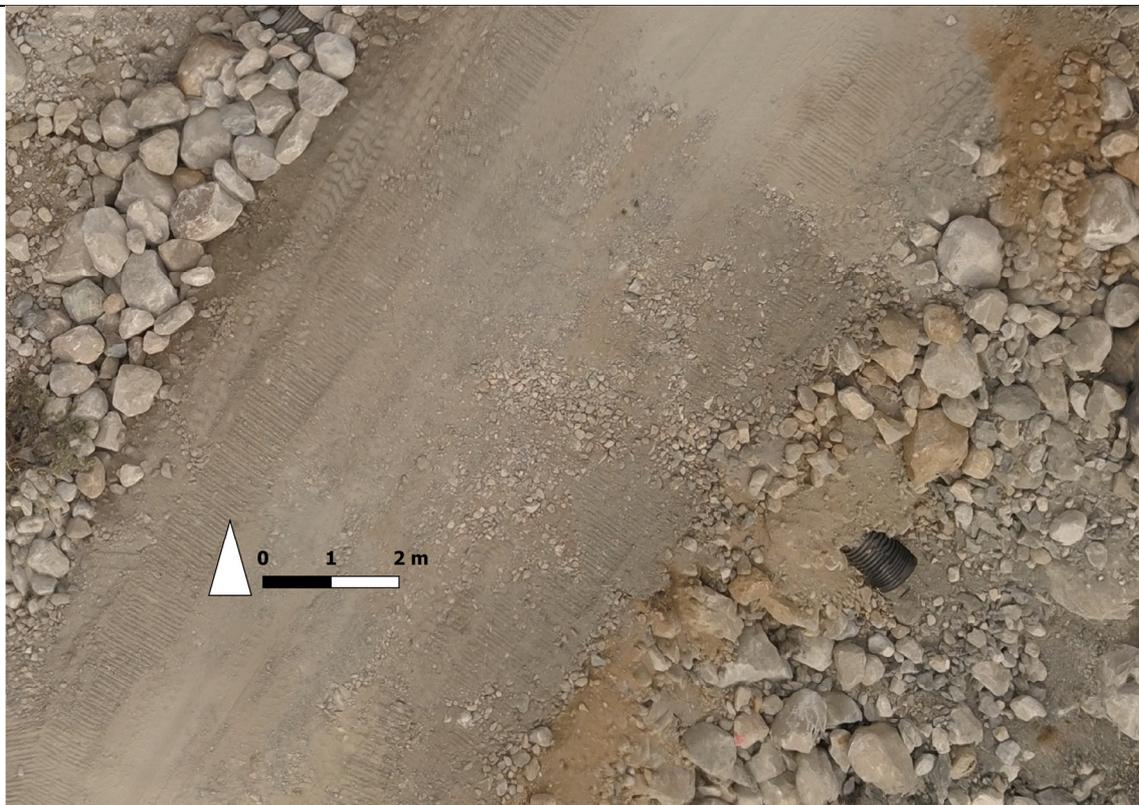
Figure A6. Example of a newly placed culvert.

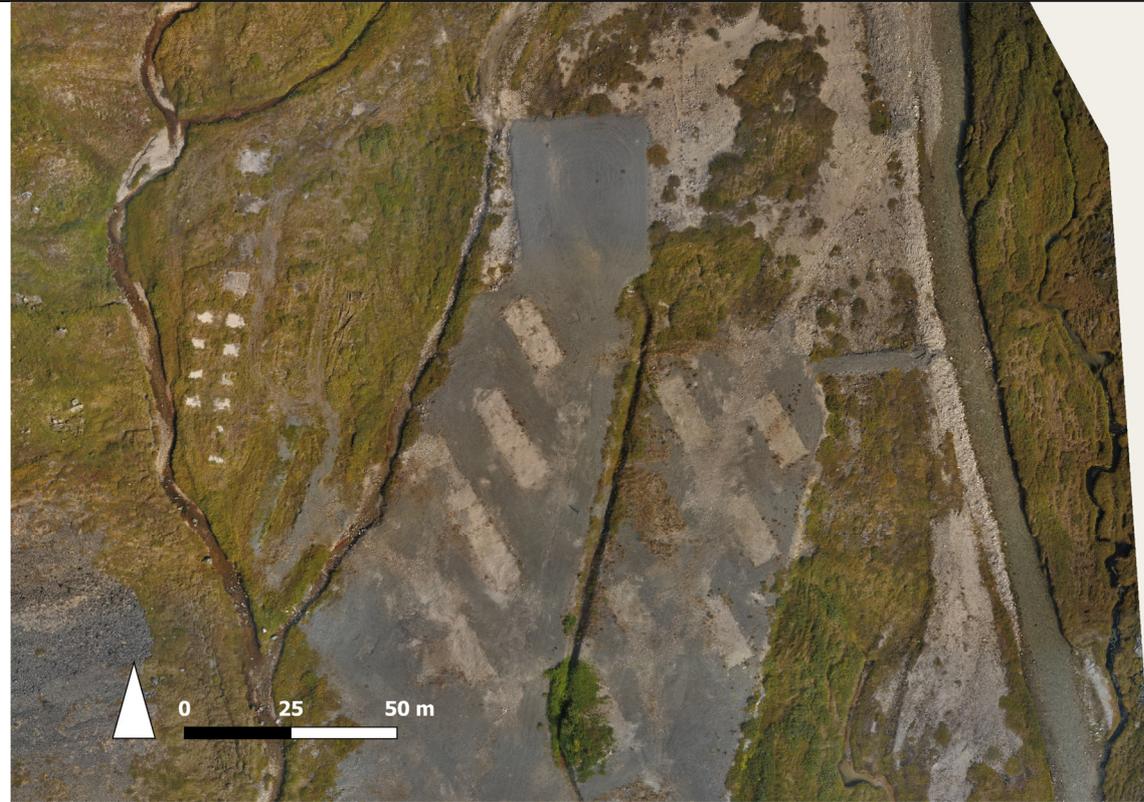
Figur A7. The former camp area, where the location of the buildings is clearly seen.

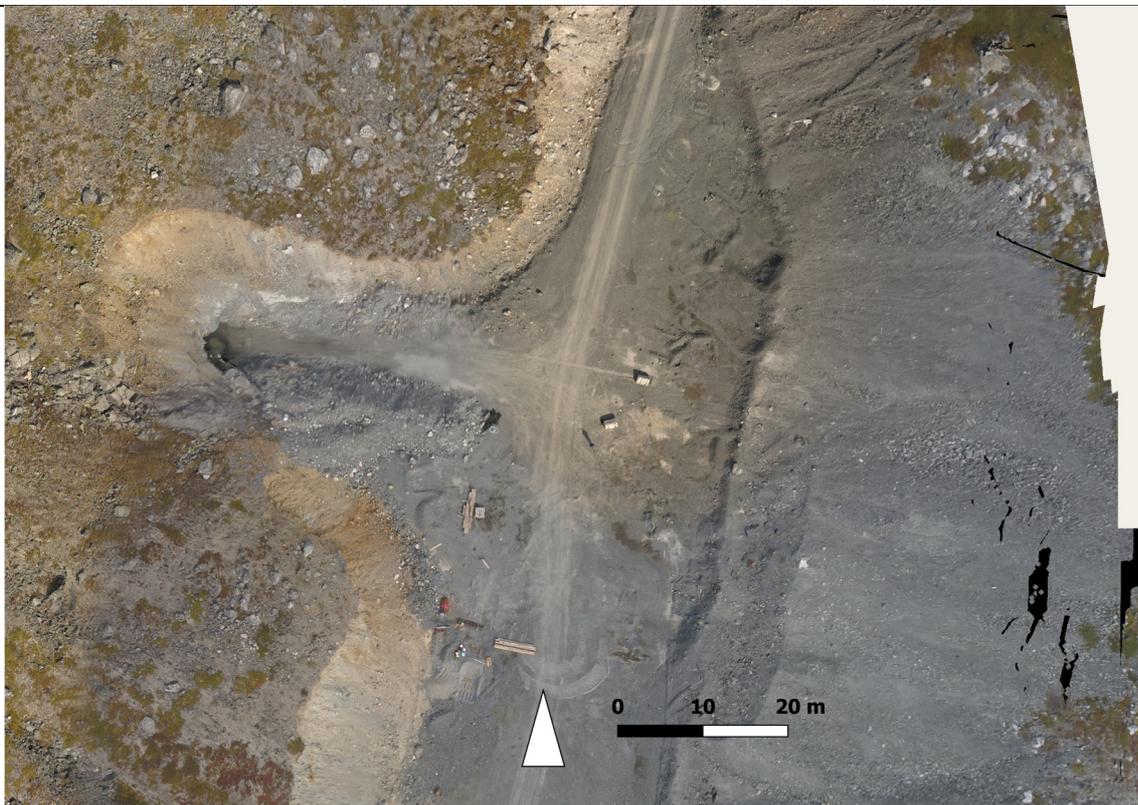
Figur A8. The 300 m portal and material placed outside of the portal.

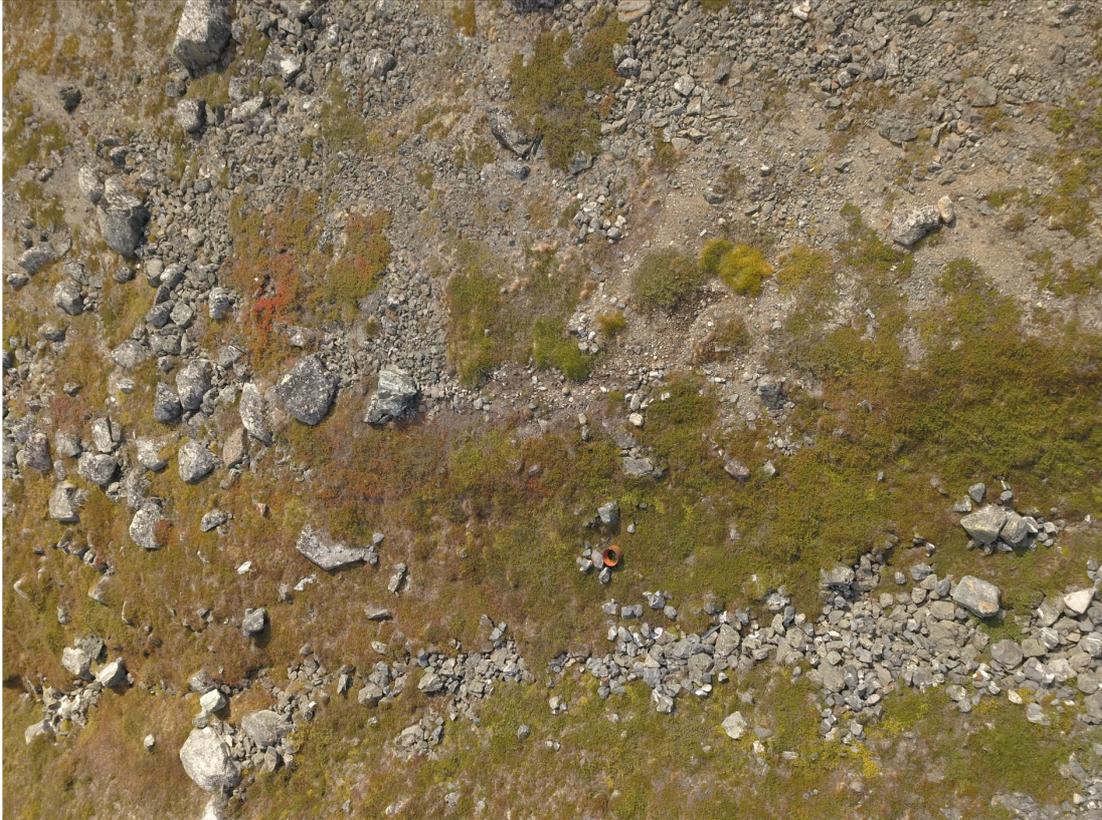
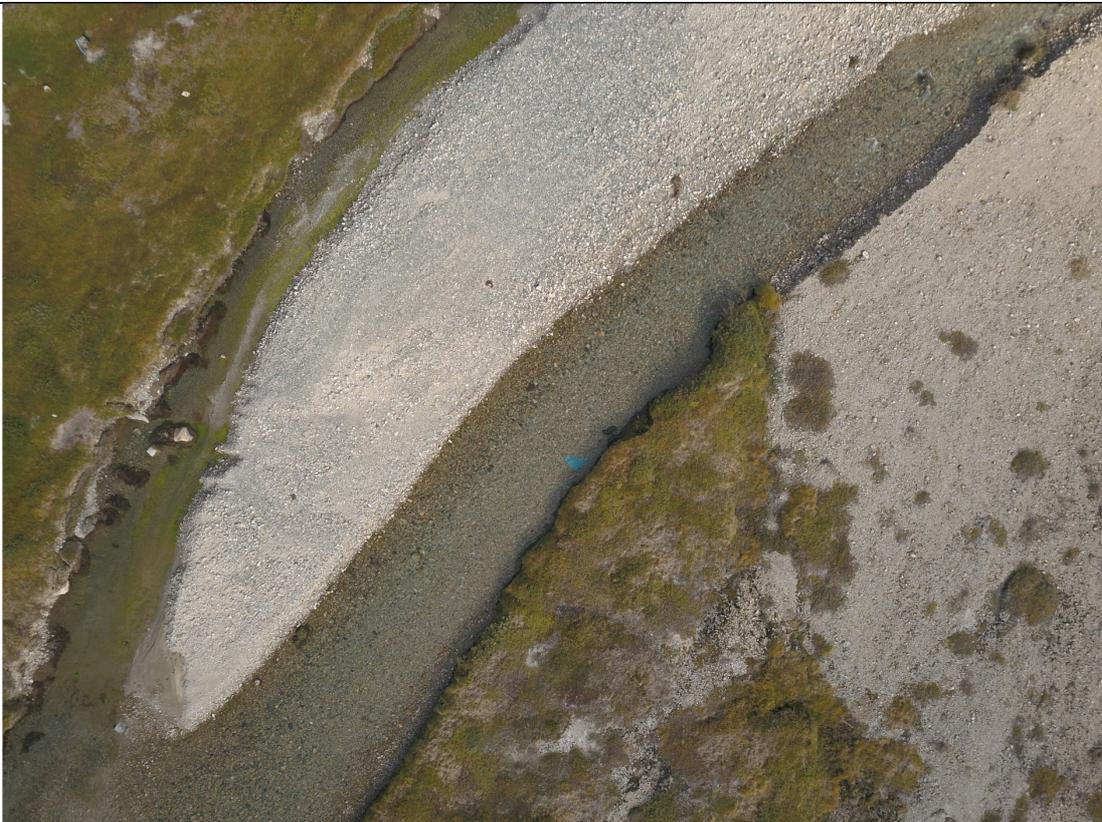
Figur A9. Two examples of waste in the terrain. A piece of orange PVC piping (top) and a piece of blue plastic in the river (bottom).

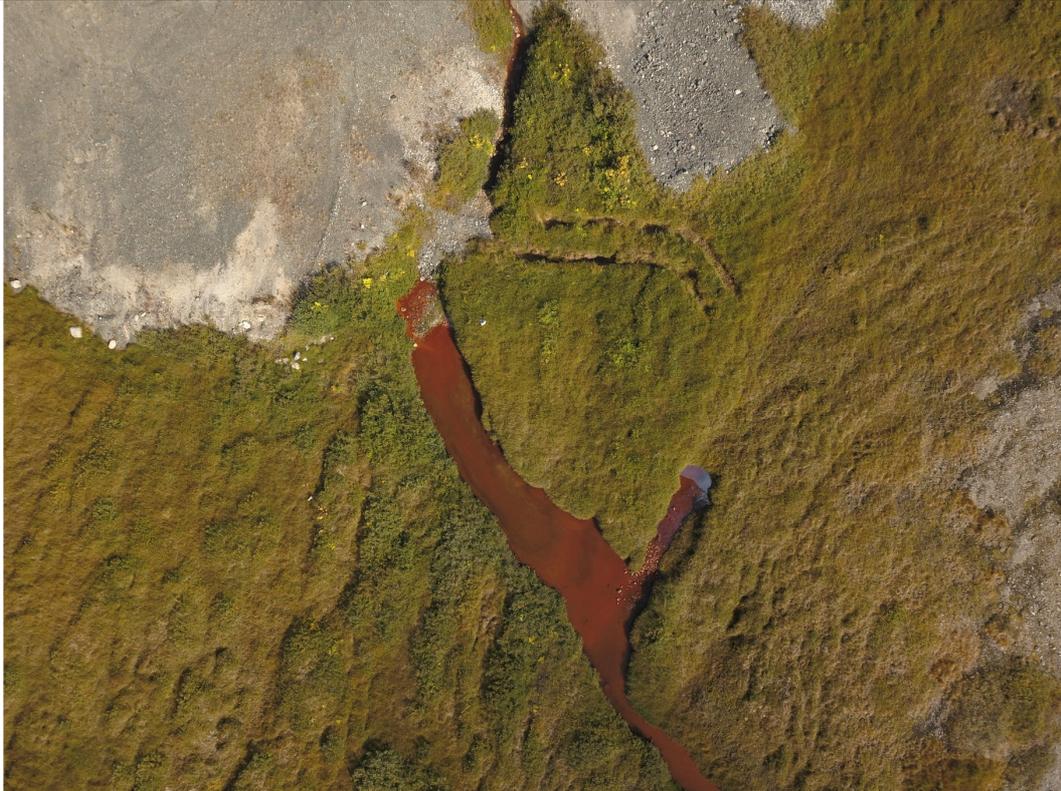
Figur A10. Leaching of iron-rich water, which is seen several places at the former camp area.

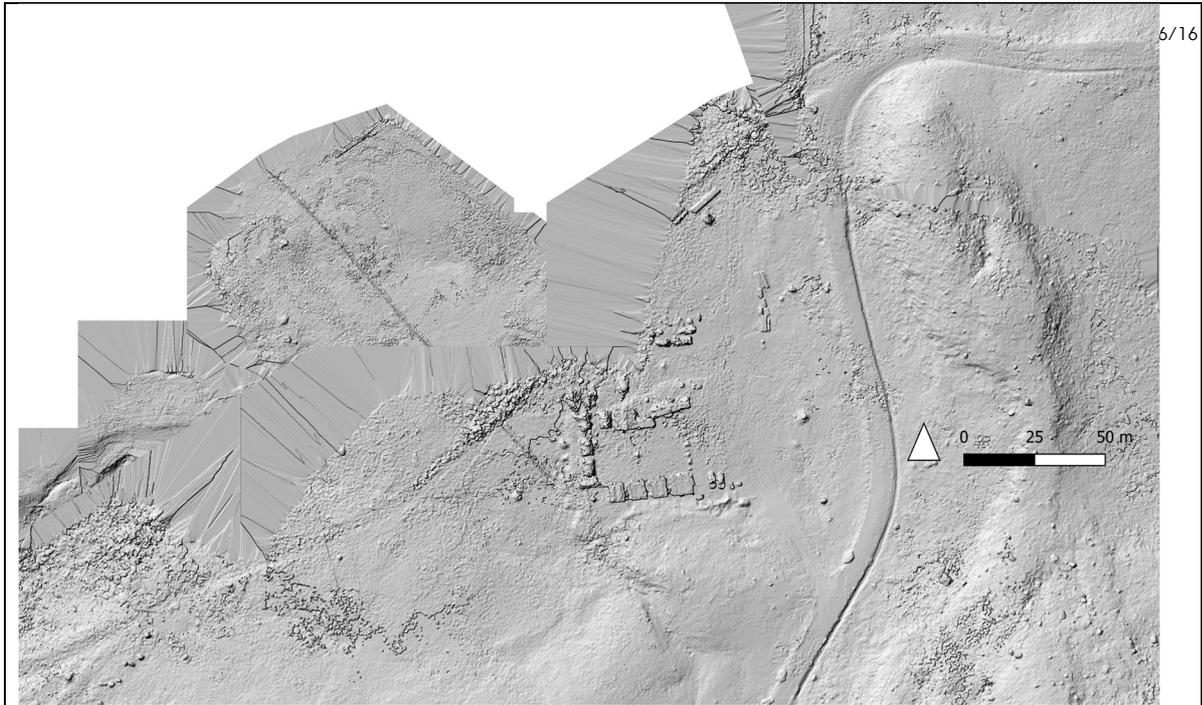
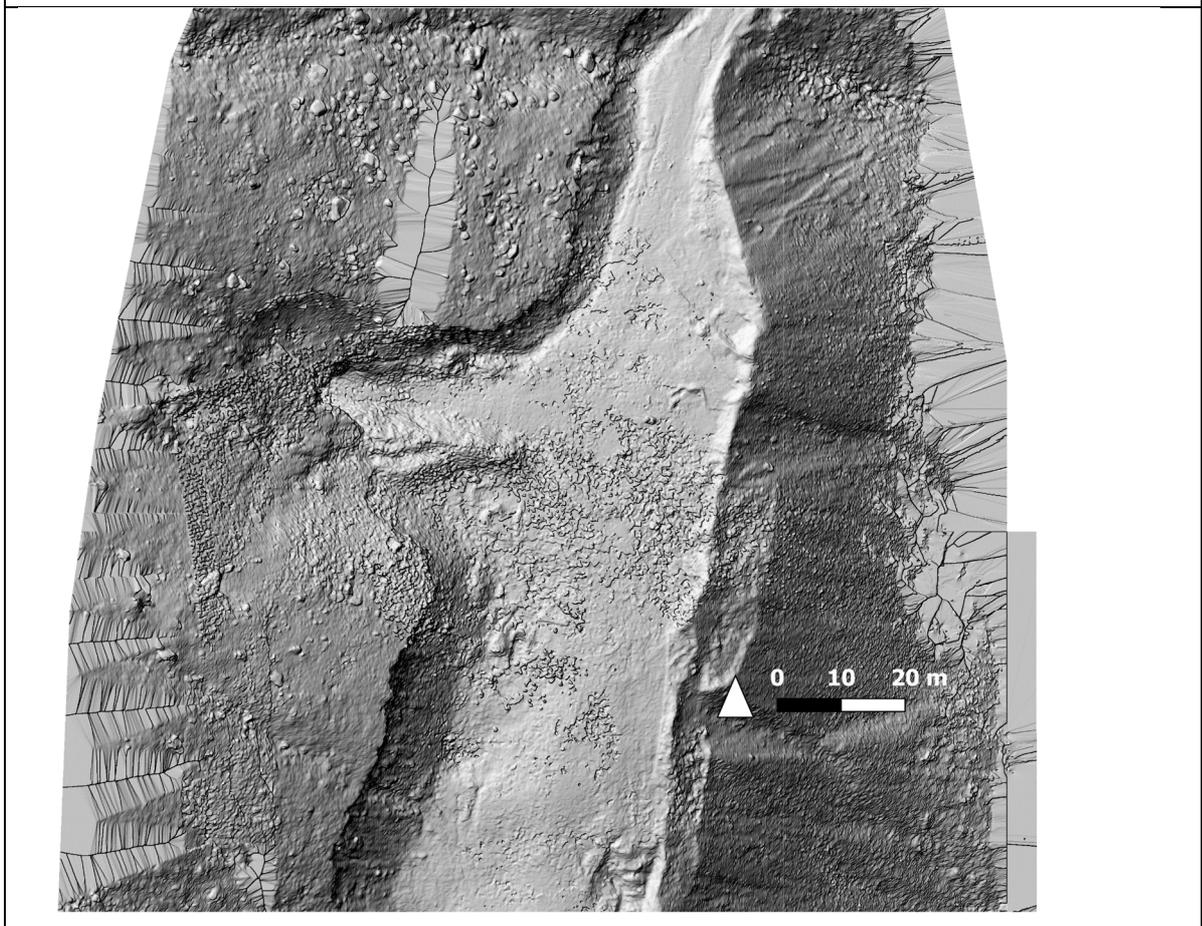
Figur A12. Examples of digital terrain models (DTM) for the camp area (top) as well as the area around the 300 m portal (bottom). The models can be used to calculate for example volumes of tailings and wasterock.
