ENVIRONMENTAL MONITORING AT THE NALUNAQ GOLD MINE, SOUTH GREENLAND, 2013

Scientific Report from DCE – Danish Centre for Environment and Energy

No. 97

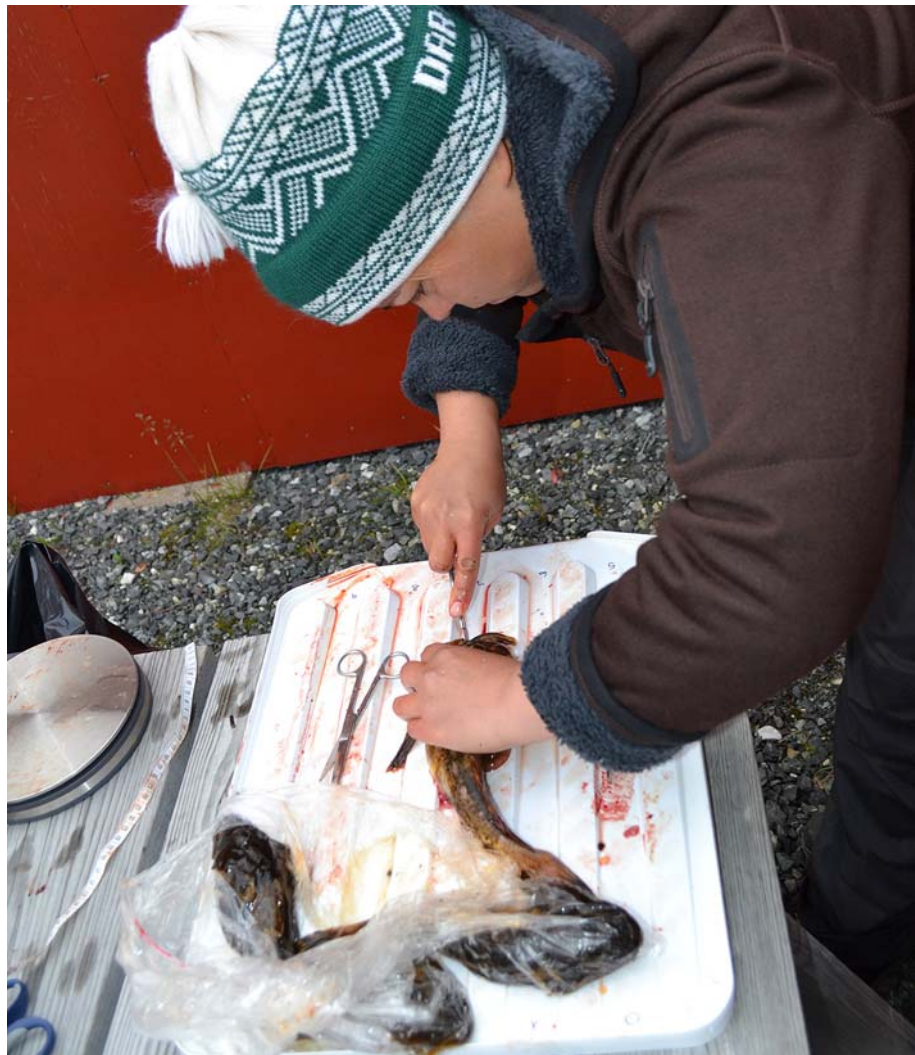
Photo 2.1. Shorthorn sculpins are caught at the marine stations and measured and weighted before the liver is dissected out for element analysis (photo by L. Bach).

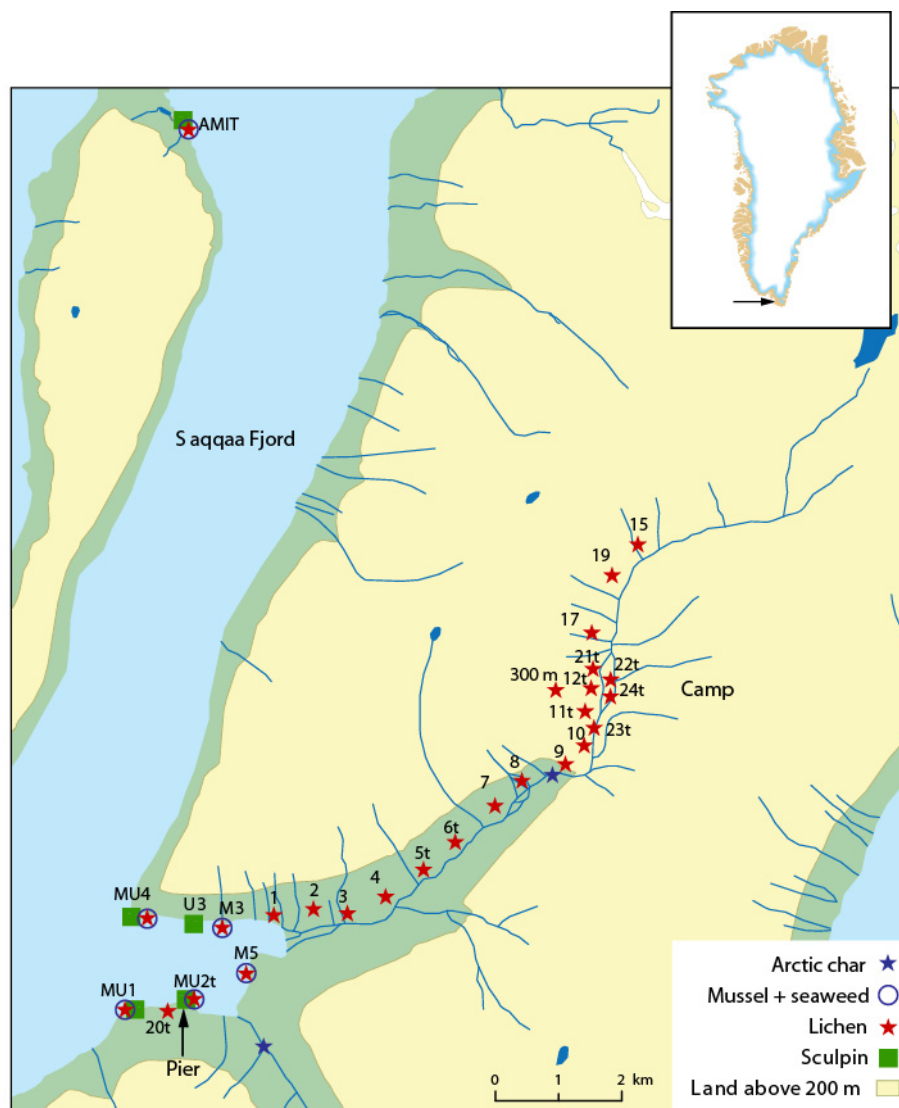
Figure 2.2. Sampling stations in the Nalunaq Gold Mine area, Nanortalik, South Greenland. M: Marine stations: Blue mussel and brown seaweed. U: Shorthorn sculpin stations. Arctic chars were caught near the lichen station 9 at the waterfall station. Lichens were sampled at 24 stations (station 1 and 2 were left out due to logistic matters). Lichens transplanted in 2012 from AMIT were sampled at stations M2-t, 5-t, 6-t, 11-t, 12-t, 20-t, 21-t, 22-t, 23-t and 24-t replaced with new lichens from AMIT. The mine entrance is west of the camp area.

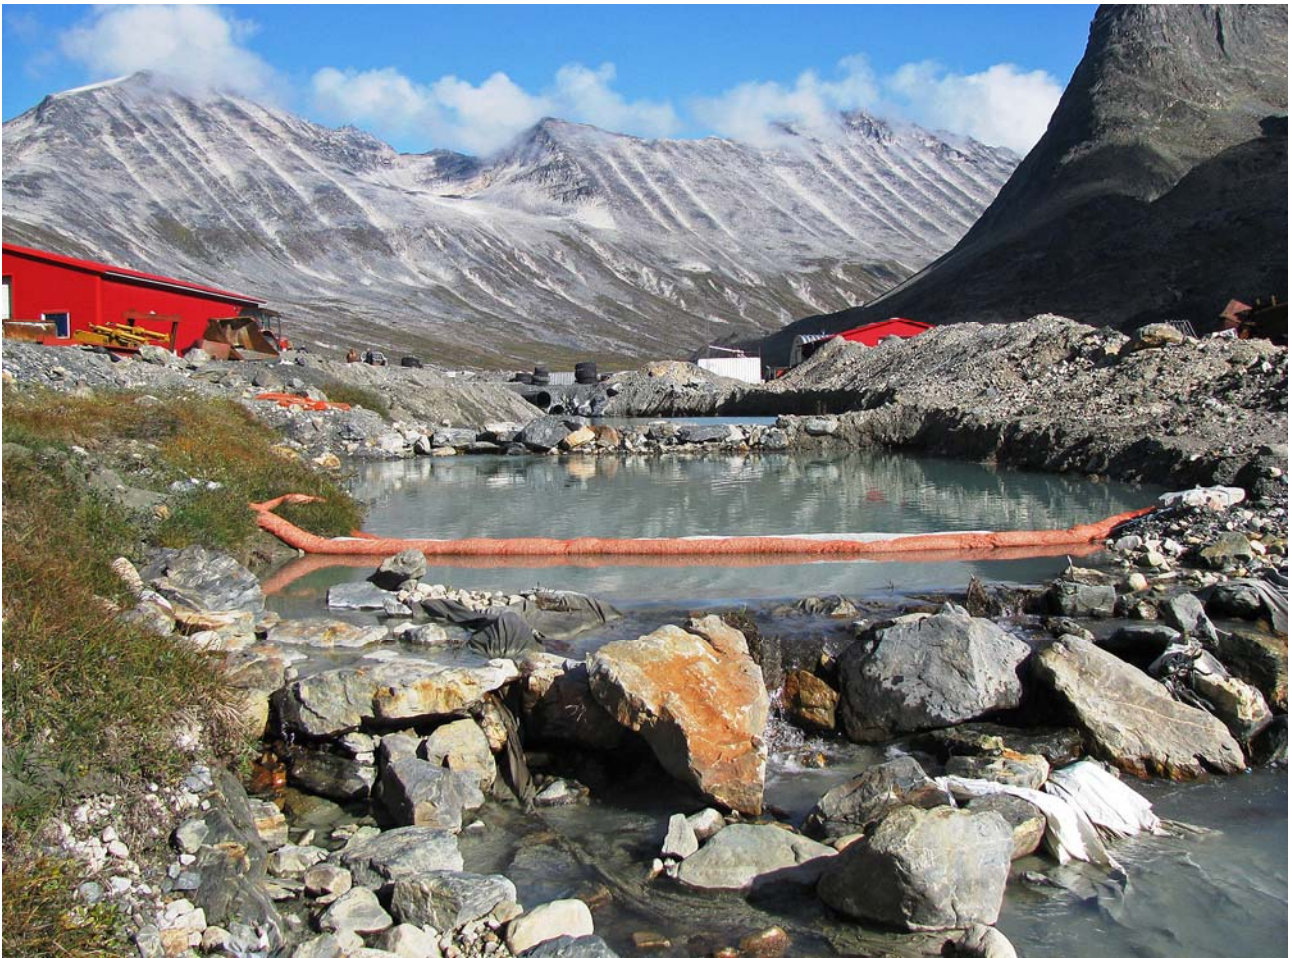
Photo 3.1. All waste water from camp and from the mine is lead through the settlement pond for sedimentation of particles and increase the retention time of the water (photo by L Bach).

Elevated concentrations of several metals, especially As and Cu, were found in the discharged wastewater from the mine. The settlement pond seems, however, to work efficiently and retains a large fraction of the metals. No elevated concentrations were measured downstream in the Kirkespir Valley and no elevated element concentrations were found in Arctic char in the Kirkespir River at the Waterfall station compared to background concentrations for the area. In general, the mine causes only little impact on the freshwater environment and as the outflow of wastewater from the mine has stopped with the closure of the mine, no impact is expected in the future.

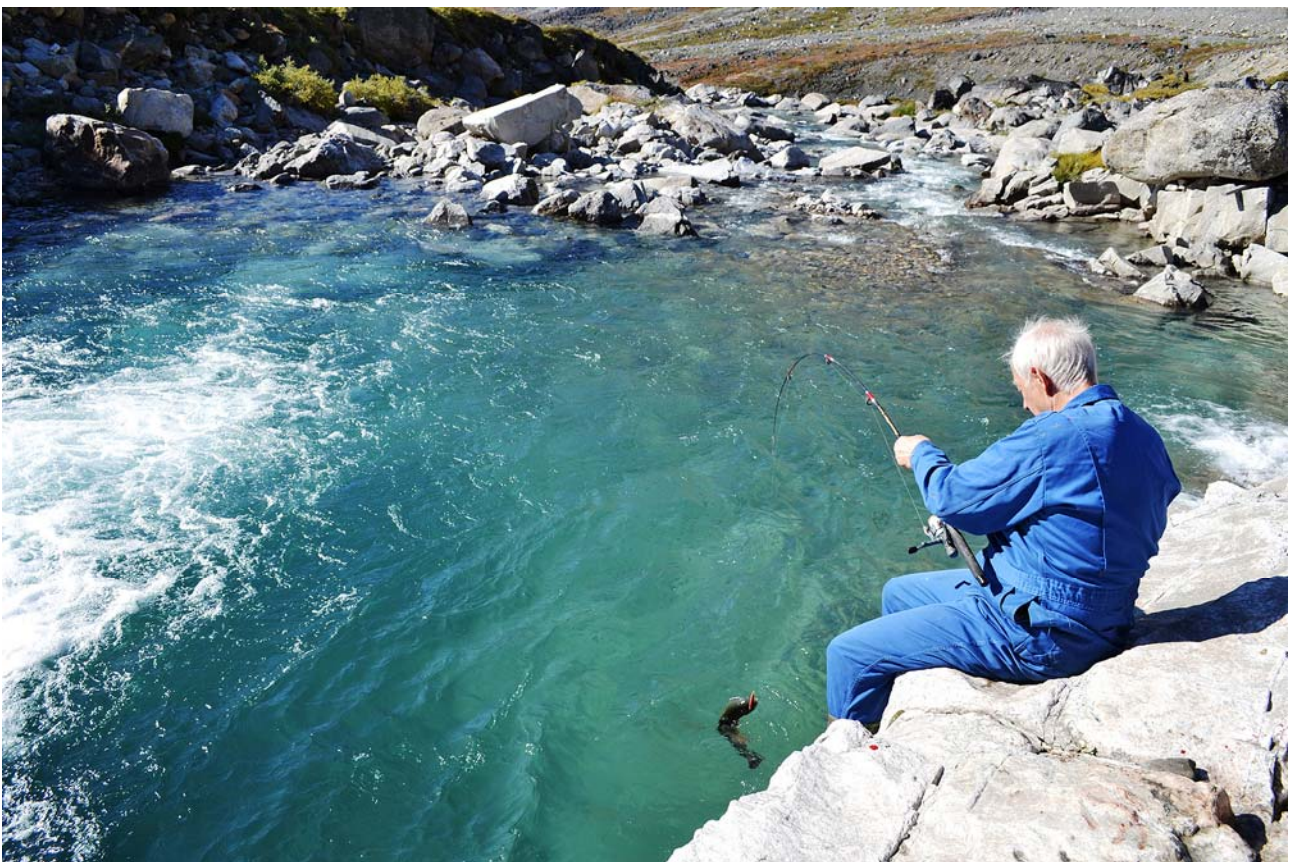
Photo 3.2. An intensive monitoring program was conducted to protect the Arctic charrs of the Kirkespir River from cyanide and metal exposure. Fish are being caught in Krikespir River, and analysed for metals (photo by L. Bach).

In livers from migrating Arctic char in Kirkespir River no element concentrations were found to be significantly different from the background data (data from 2000) (Appendix 4). Arctic chars were also caught upstream in the area shortly after the camps sewage treatment plant. These chars were of non-migrating small specimens. This is the first year that a larger stock of fish has been observed in this area. These chars had higher concentrations (2-4 times) of As, Au, Fe and Se than migrating fish from the Waterfall station in Kirkespir River, which most likely is related to their stationary way of life and the natural high occurrence of these elements in the area.

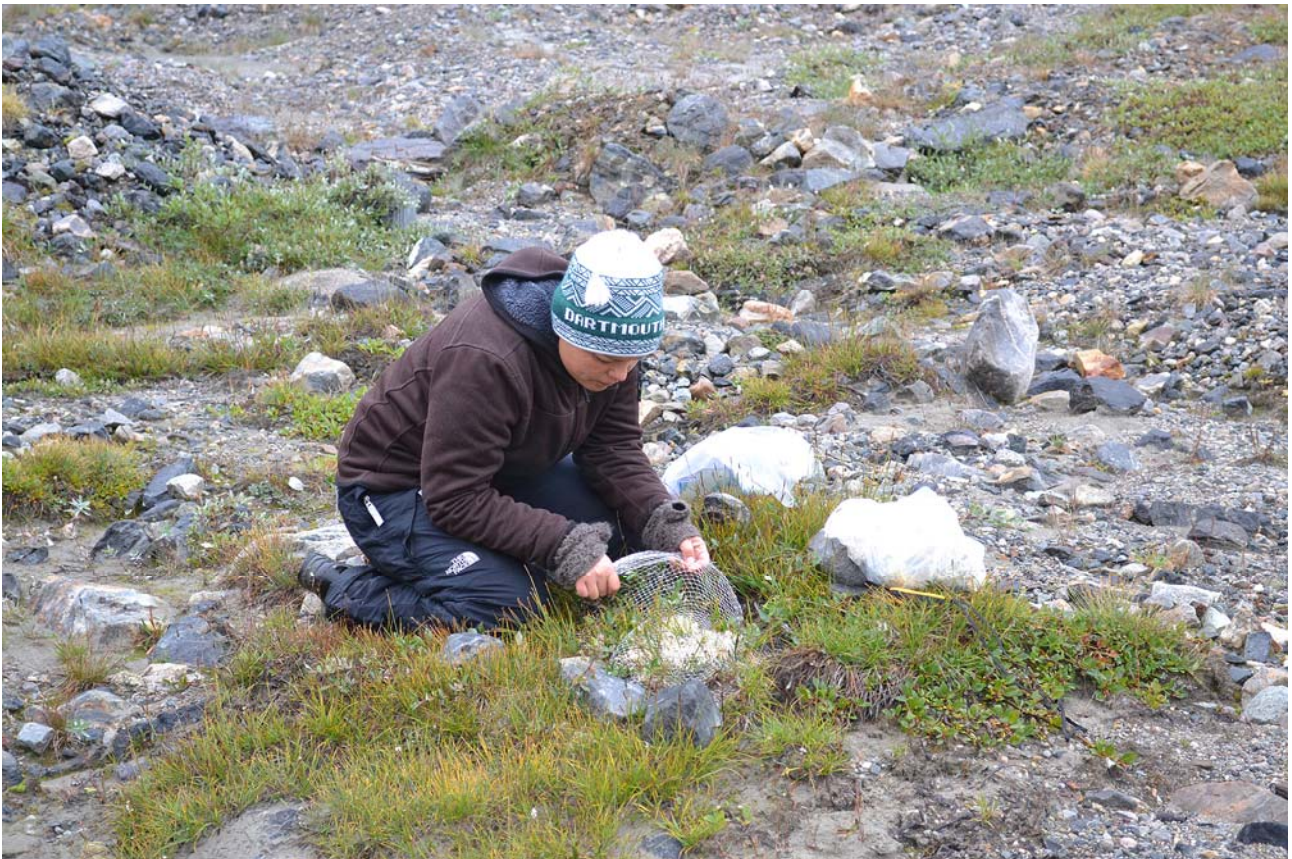
Photo 3.3. Lichens (*Flavocetraria nivalis*) transplanted early September 2012 in the Kirkespir Valley were sampled early September 2013. Transplanted lichens were covered by a net secured by stones. Lichens sampled at Amitsoq Island (reference site) in 2013 replaced the sampled lichens (photo L. Bach).
